Re: Submission regarding No. 725-133 at # 4990 Sunnybrae-Canoe-Point Road, Tappen

## **2014 McIntyre Creek Debris Flow Emergency Response and Investigation Findings**

## **Summary of Emergency Response Activities and Initial Geotechnical Assessment of the 2017 Robinson Creek Debris Flow**

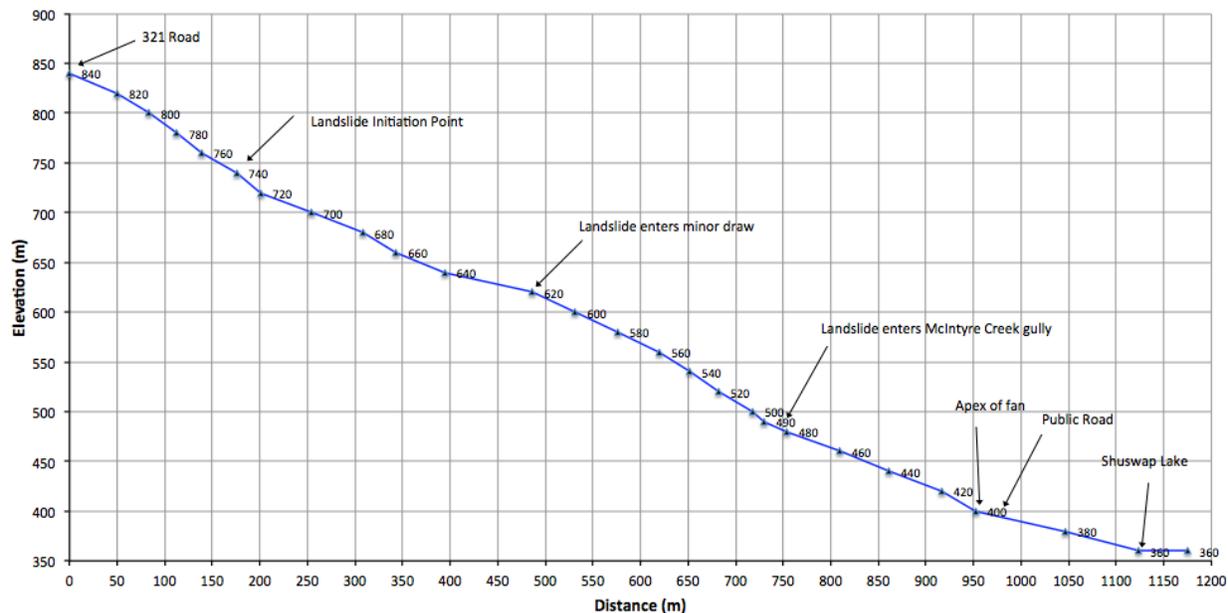
The debris slide became confined in a broad, 1.5 to 2 m deep draw below the initiation zone, where it transformed into a debris flow. It then entrained additional material from the sidewalls and channel of the draw. At about 350 m from the initiation point (elevation  $\pm 620$  m), the debris flow entered a larger, but broader, draw that drains the area below the 321 Road switchback [Figure 1]. This draw contained a small stream. There was less debris entrainment below this point as the channel bottom was mostly bedrock. At about 650 m from the initiation point (elevation 470 m), the debris flow spilled over a 20 m high cliff into the McIntyre Creek canyon. It then travelled 200 m along the creek channel, where it entrained additional sediment and several large trees. The profile of the landslide track is shown on Figure 2.

Figure 2 – Profile of McIntyre Creek debris flow path, based on TRIM map contours.

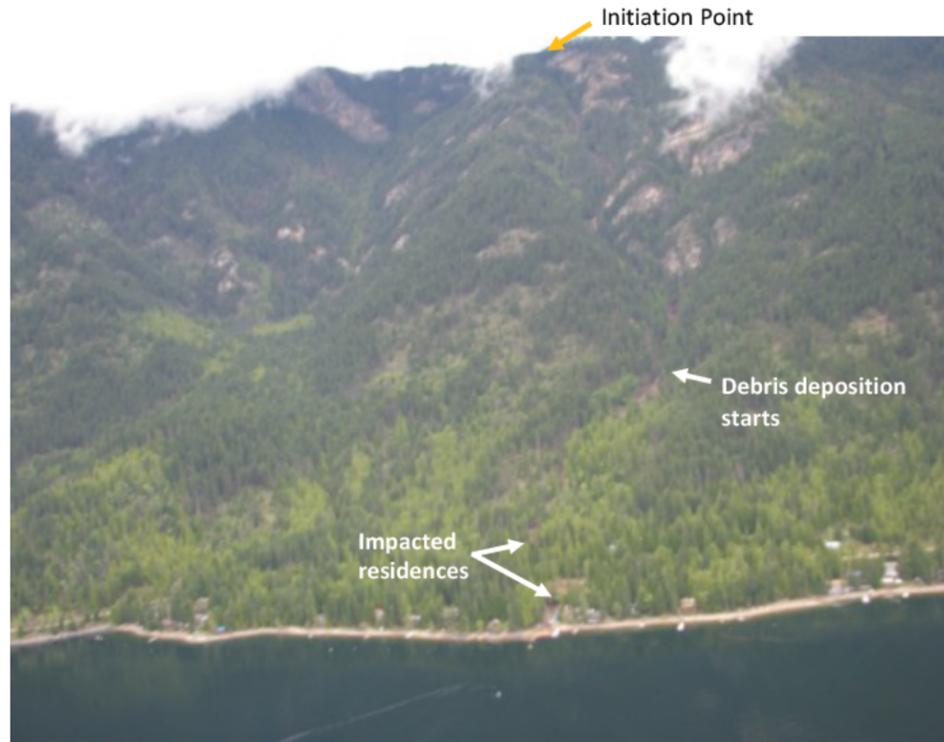
*Photo 1 – View north of the Robinson Creek drainage on the morning of May 6, 2017, showing the extreme relief and the key features.*

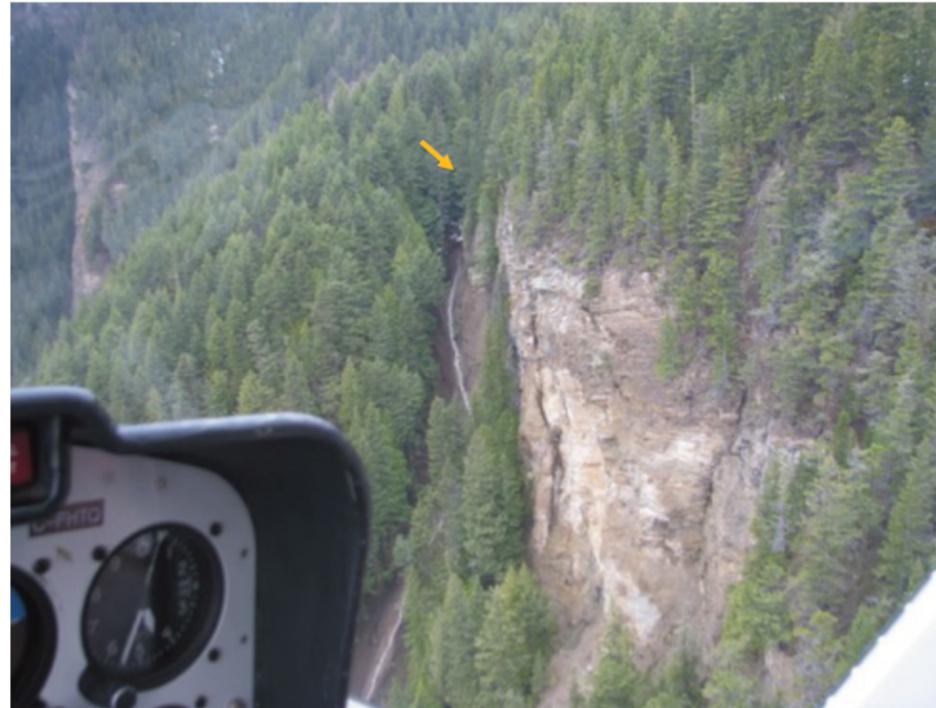
*Photo 2 – View northwest into the bedrock crevice / draw showing the debris flow initiation point (orange arrow), taken May 6, 2017.*

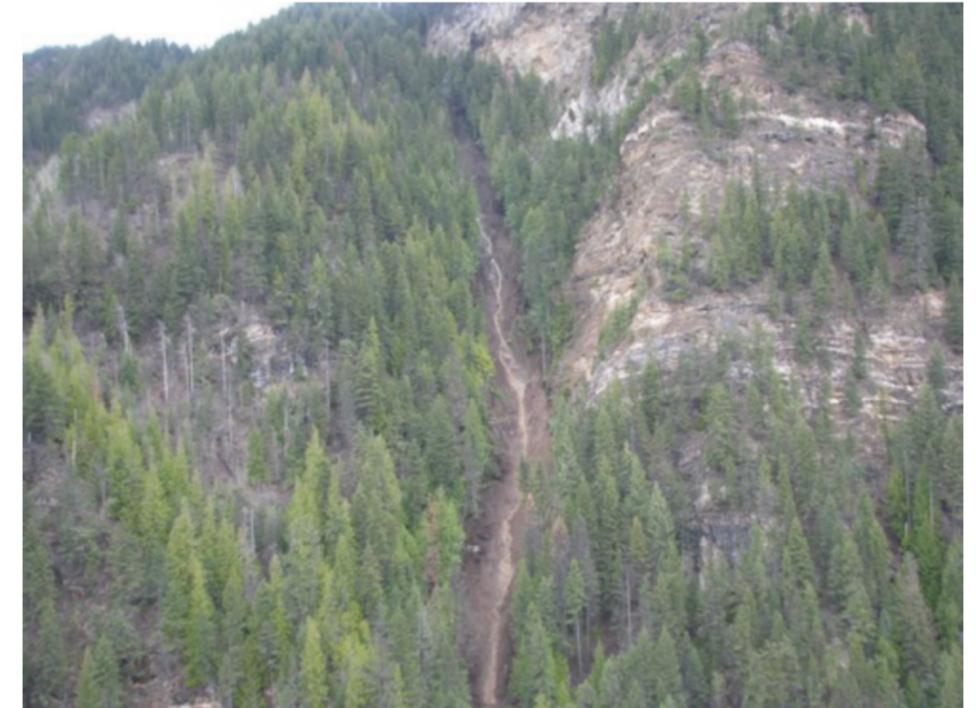
*Photo 3 – View of the steep gully channel in the upper part of the west branch of Robinson Creek, taken May 6, 2017.*

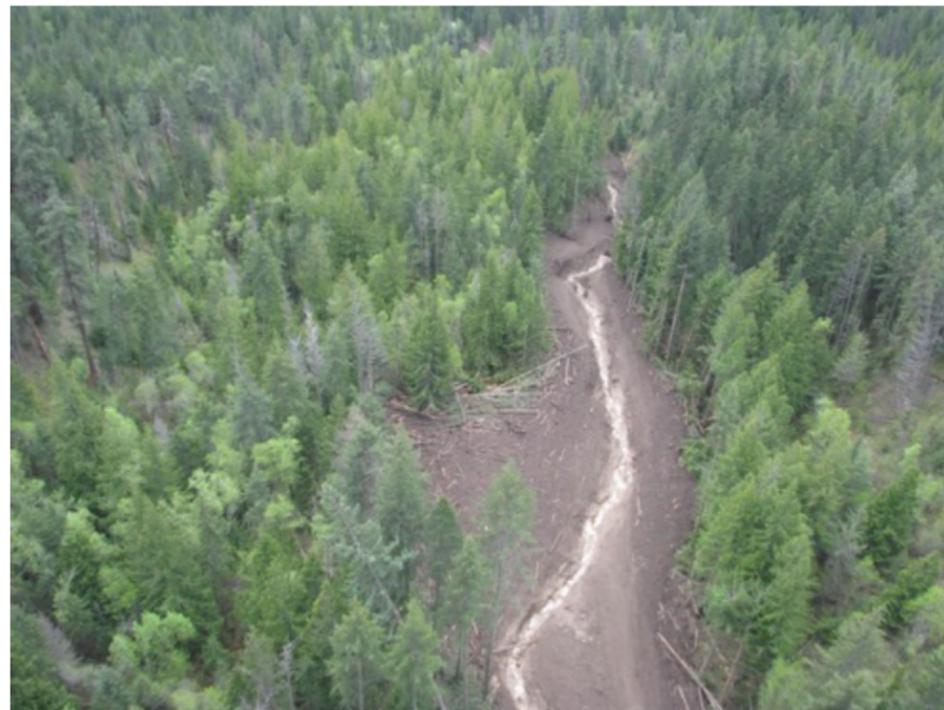
*Photo 4 – View downstream (south) of the upper part of the logjam and debris deposit, just downstream of the fan apex. This deposit may have deflected the debris away from the east side of the fan.*

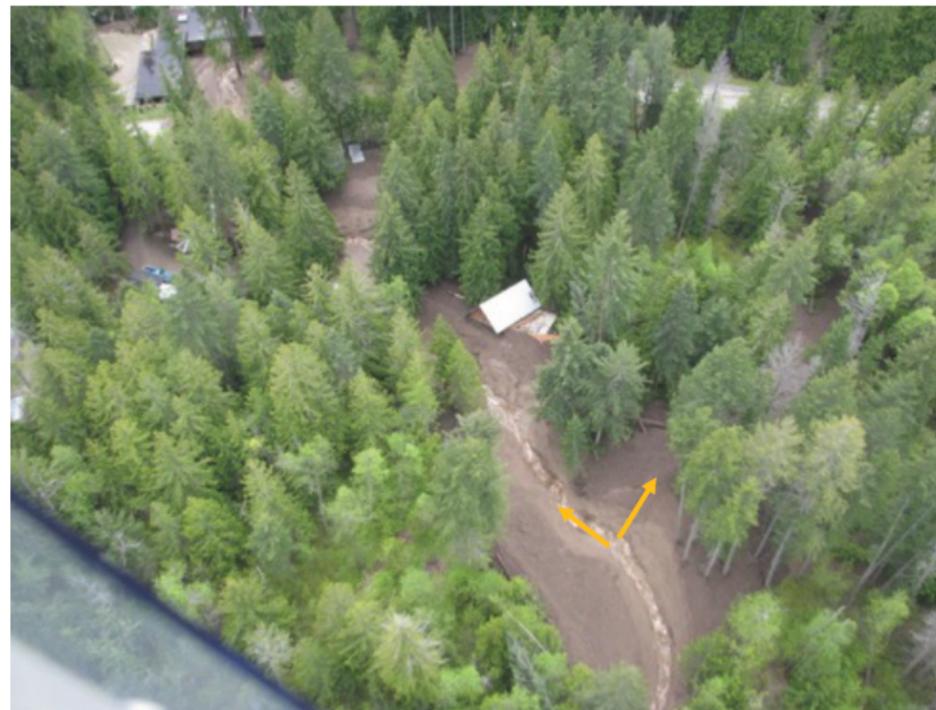
*Photo 5 – View downstream of the residence on 5921 Sunnybrae – Canoe Point Road that was destroyed on May 6, 2017. The debris flow bifurcated as shown and a small lobe of debris travelled through the trees to the right.*

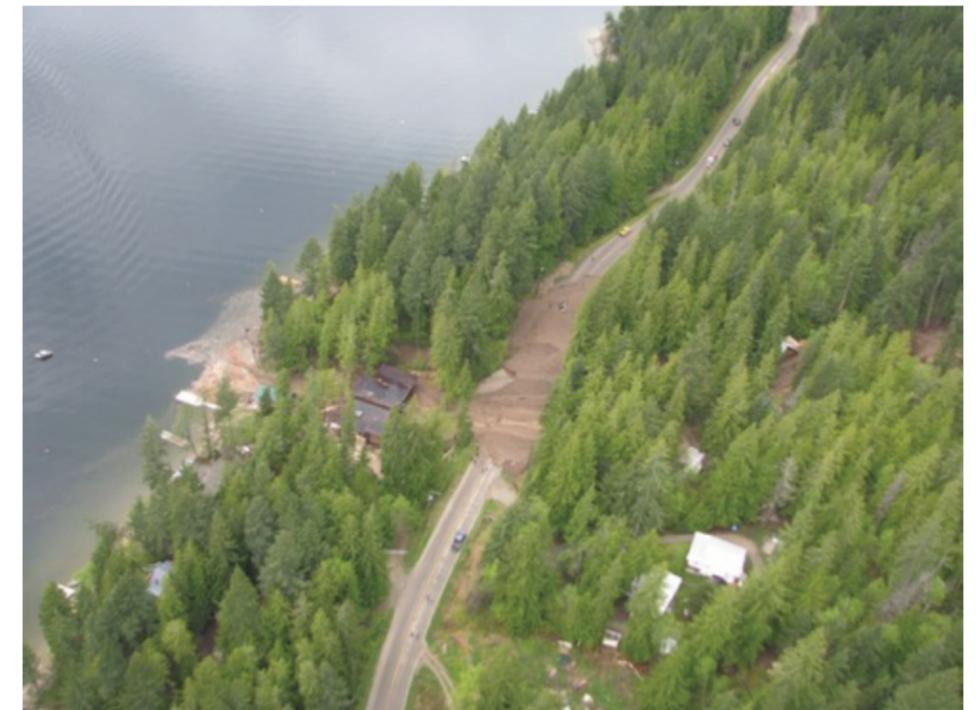
*Photo 6 – View southwest of the debris that covered the Sunnybrae – Canoe Point Road. The impacted residence at 5932 Sunnybrae – Canoe Point Road is visible below the road.*

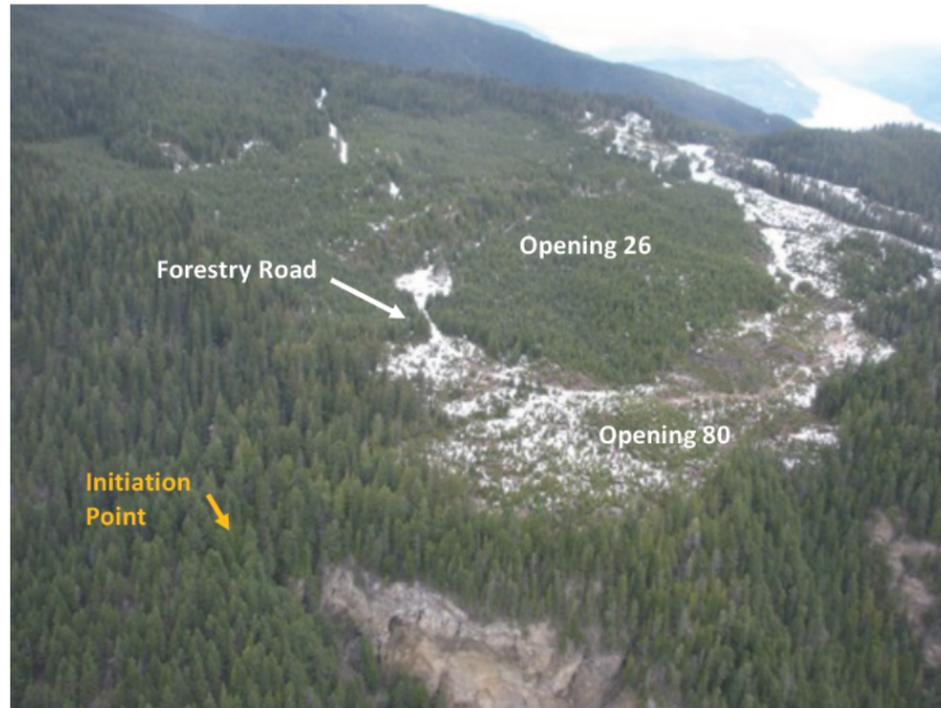
*Photo 7 – View northeast over the two logging blocks on the plateau. This photo was taken on May 15 after a lot of the snow had melted in the opening. The initiation point is noted.*

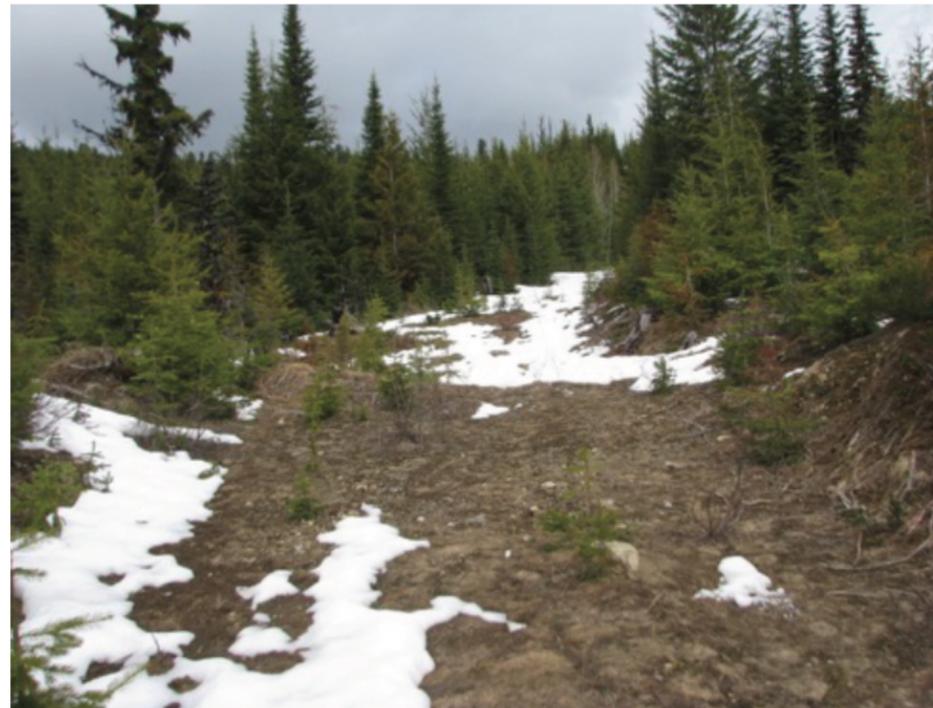
*Photo 8 – Typical view of the forestry road in Opening 80, taken May 15, 2017.*

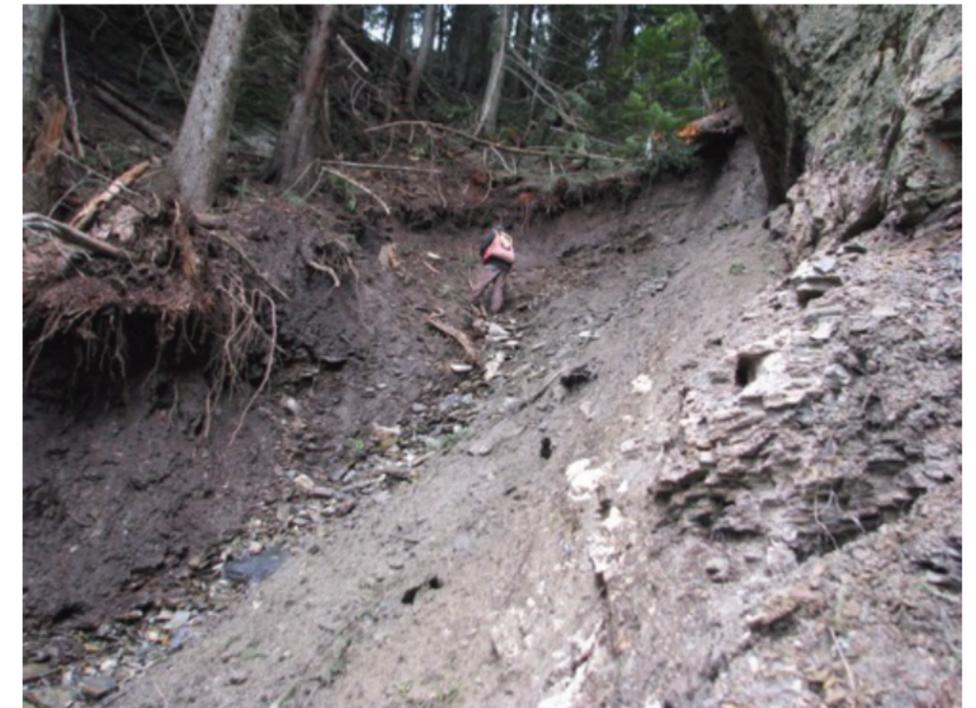
*Photo 9 – View up to the scarp taken on May 15, 2017. Note the bedrock present on the right side of the photo, which extends up a high cliff to the plateau edge. A stream emerges from the rubble below the person. Tension cracks were observed to the left behind the tree (Photo 11).*

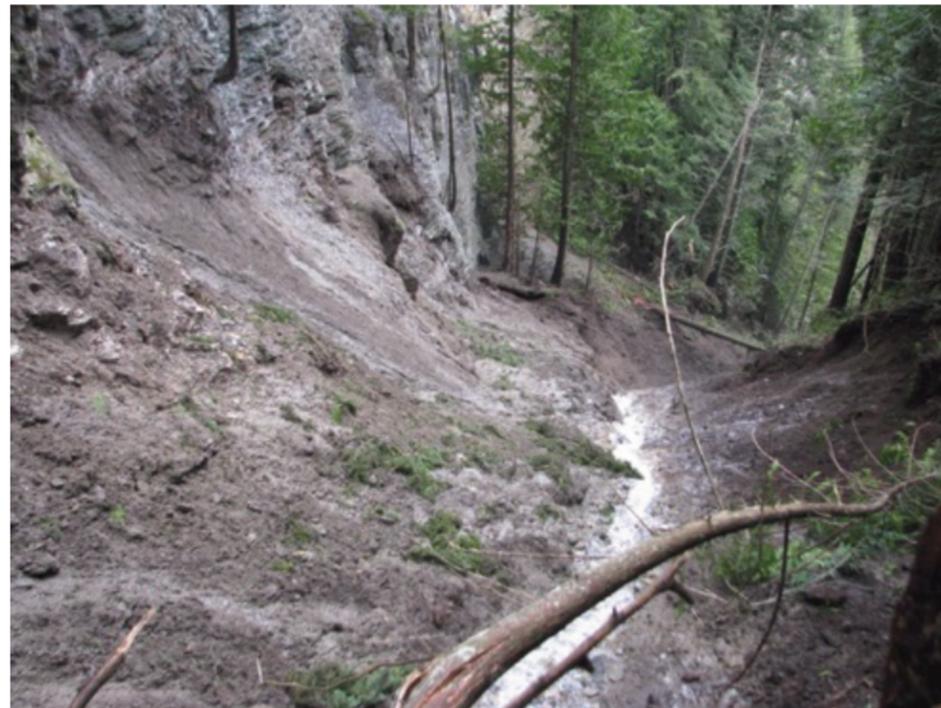
*Photo 10 – View downstream from the scarp showing the transition between the initiation zone and the debris flow translation zone in the very steep gully below. Sidewall slope failures are visible in the right side of the photo. The photo was taken on May 6, 2017.*

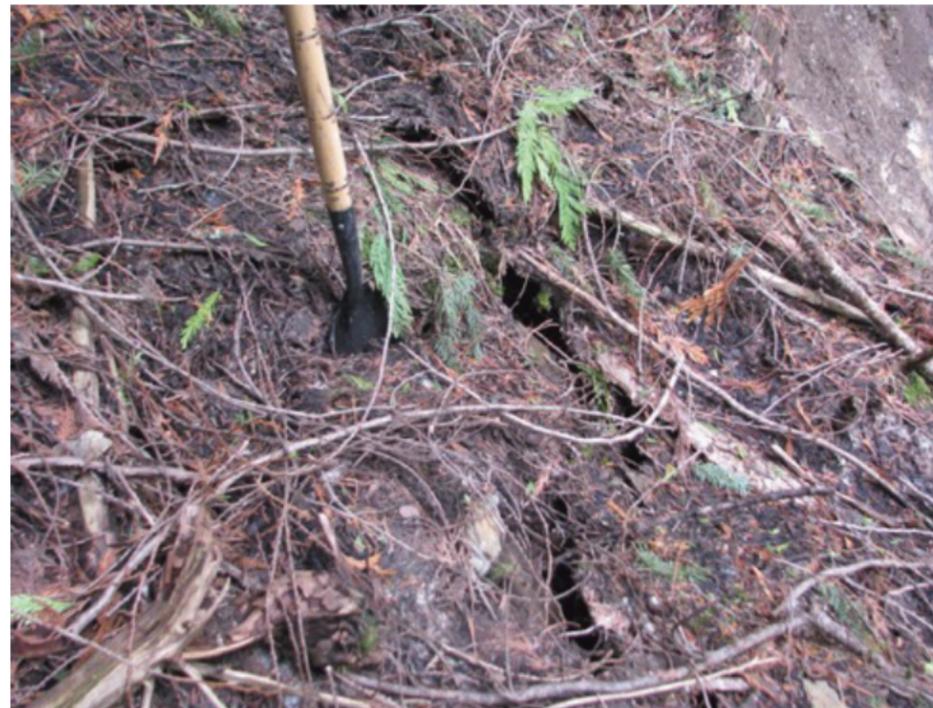
*Photo 11 – This photo shows tension cracks that had formed in the colluvium on the right bank near the scarp. Photo was taken on May 15, 2017.*

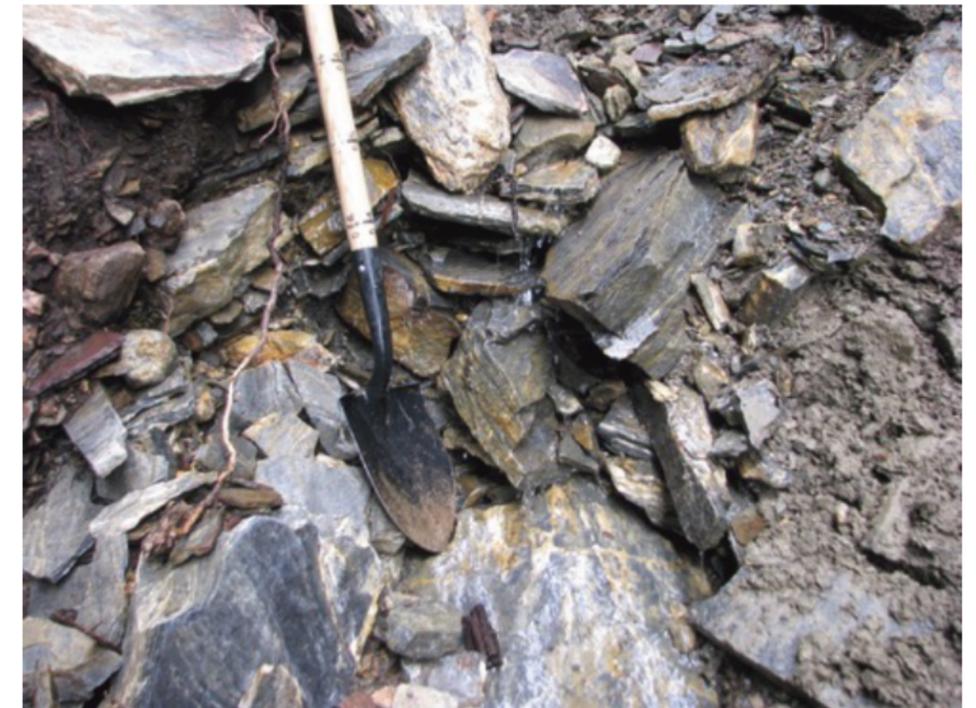
*Photo 12 – View of the coarse angular fragments in the gully channel, in the lower part of the initiation zone. The gradation on the shovel is 10 cm. A spring was emerging from the coarse sediment. Photo was taken on May 15, 2017.*

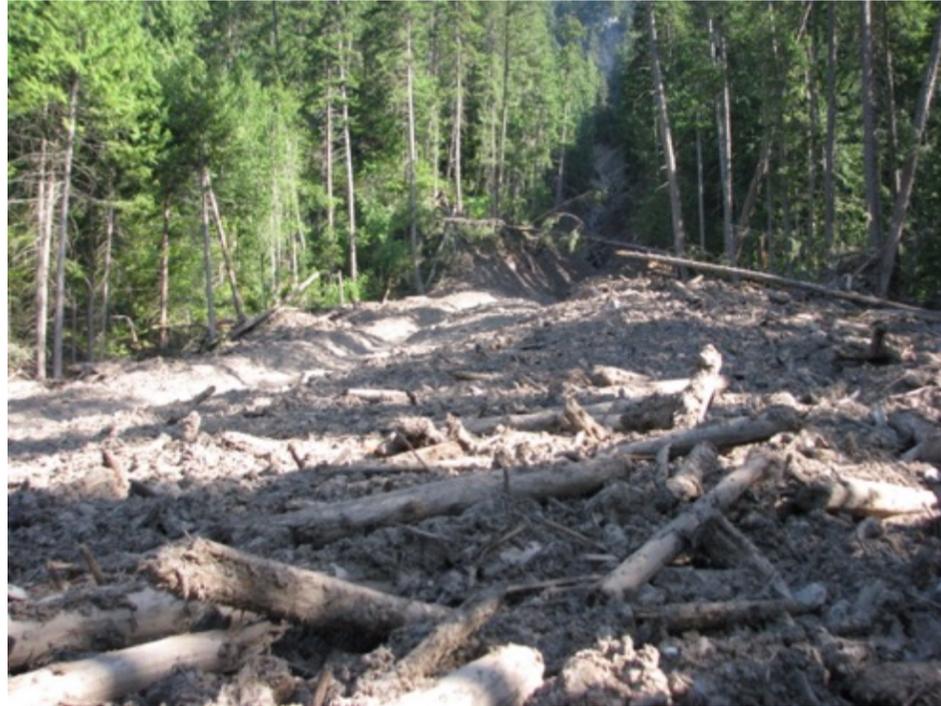
**Photo 13** – View upstream at the large accumulation of debris arrested by the large log jam at Wpt 088 (see also Photo 4). The debris deposit was about 60 m wide at this location. Photo was taken on May 29, 2017.

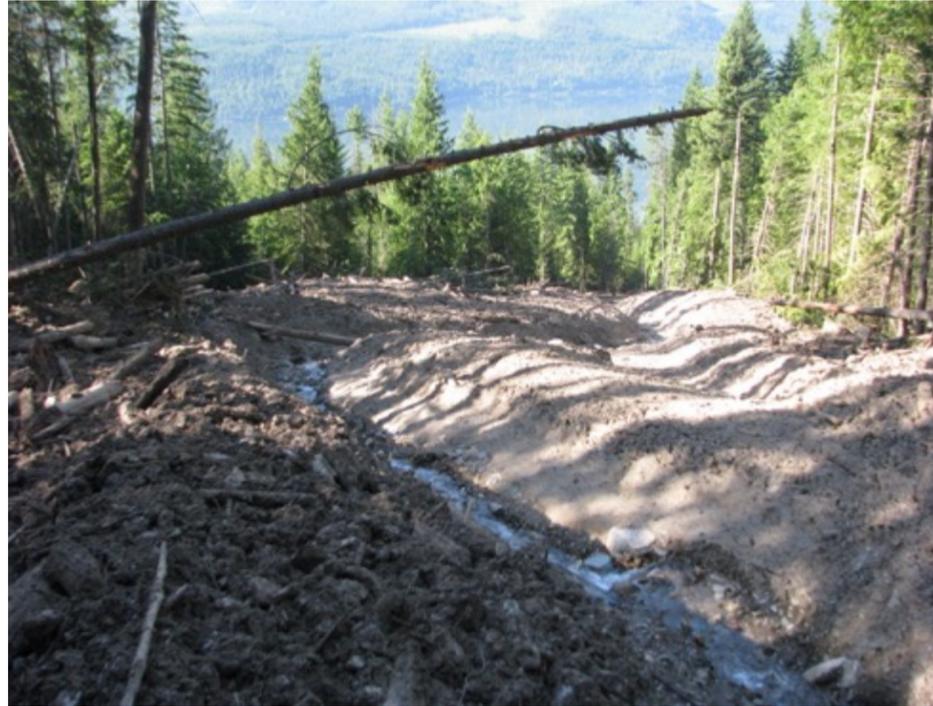
**Photo 14** – View downstream at the large accumulation of debris arrested by the large log jam at Wpt 088 (see Photo 4). This caused the creek to turn to the west. Photo taken on May 29, 2017.

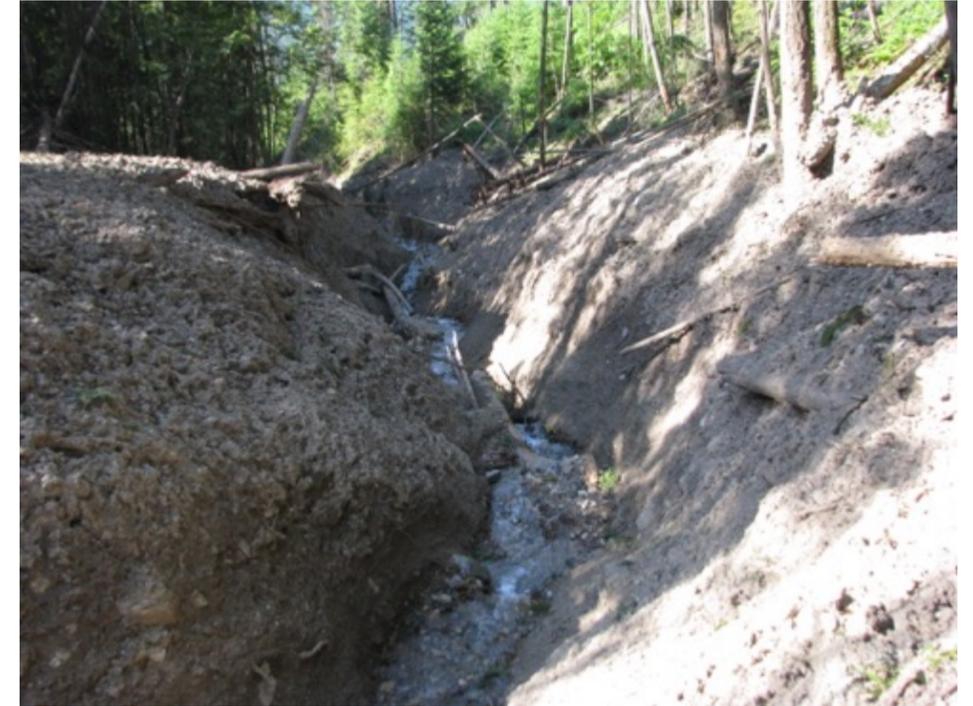
**Photo 15** – View downstream of the typical creek channel eroded into the new debris and possibly old fan deposit. Location is in the upper part of the fan. Note the over-steep sidewalls. Photo taken on May 29, 2017.

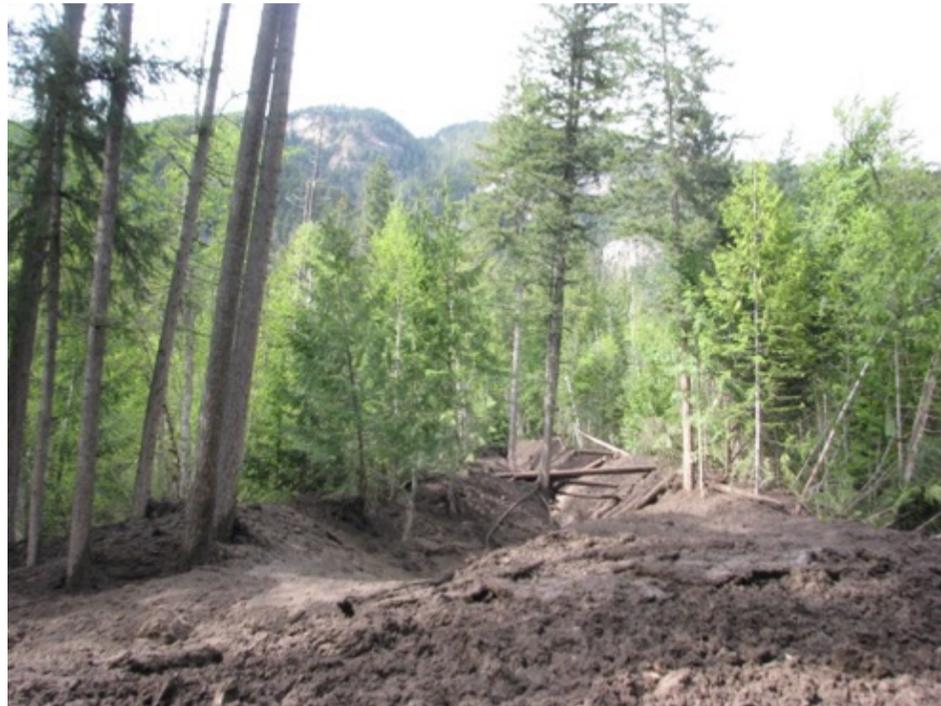
**Photo 16** – View upstream showing the typical debris deposit and levees in the lower part of the fan. The photo was taken on May 6, 2017.

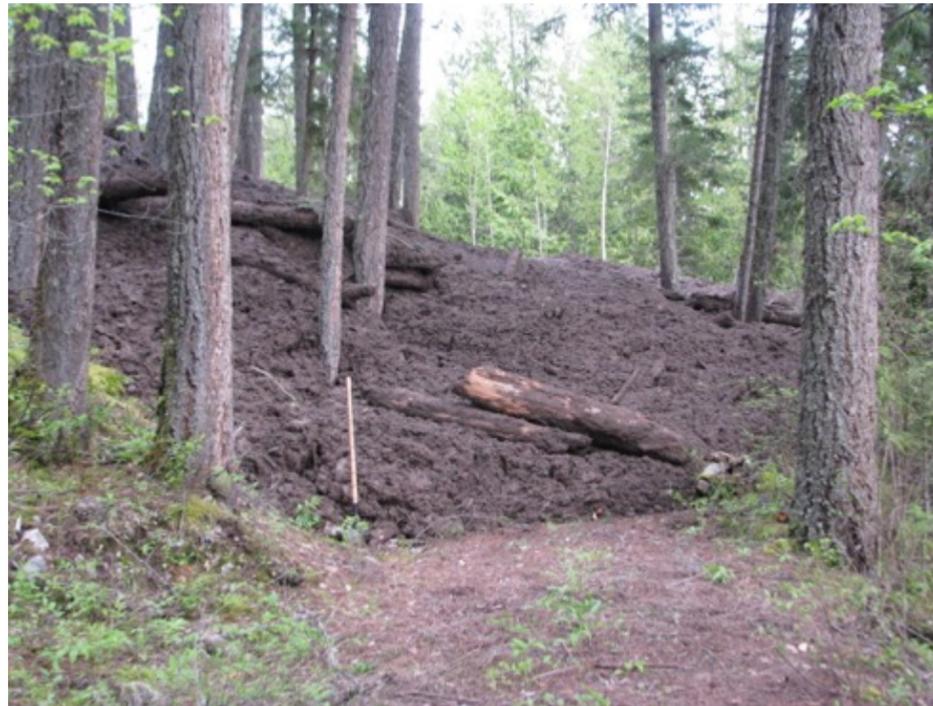
**Photo 17** – View east of a deposit of debris along the west margin in the lower part of the fan near Wpt 091. The shovel reference is about 1.3 m high. Photo was taken on May 6, 2017.

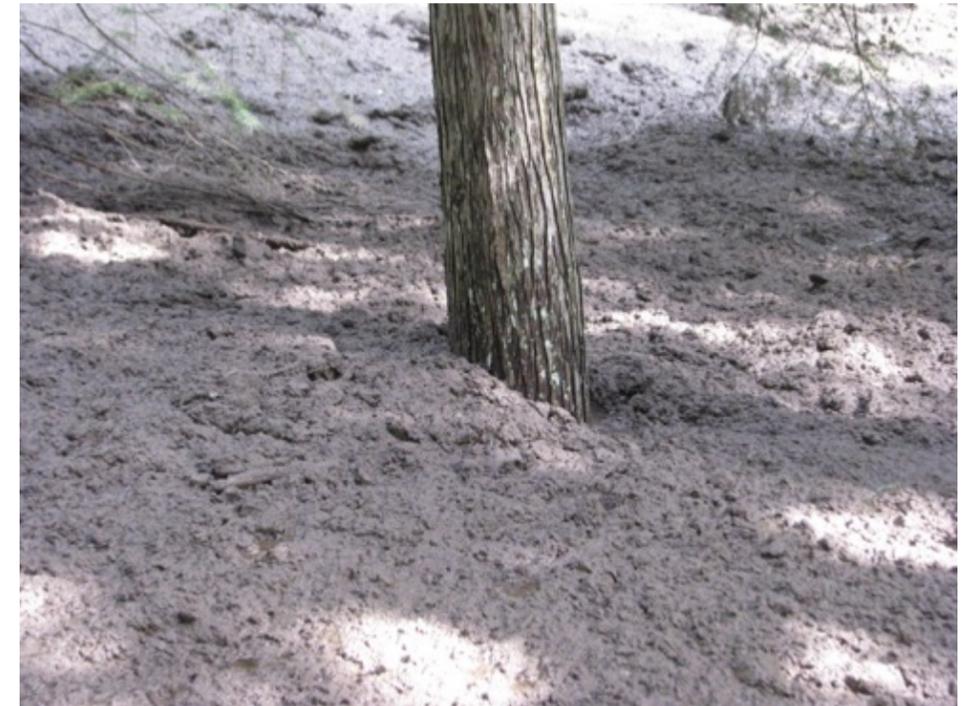
**Photo 18** – View of the typical debris flow deposit in the minor southwest lobe below Wpt 091. Photo was taken on May 6, 2017.

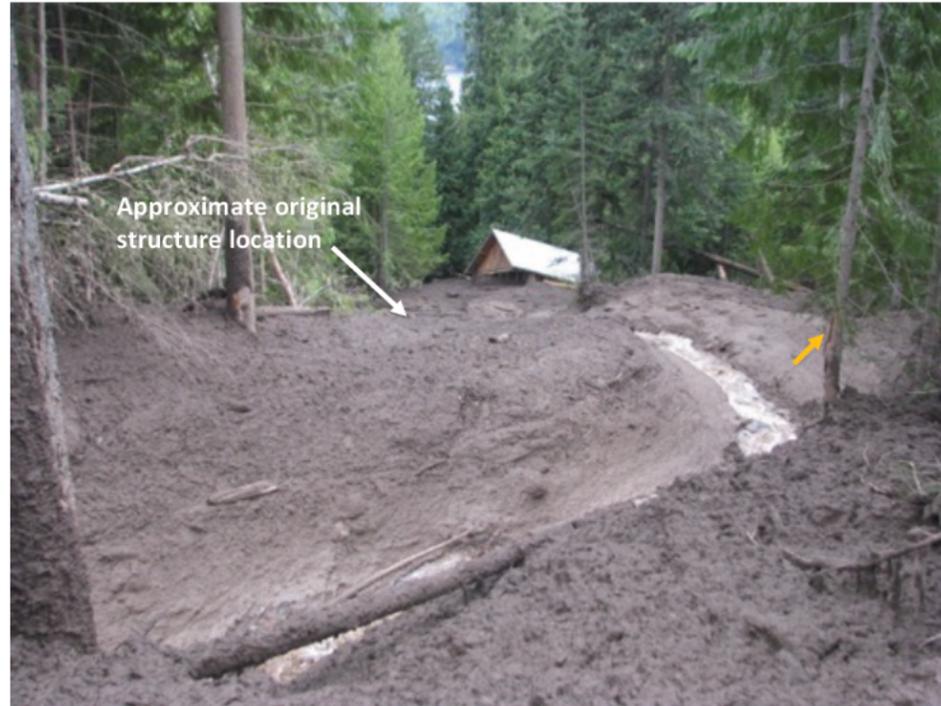
*Photo 19 – View downstream from the upper part of the 5921 Sunnybrae – Canoe Point Road property near Wpt 091, showing the approximate original location of the residence and the destroyed structure. A minor lobe of debris travelled to the southwest as indicated by the orange arrow.*

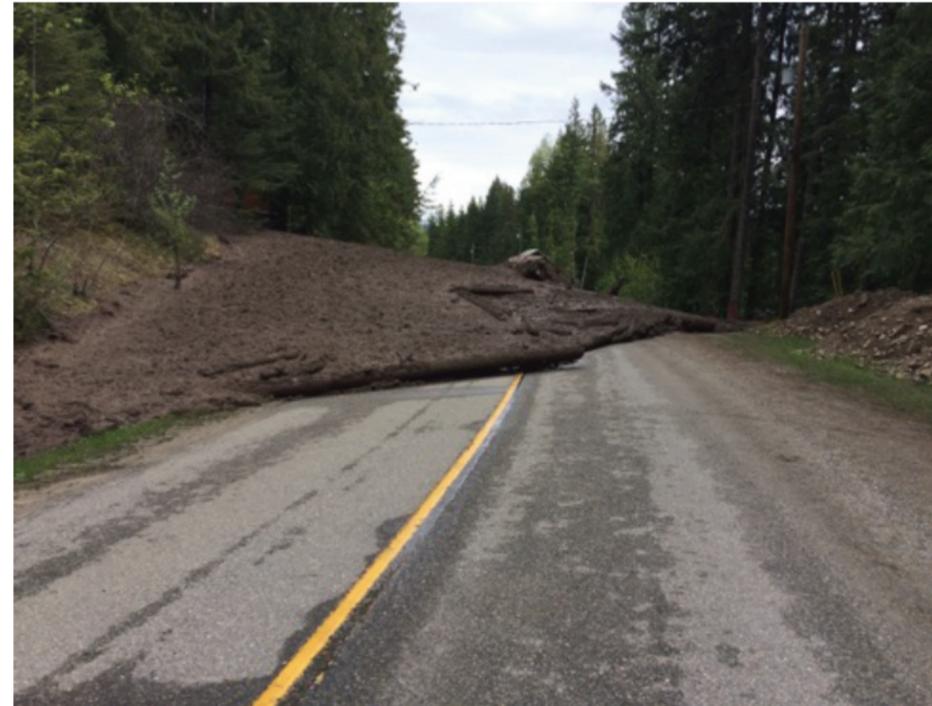
*Photo 20 – View east along the public road on May 6, 2017. The debris piled to the right was present prior to the debris flow (see also Photo 24).*

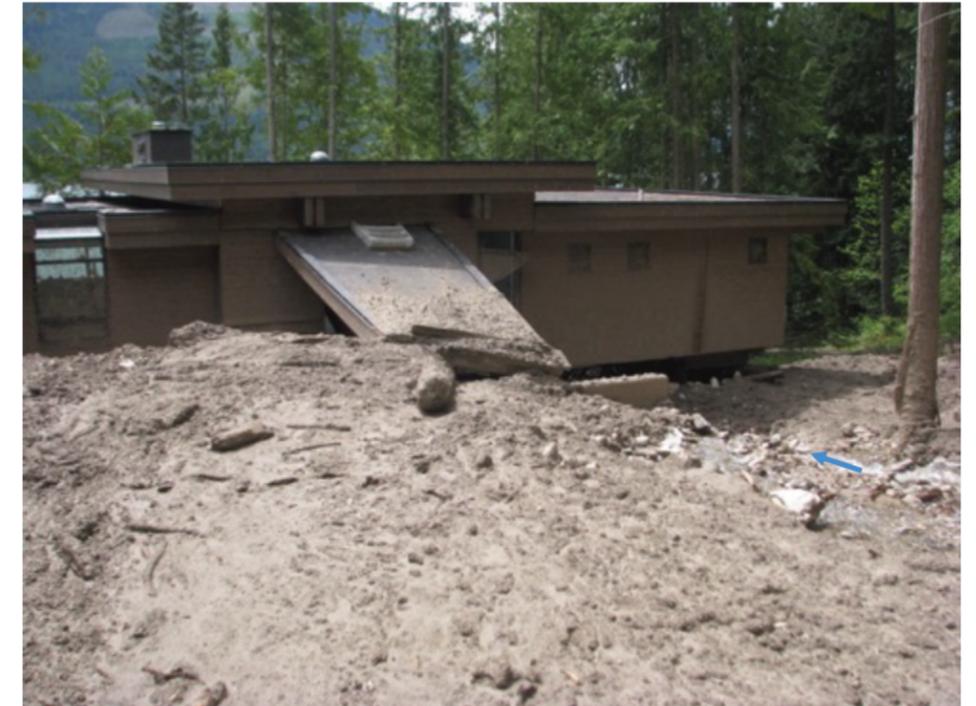
*Photo 21 – View downstream of the primary residence on the 5932 Sunnybrae – Canoe Point Road, showing debris piled up against the north wall. The debris flow passed through and around the residence, and the stream (blue arrow) now flows under the structure.*

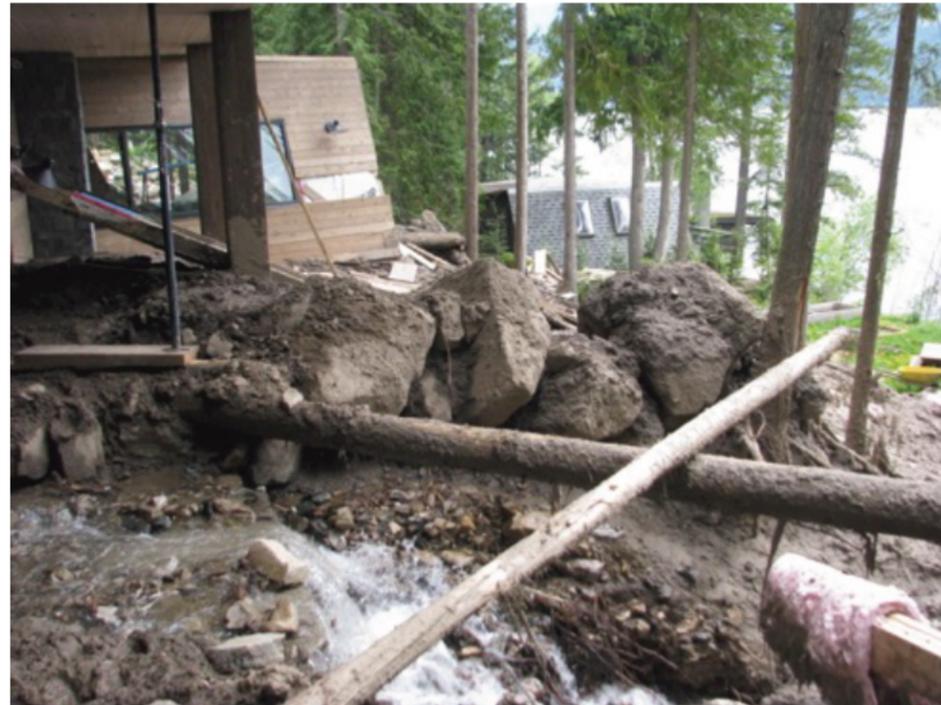
*Photo 22 – View east on the downhill side of the primary residence on the 5932 Sunnybrae – Canoe Point Road property, showing the stream flowing out from beneath the structure. The large boulders may have passed through the residence, but this is unconfirmed.*

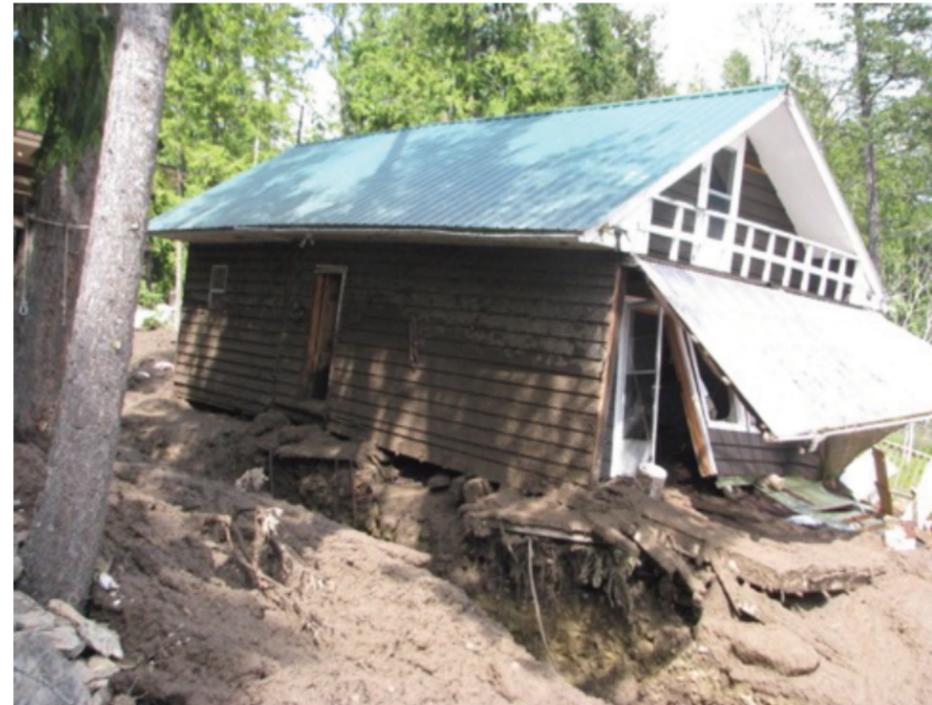
*Photo 23 – View northeast of the ancillary residence on the 5932 Sunnybrae – Canoe Point Road. Debris passed through and may have been displaced the building. The creek now passes along the west side of the structure (foreground).*

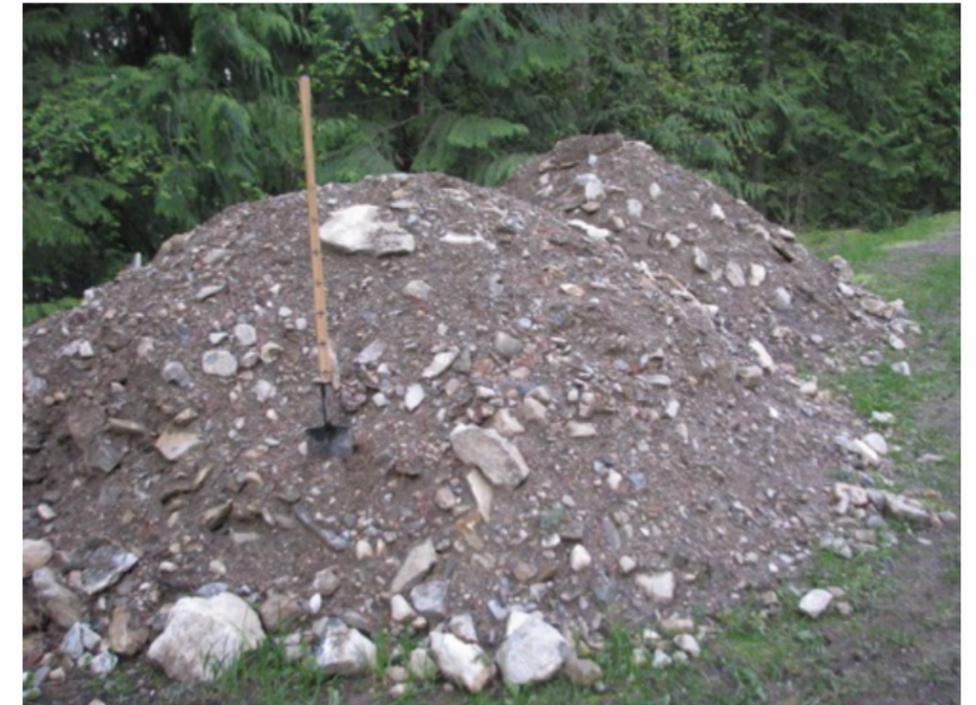
*Photo 24 – View of the typical fan material that was piled up on the public road shoulder from a local excavation. It shows the gradation of the material. A gradation analysis on the minus 75 mm fraction of the debris deposit is attached in Tab 4.*
