TECHNICAL MEMORANDUM

Date: October 6, 2018

Re: **Monitoring Results and Summary Recommendations**
Newsome Creek Erosion below Highway 1

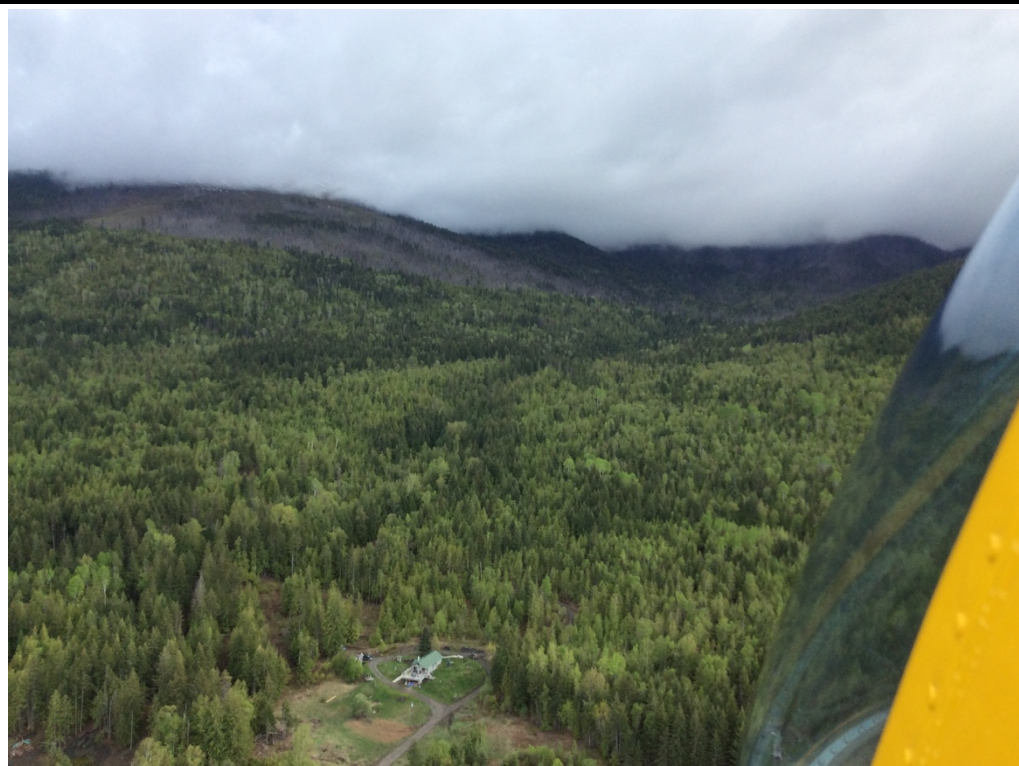
Photo 1 – View looking south up the east tributary creek south of (above) Taylor Road and west of Hannett Road. The wildfire burned area in the upper slopes can be seen in the background. [May 9, 2018]

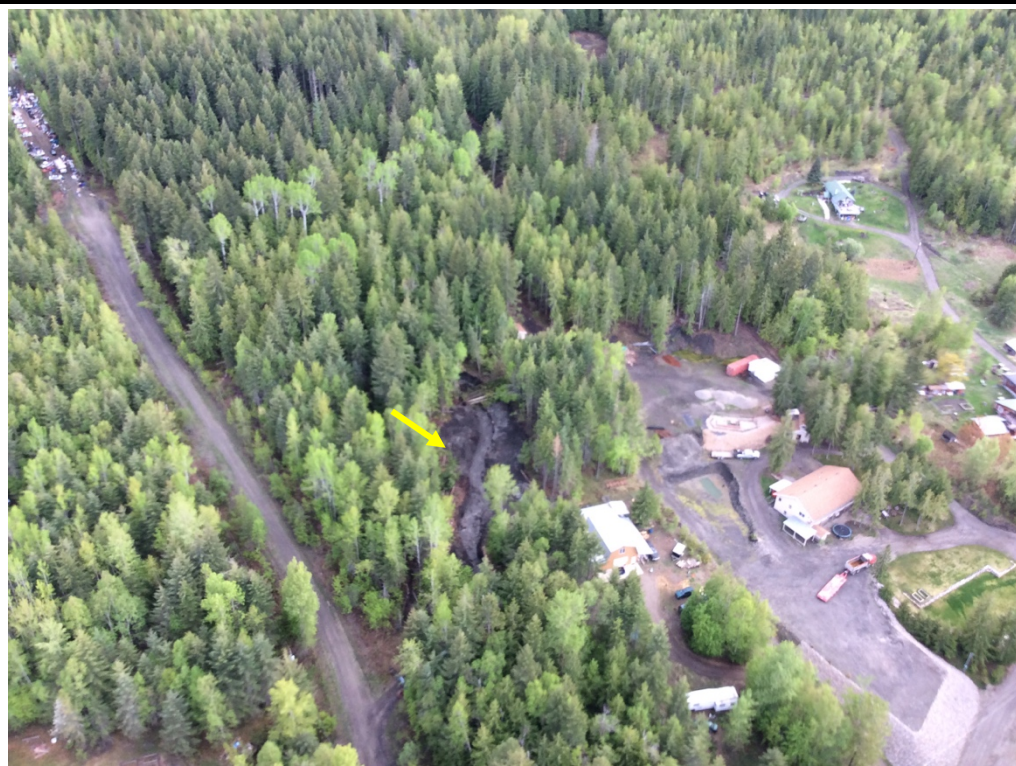
Photo 2 – View looking south at the bank instability and channel disturbance (arrow) within the east tributary creek south of (above) Taylor Road and west of Hannett Road (the road on the left side of the creek). [May 9, 2018]

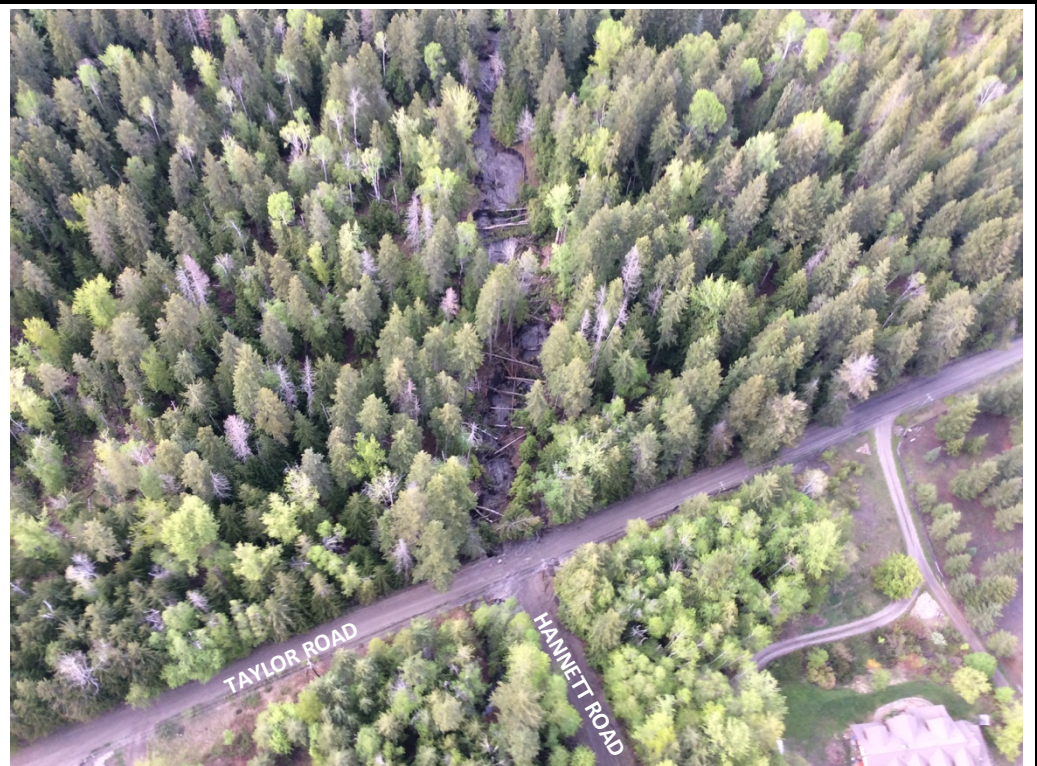
Photo 3 - View looking north (downstream) at the channel disturbance below Taylor Road crossing near Hannett Road. [May 9, 2018]

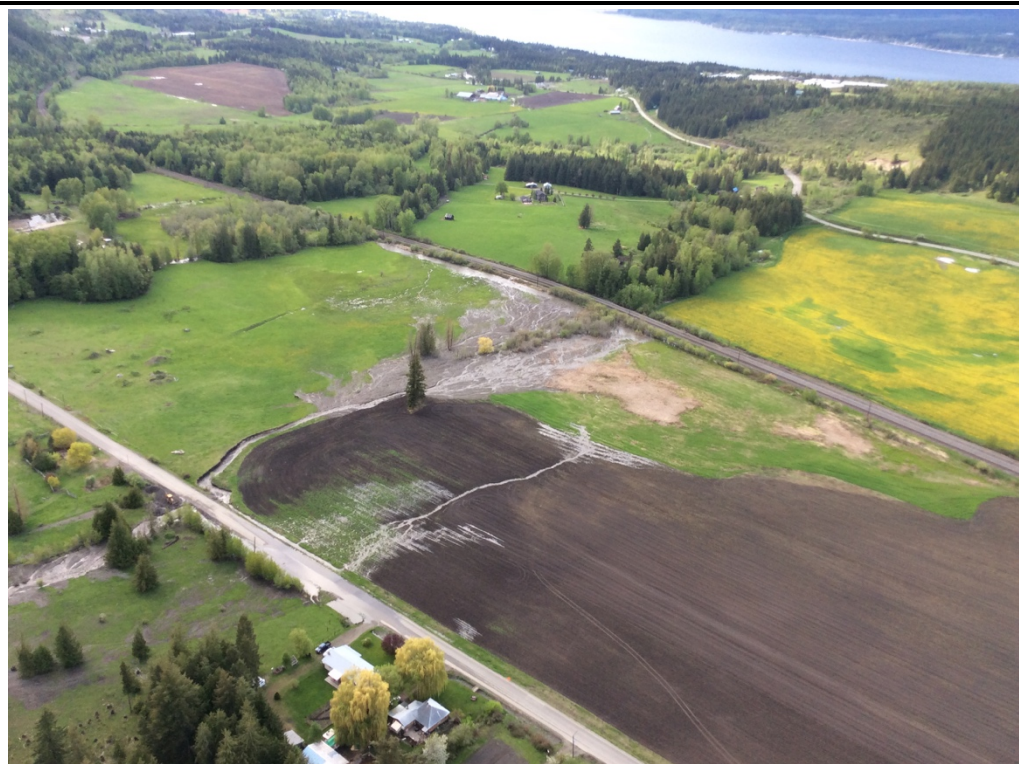
Photo 4 – View looking northwest at an area with considerable sediment deposition along the east tributary creek between London Lane (foreground) and the CP Railway. Deposition is visible upstream of London Lane in the left side of the photograph [May 9, 2018]

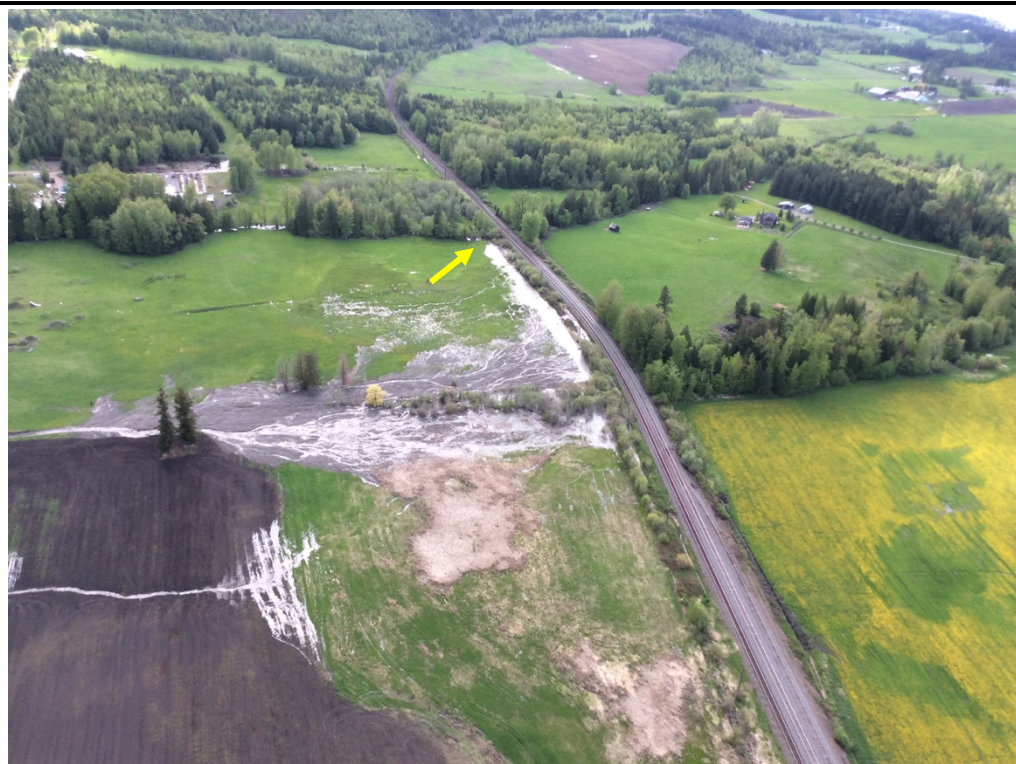
Photo 5 – View looking east over the sediment deposition above the CP Railway. At the time, the east tributary appears to have been partially diverted to the west tributary (arrow). [May 9, 2018]

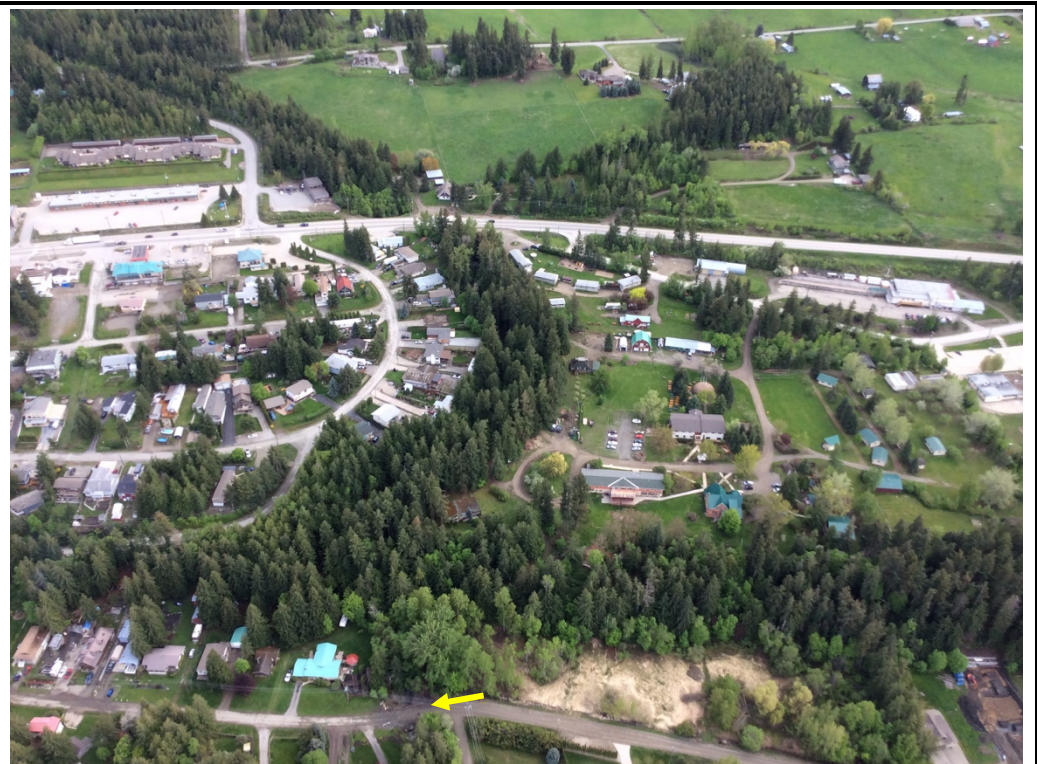
Photo 6 – View looking south at the Newsome Creek gully below Highway 1. Caen Road is to the immediate left (east) and the location of the washed out crossing on Dieppe Road is shown with the arrow. [May 9, 2018]

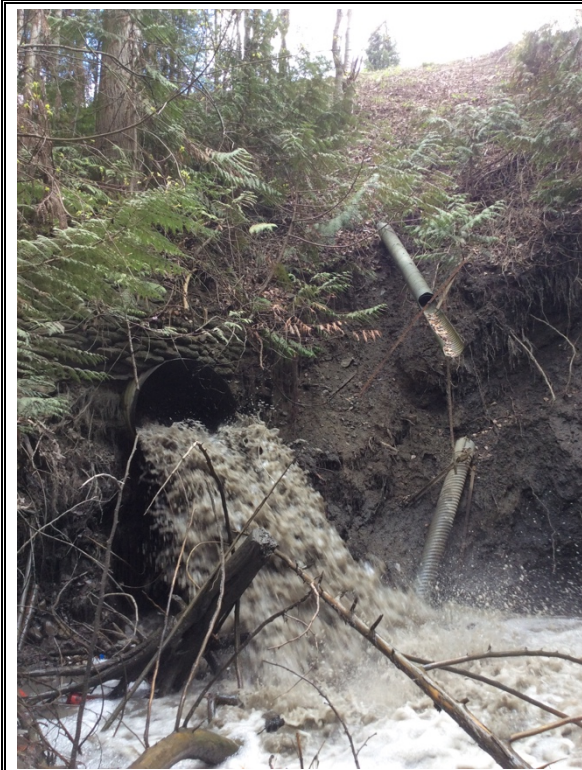
Flow through the Highway 1 culvert on May 1, 2018 is shown on Photo 7. Below the highway, the Caen Road residents reported renewed channel and slope instability and the toppling of trees along the gully. The culvert at Dieppe Road also washed out.

Observations suggest that the culvert on Highway 1 crossing is generating a high discharge velocity at the outfall, and this has resulted in the development of a significant scour pool below the outfall and some undercutting of the highway embankment. It is not clear if this has led to the development of the near-vertical bank adjacent to the 1185 Passchendaele Road property or not, or if this feature has developed subsequent to the 2009 wildfire. A more detailed study would be required to assess this with more certainty.

Photo 7 – View of culvert outlet (1200 mm diameter) in Highway 1. Note the scour in the embankment to the immediate right. [May 1, 2018]

- 3) A feasibility study should be undertaken to determine how the gully below Highway 1 could be stabilized.
- 4) The condition of the existing culvert and the adjacent embankment in the Highway 1 crossing stability should be evaluated and stabilized if considered necessary.

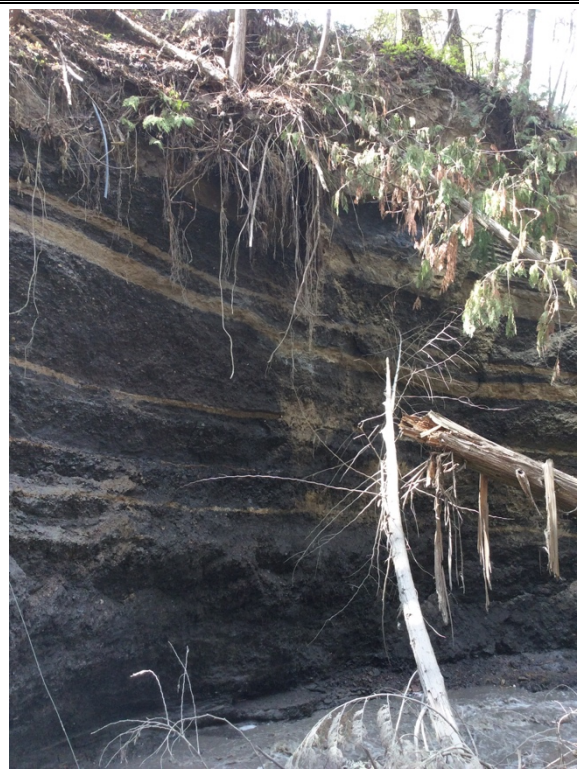
Photo 8 – View looking downstream at the 10 m high, near-vertical silt/clay deposit adjacent to 1185 Passchendaele Road. [May 1, 2018]

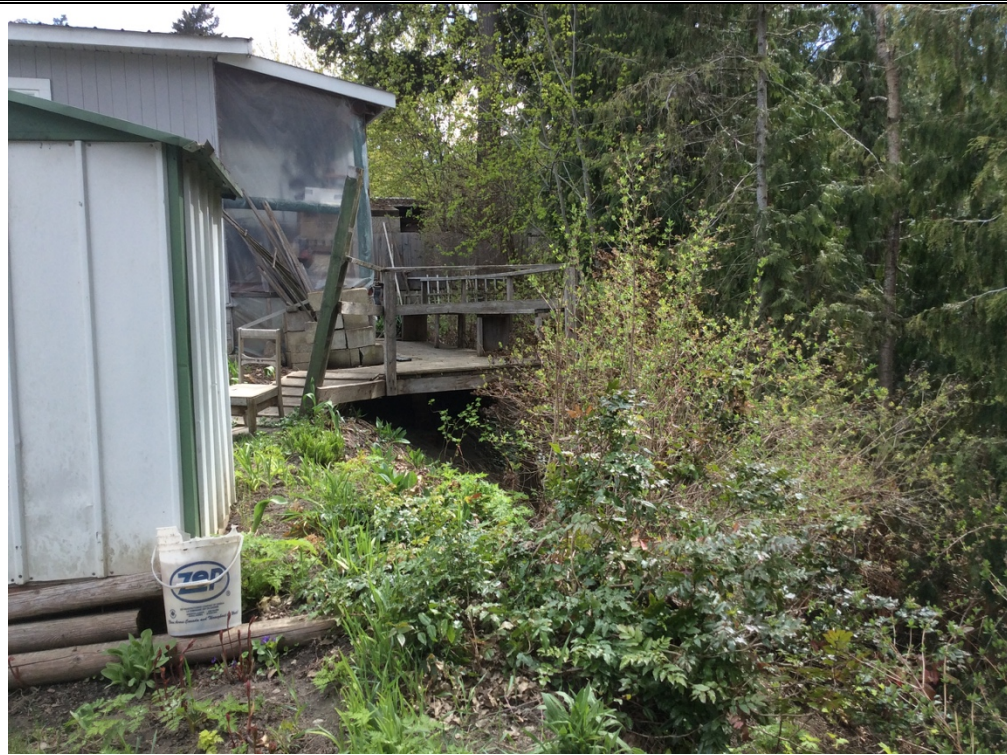
2807 Caen Road	Residence with patio deck. <ul style="list-style-type: none"> • Residence is at the gully crest. • Deck extends over crest and is supported on the steep gully sidewall (Photo 9). • Sidewall slope has failed in the past (relict). • No active erosion was noted in 2018 (Photo 10). 	The residence is potentially at risk due to its proximity to the steep gully sidewall. Risk will increase if the gully sidewall fails and/or erosion occurs at the toe. The owner should continue to monitor the slope. If stability worsens, i.e. if the creek undercuts the slope, measures to protect the house may be needed.
2809 Caen Road	Residence with elevated deck. House has a commercial operation (barber). <ul style="list-style-type: none"> • Residence is setback about 3 m from the gully crest (Photo 11). • Attached elevated deck is supported by shallow footings about 0.5 m back from the gully crest. • Aggressive creek undercutting caused a shallow landslide in the lower sidewall slope in 2018 (Photos 12, 13). 	The risk to the residence is high. The owner should stabilize the slope or move the residence to the front of the property. The owner should continue to monitor the slope.

Photo 9 – 2807 Caen Road: view looking upstream along the gully crest at the patio deck, which is supported on the steep sidewall slope. [May 7, 2018]

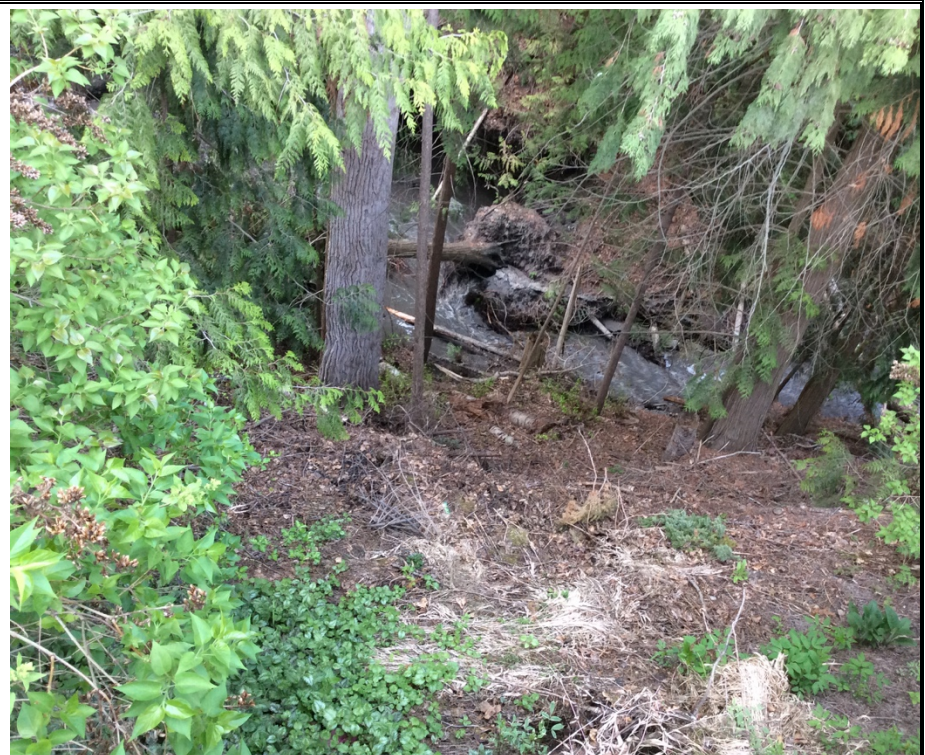
Photo 10 – 2807 Caen Road: view looking down the slope at the reach upstream from this property. [May 7, 2018]

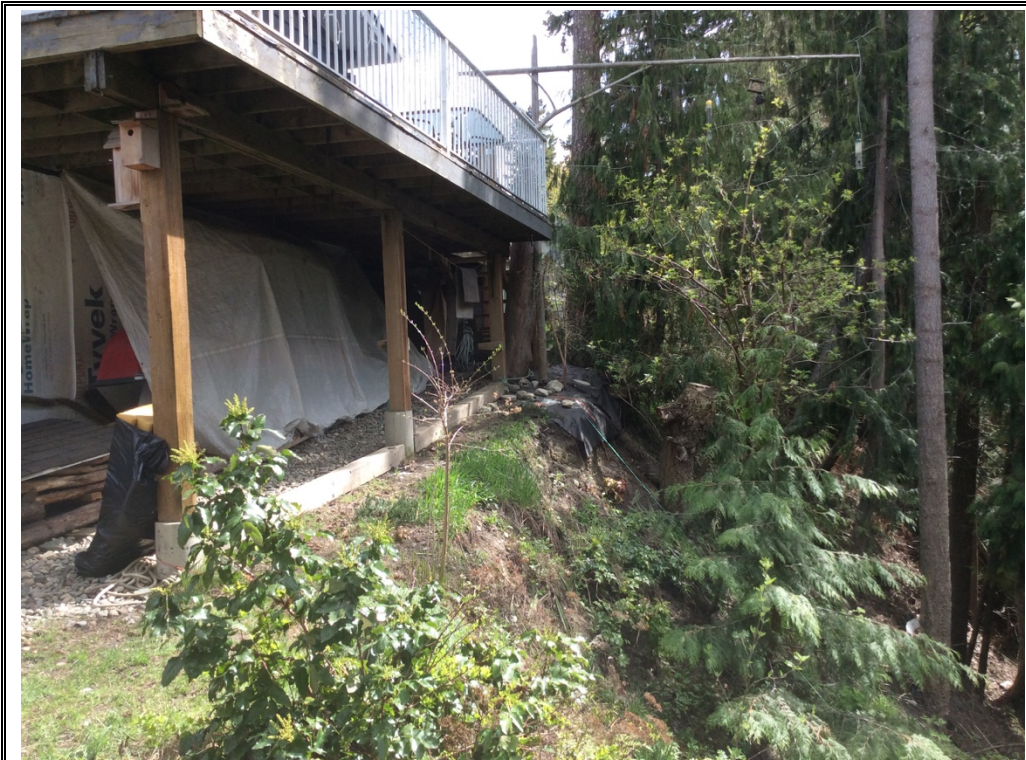
Photo 11 – 2809 Caen Road: view looking upstream along the gully crest at the very steep slope below the elevated deck. The house is about 3 m back from the crest. A shallow debris slide occurred below this area (see Photo 12). [May 7, 2018]

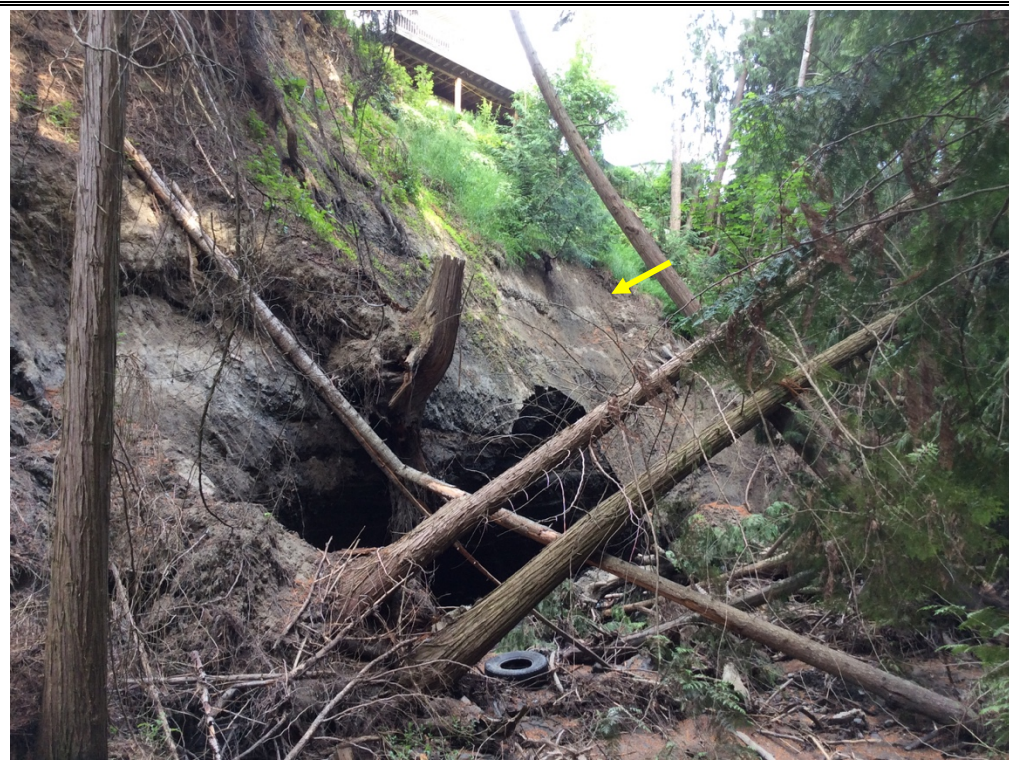
Photo 12 – 2809 Caen Road: view looking upstream at the bank instability. The elevated deck is visible in the background. A small debris slide (arrow) that occurred early in May 2018 is shown with the arrow. [May 26, 2018]

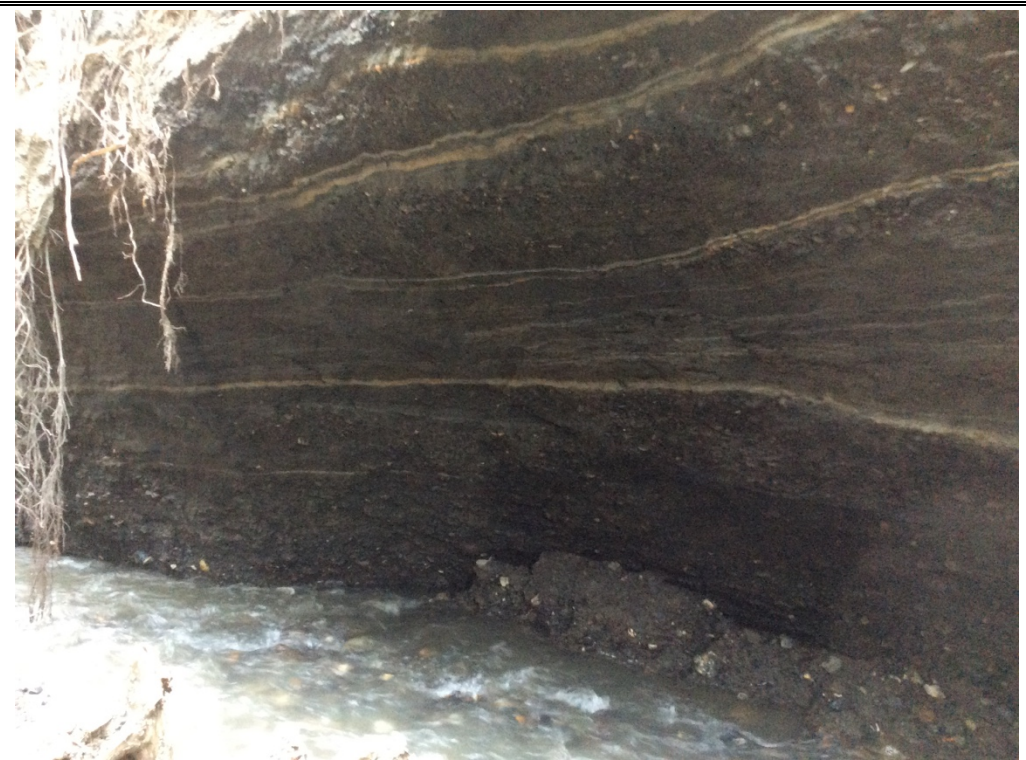
Photo 13 – 2809 Caen Road: view looking downstream at the gravel deposit (below the lowest tan-coloured line) that eroded throughout May 2018 and undercut the bank. [May 26, 2018]

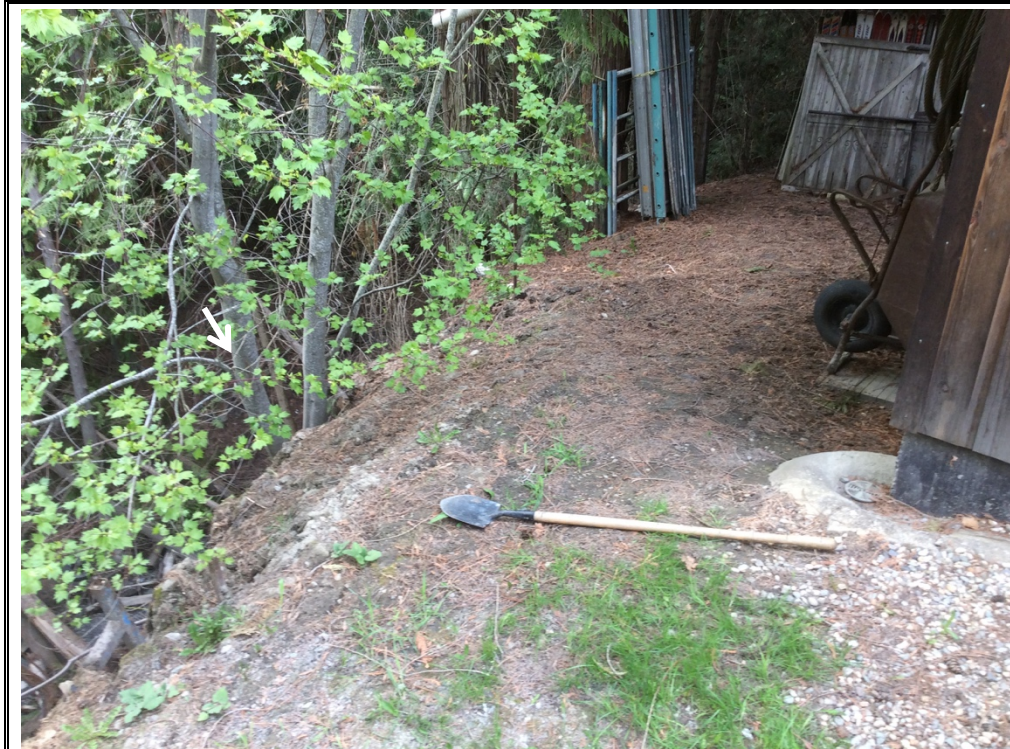
Photo 14 – 2819 Caen Road: view looking downstream (north) along the gully crest at the southwest corner of the shop (~2 m setback). Photo 15 shows the slope to the lower left of the corner of the photo. [May 3, 2018]

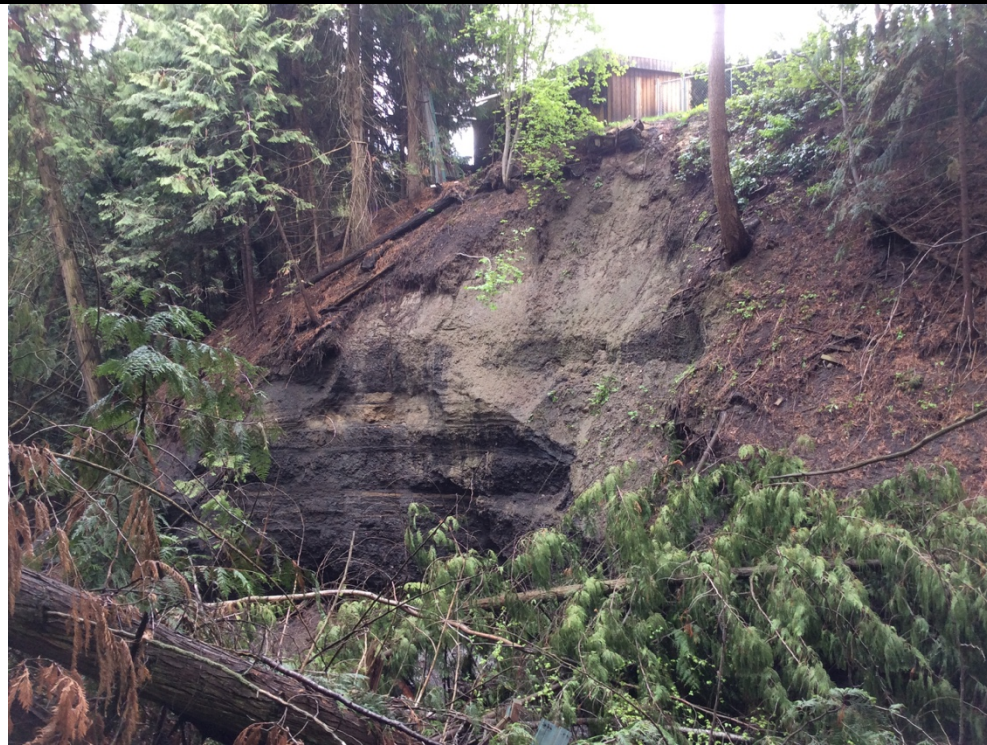
Photo 15 – 2819 Caen Road: view looking downstream (northeast) at the undercut bank and failing slope above, adjacent to the shop building (in the background). See also Photo 16. [May 9, 2018]

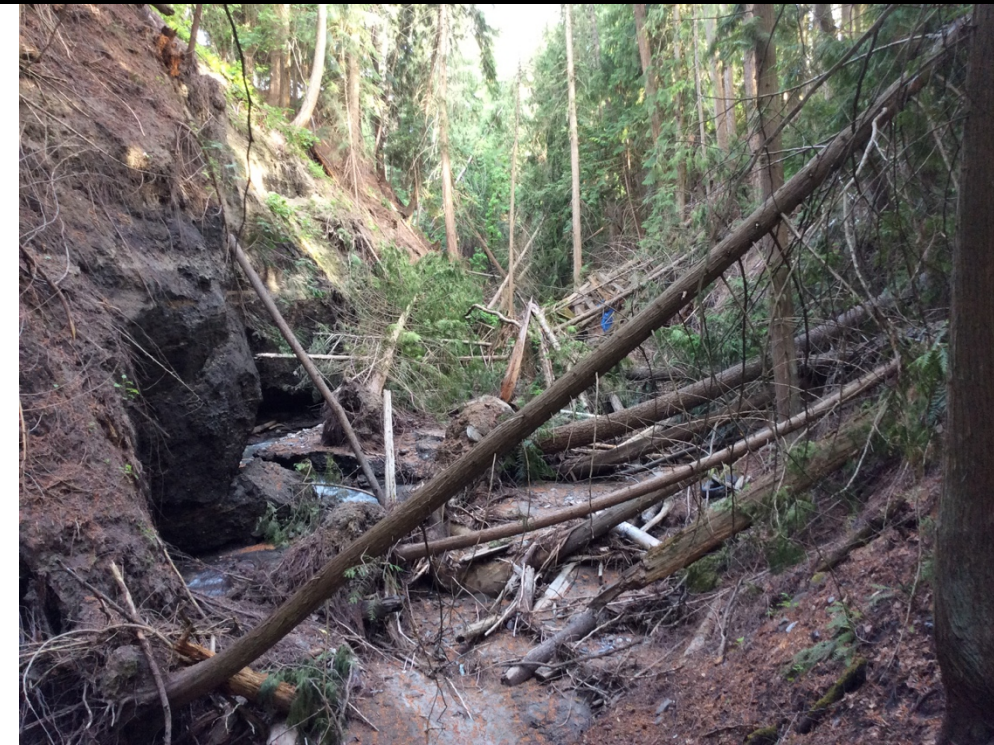
Photo 16 – 2819 Caen Road: view looking upstream (south) at the sand and gravel deposit that eroded throughout May 2018 and undercut the bank. [May 26, 2018]

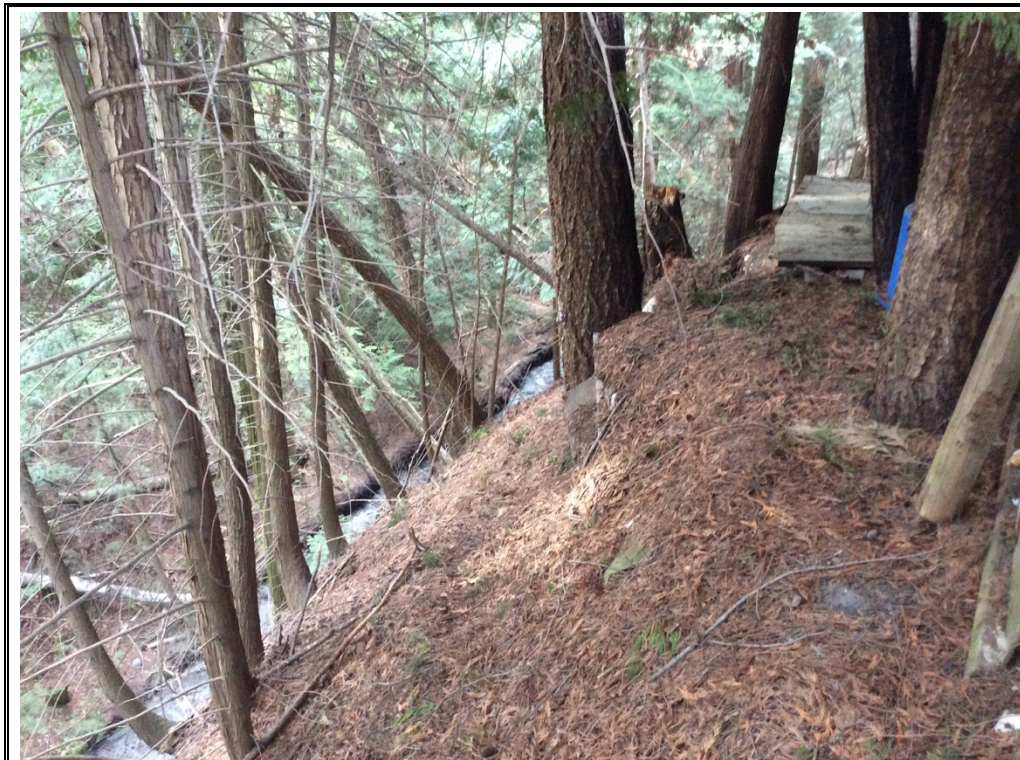
Photo 17 – 2821 Caen Road: view looking downstream (north) along the gully crest behind the pottery shop (1.5 m setback). See also Photo 21, which shows the other side of the property. [May 7, 2018]

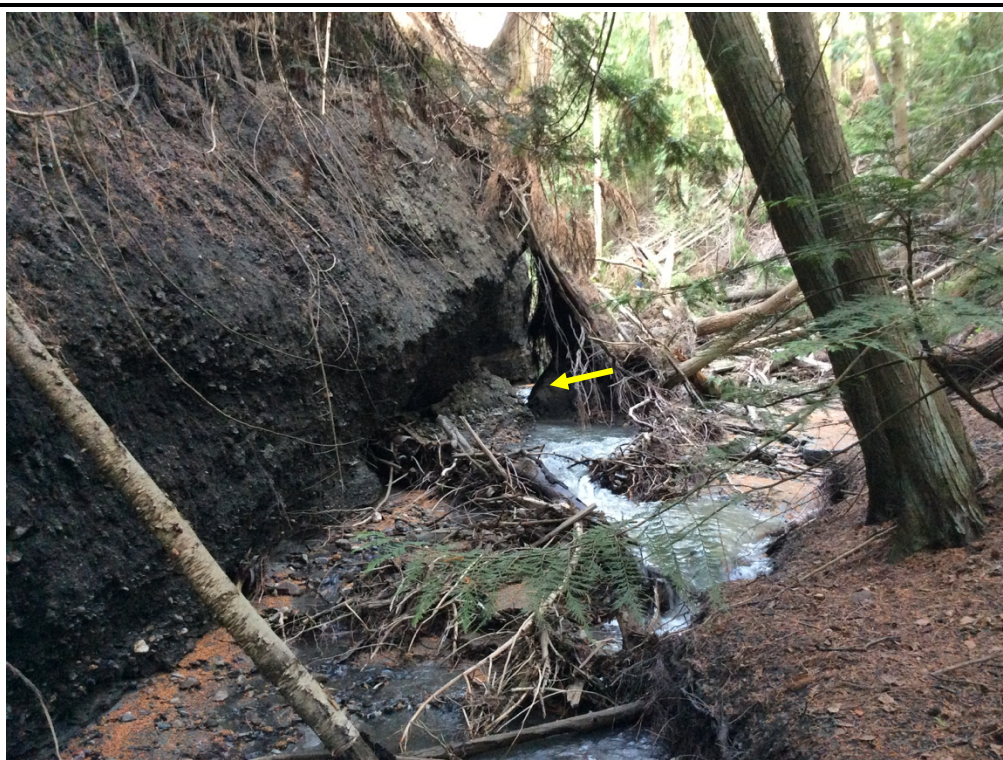
Photo 18 – 2821 Caen Road: view looking upstream (south) at the undercutting bank below the pottery shop. Note the creek has cut a channel in behind the roots of a large cedar tree (arrow), as shown in the closer view in Photo 19. [May 26, 2018]

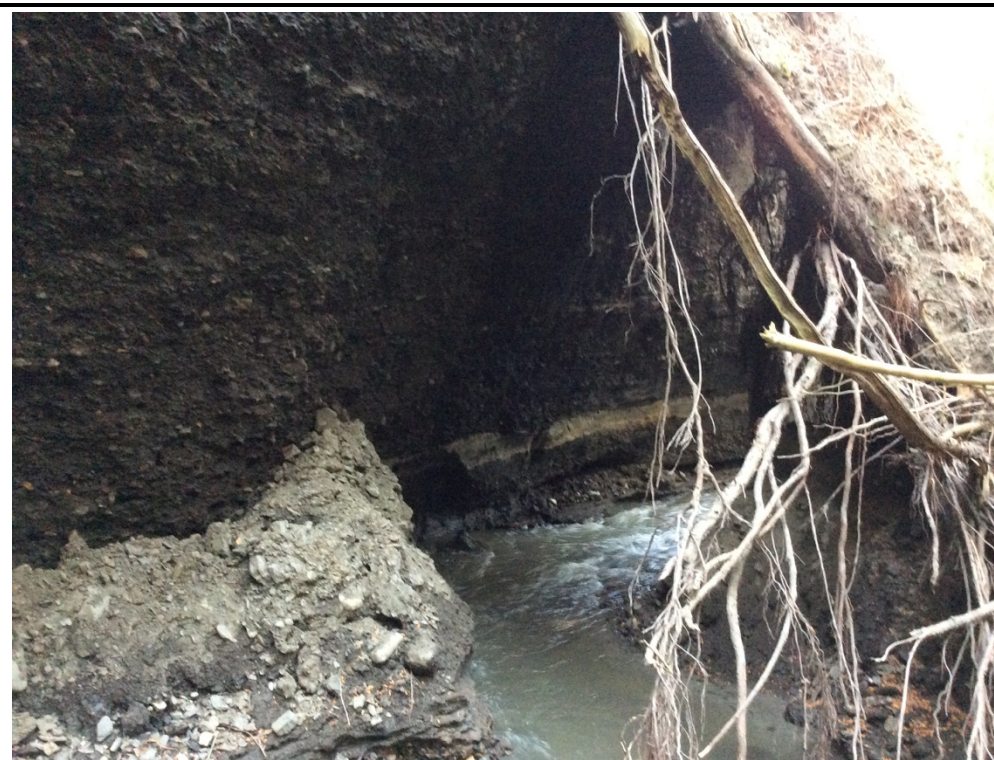
Photo 19 – 2821 Caen Road: view looking upstream (southeast) at the sand and gravel deposit that eroded throughout May 2018 and undercut the bank. Undercut bank is about 3 m high. Roots supporting the cedar tree are on the right side. [May 26, 2018]

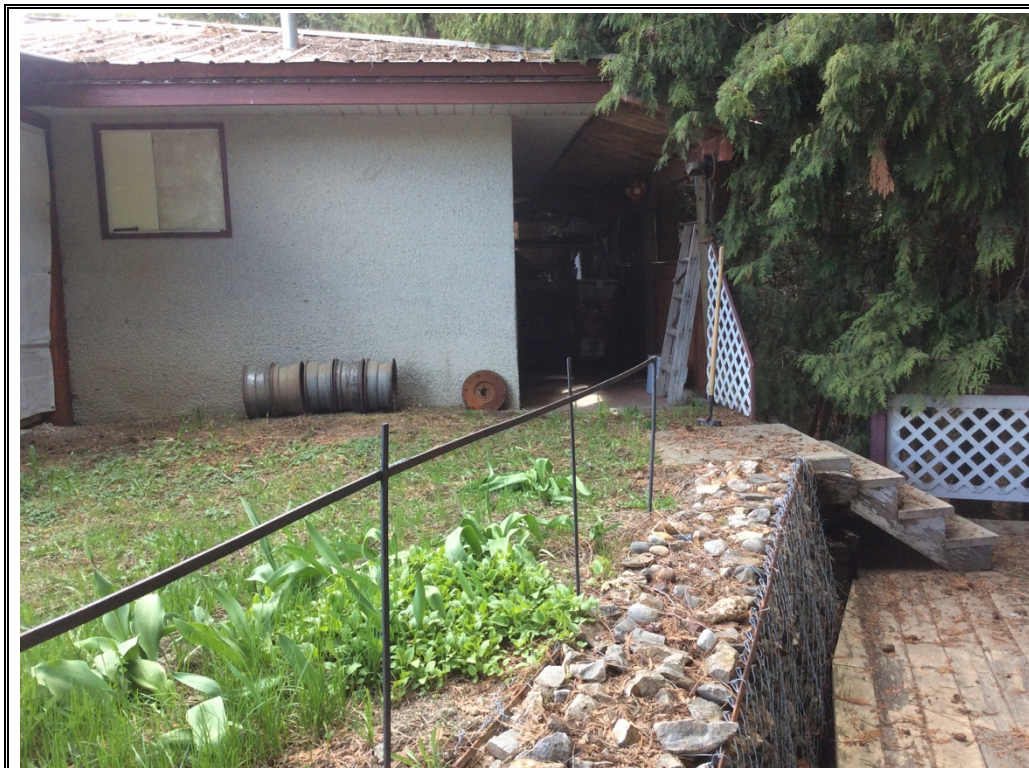
Photo 20 – 2823 Caen Road: view looking upstream (south) along the gully crest at the west side of the shop (~2 m setback). Note the fenced shed extends out to the crest (see Photo 21) and the gabion retaining wall and external patio deck in the lower right. [May 1, 2018]

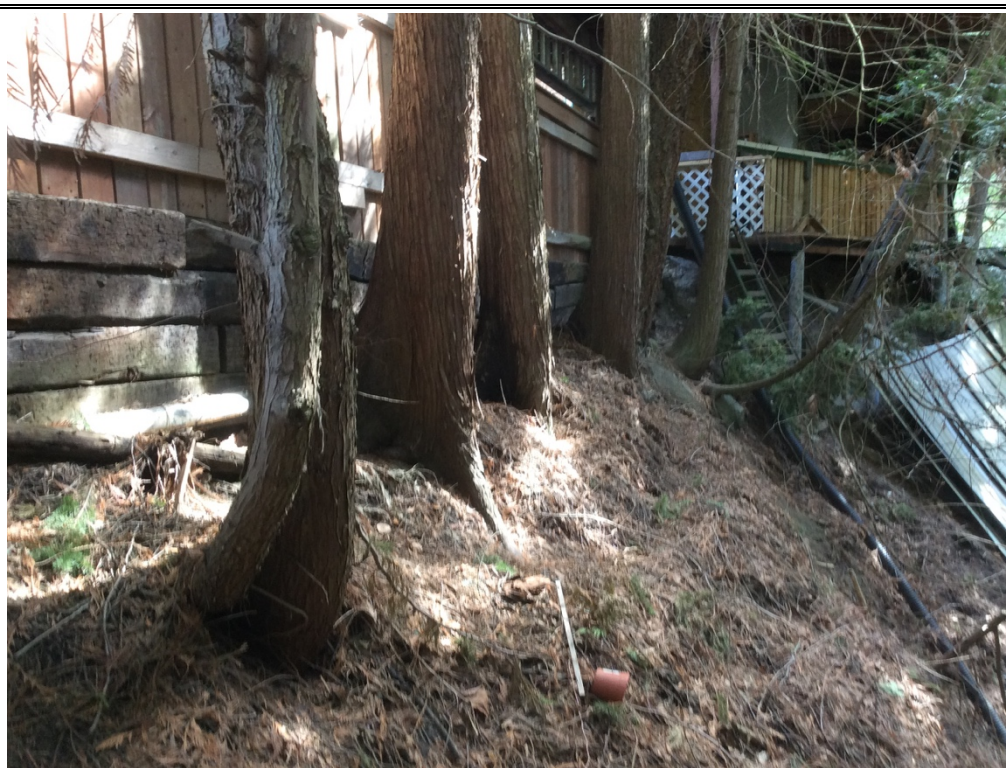
Photo 21 – 2823 Caen Road: view looking upstream along the gully crest at the retaining wall that is supporting the shed roof. The patio extending out behind the pottery shop at 2821 Caen Road can be seen in the background. [May 1, 2018]

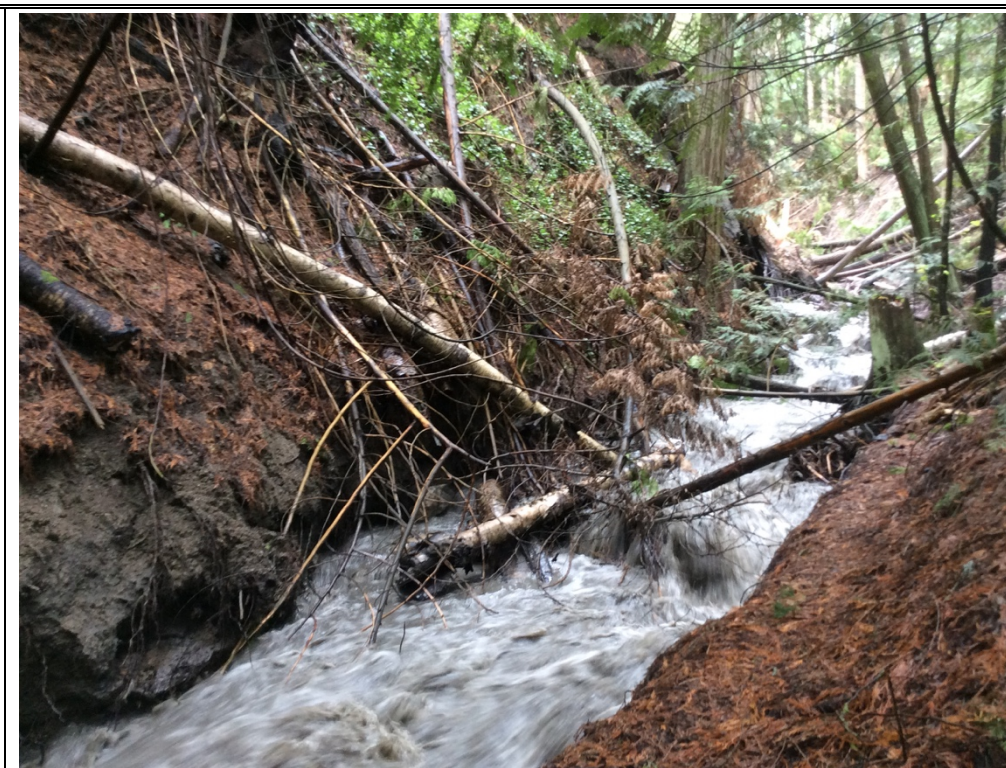
Photo 22 – 2823 Caen Road: view looking upstream (south) along the creek showing the downcutting that is occurring along this reach. [May 9, 2018]

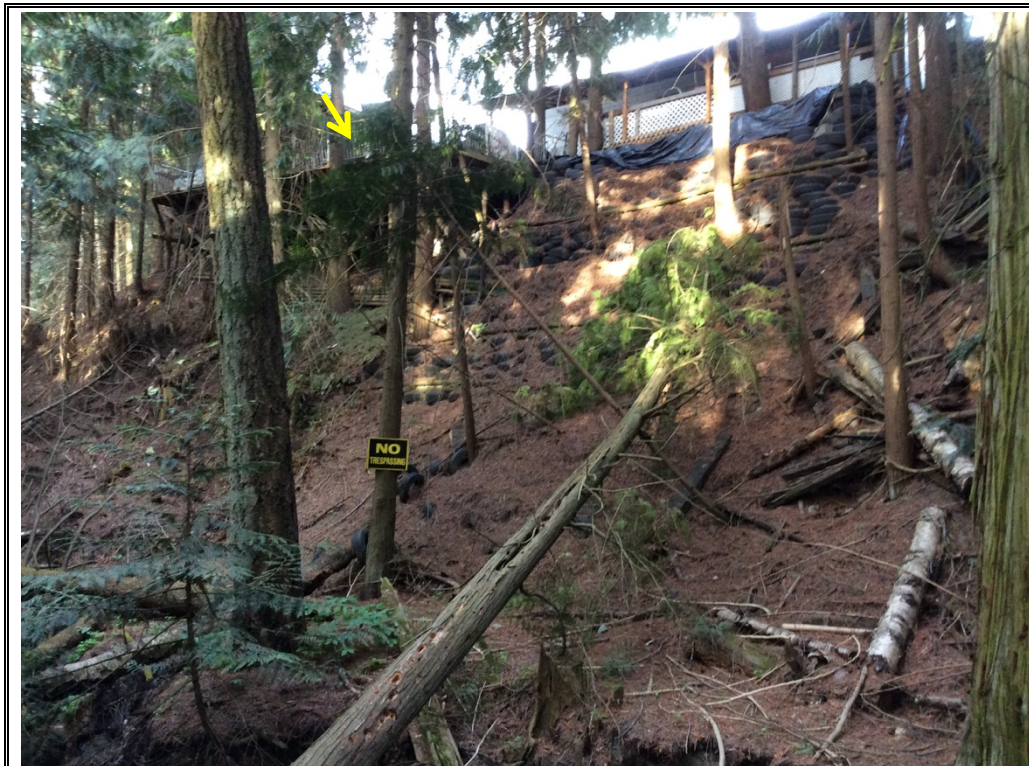
Photo 23 – 2825 Caen Road: view looking downstream (northeast) at the slope below the residence on this lot. Note the rubber tire retaining wall below the house. The elevated deck is shown with the arrow. [May 26, 2018]

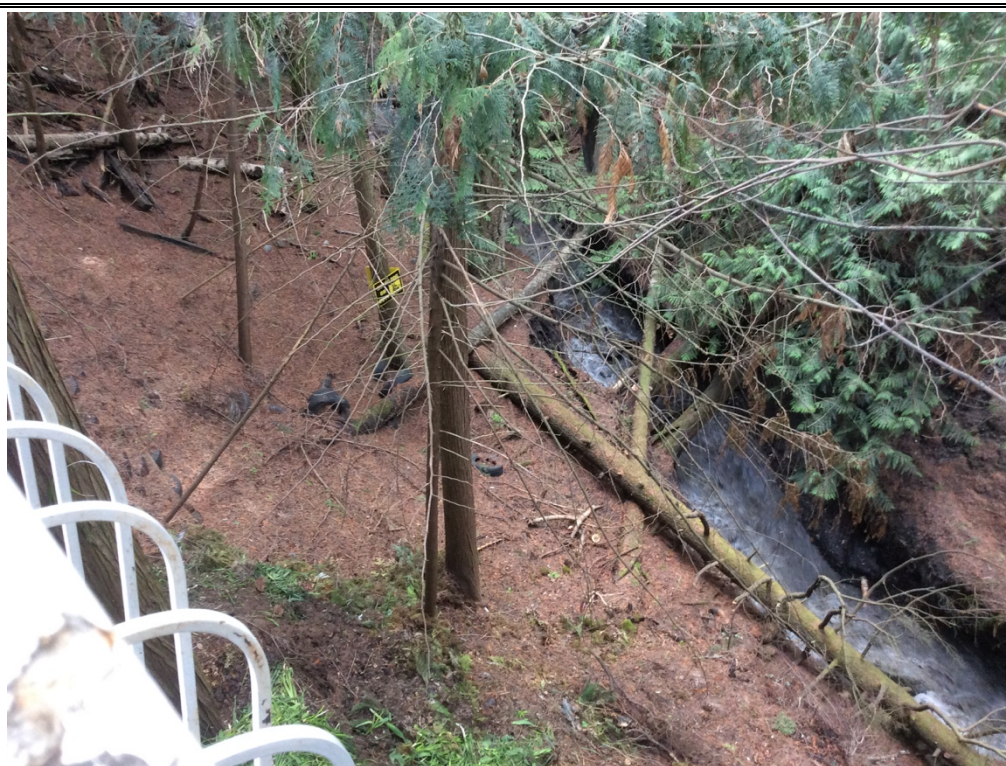
Photo 24 – 2825 Caen Road: view looking upstream (southwest) from the elevated deck at the creek below this lot. The creek is downcutting through this reach. [May 3, 2018]

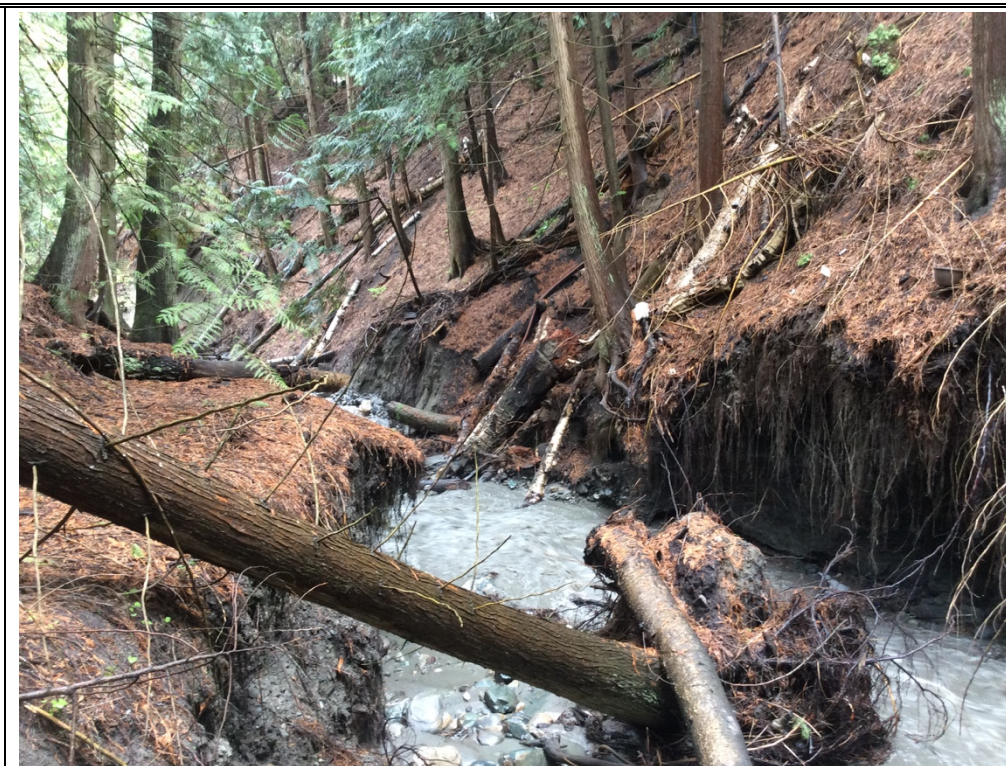
Photo 25 – 2825 Caen Road: view looking downstream (north) along the downcutting creek channel below this lot. [May 3, 2018]

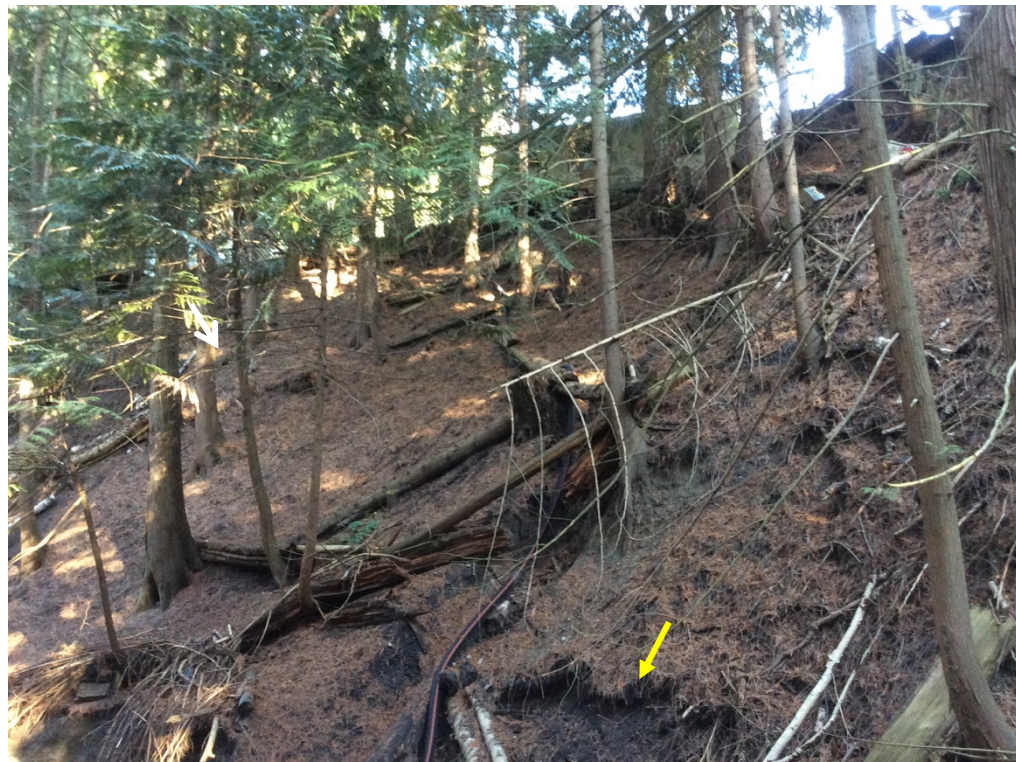
Photo 26 – 2827 Caen Road: view looking downstream (northeast) at the slope below the out-building at the rear of the property. The top of the debris slide is shown with an arrow and can be seen in Photo 27. [May 1, 2018]

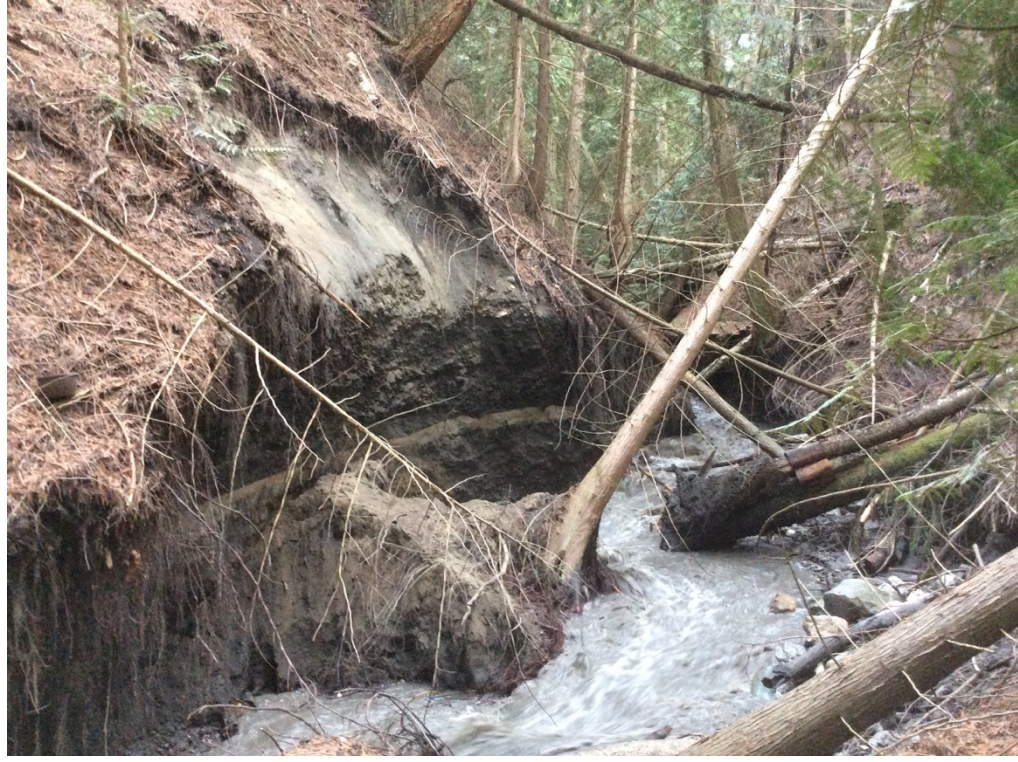
Photo 27 – 2827 Caen Road: view looking upstream (south) showing the undercutting and debris slide shown with arrow in Photo 26. [May 3, 2018]

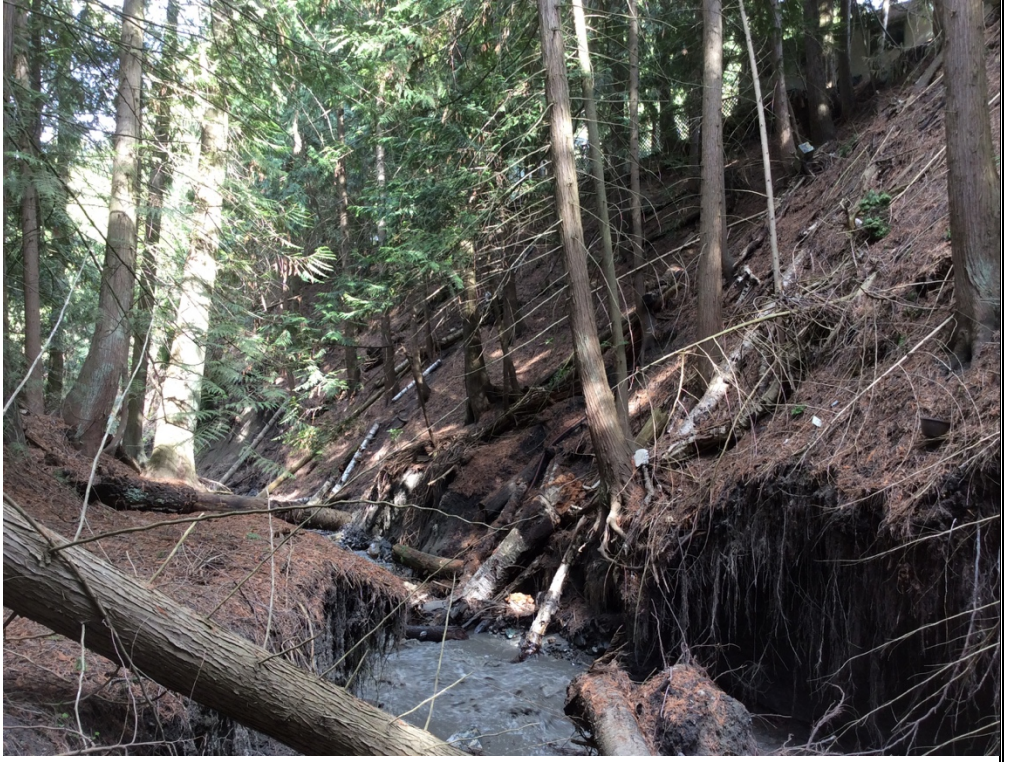
Photo 28 – 2827 Caen Road: view looking downstream at the channel downcutting below the north side of the lot. [May 7, 2018]
