TECHNICAL MEMORANDUM

Date: October 6, 2018

Re: **Monitoring Results and Summary Recommendations**
Newsome Creek Erosion below Highway 1

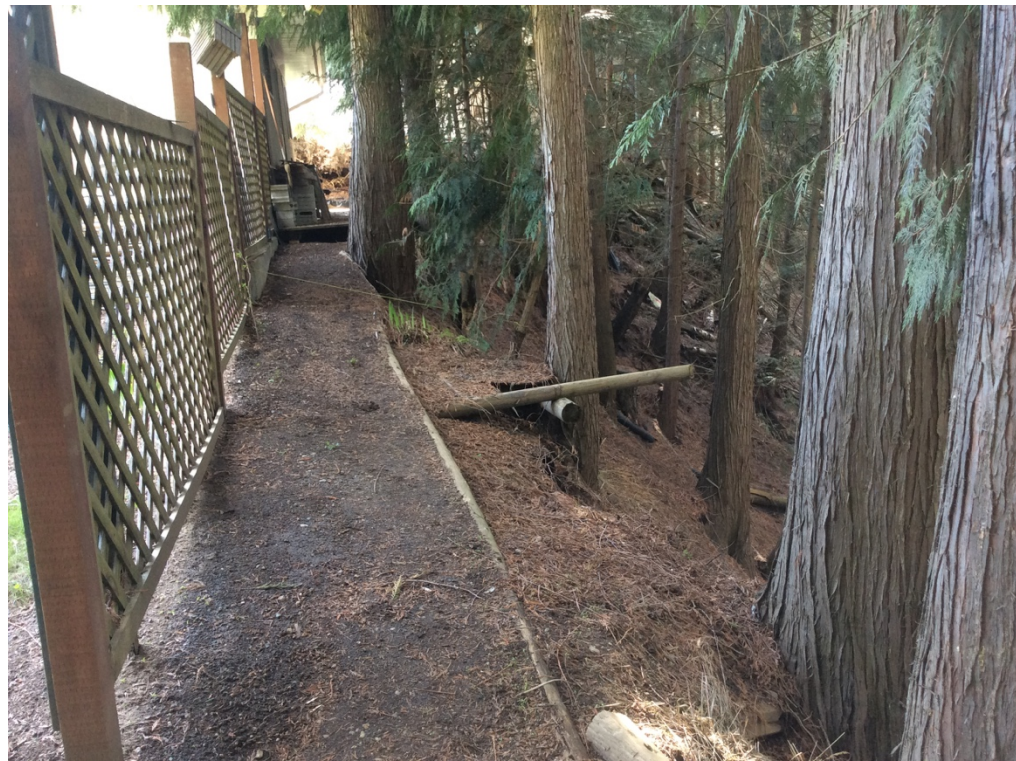
Photo 29 – 2829 Caen Road: view looking upstream (south) along the gully crest at the west side of the property. [May 1, 2018]

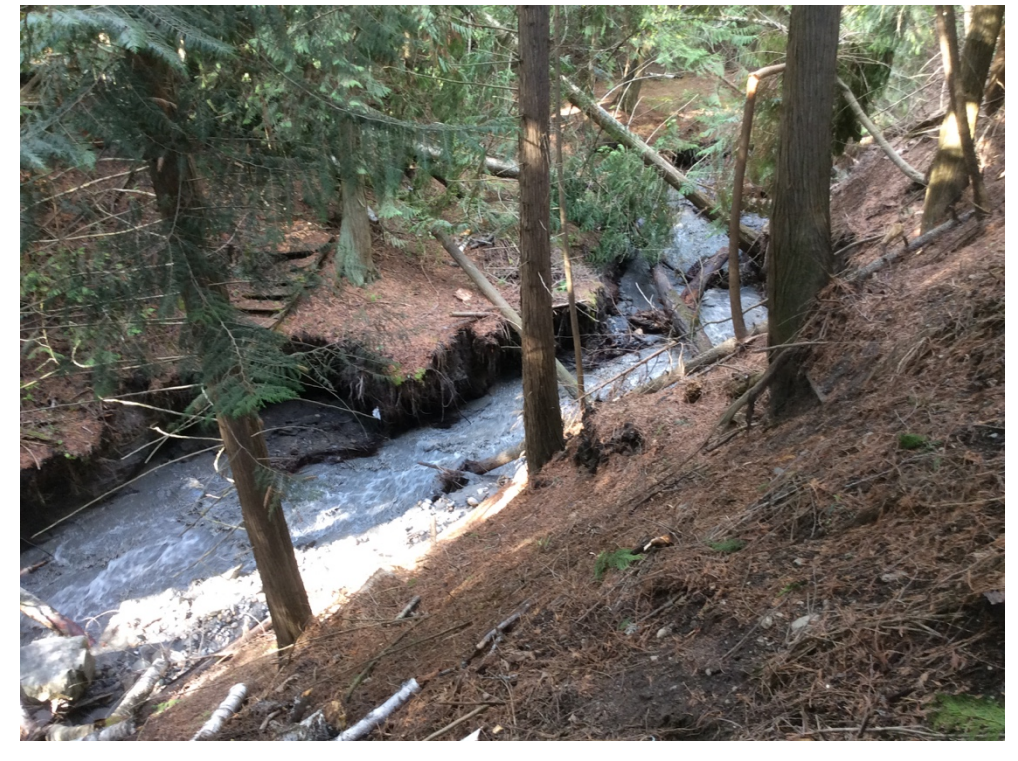
Photo 30 – 2829 Caen Road: view looking downstream (northwest) from the gully crest showing the creek downcutting. [May 1, 2018]

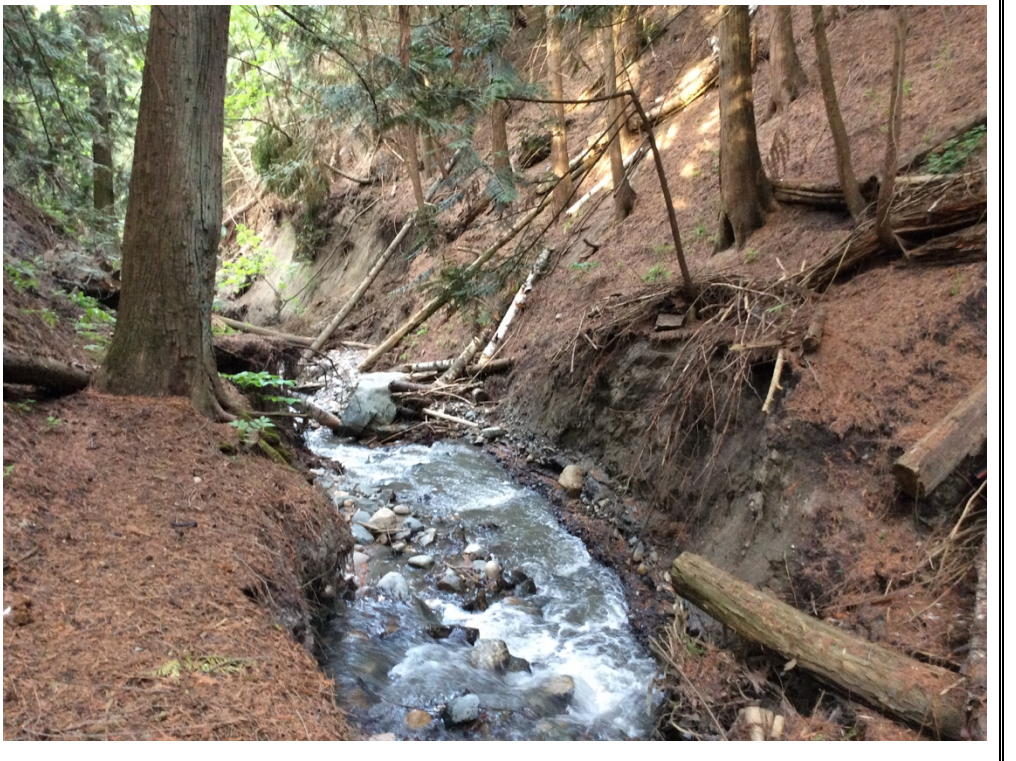
Photo 31 – 2829 Caen Road: view looking downstream (north) along the creek channel showing the creek downcutting. Note the bank failures farther downstream. [May 26, 2018]
