**Landslide Hazard Assessment for the
Proposed Subdivision of Lot 1, Section 22,
Township 21, Range 10, West of the 6th
Meridian, Kamloops Division Yale District,
Plan 38427**

**3453 Ford Road
Tappen, BC**

September 26, 2018
File: 1765-1

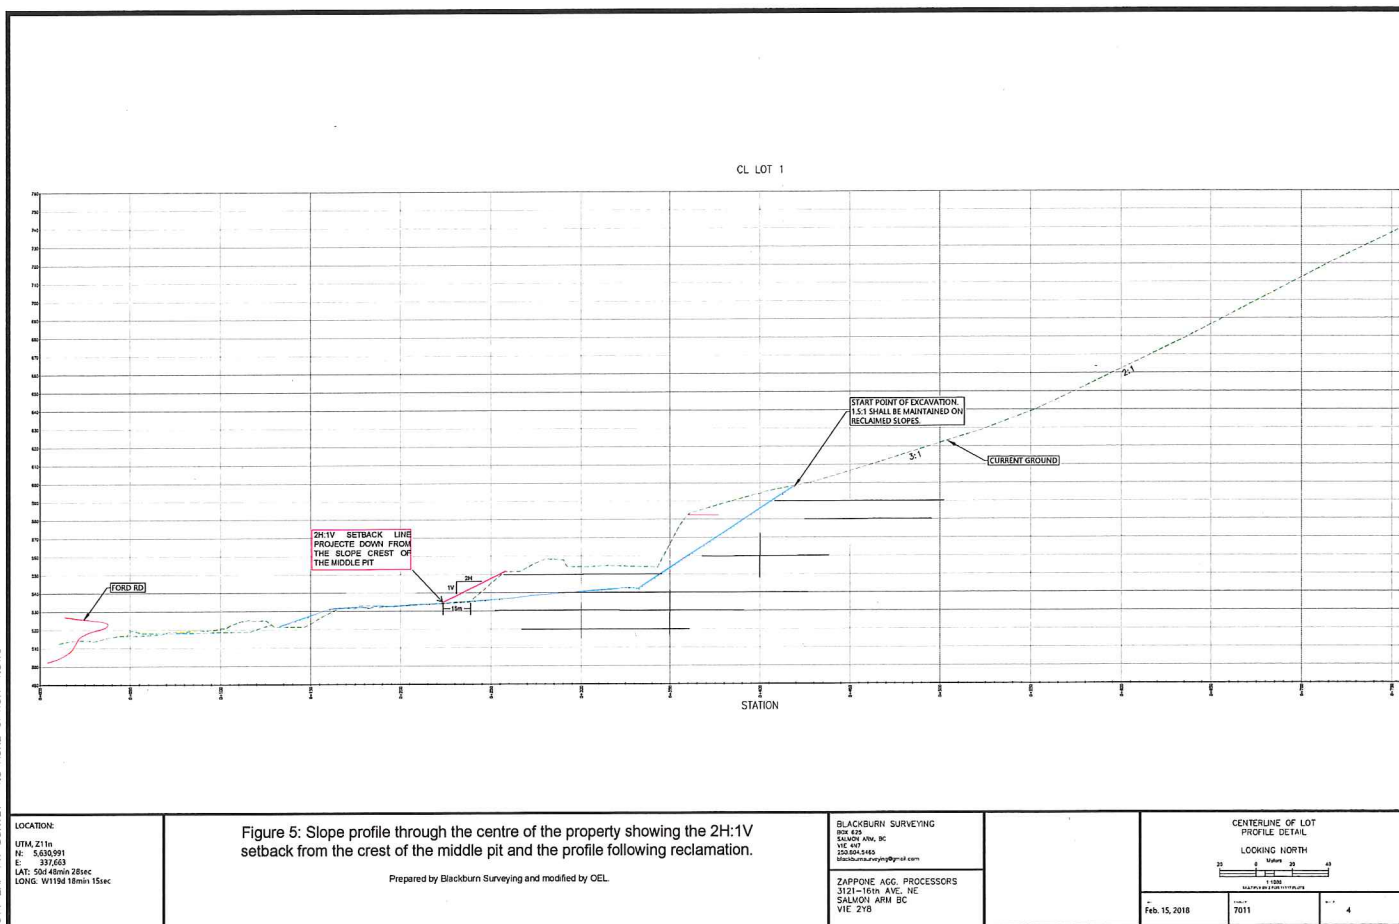
Under present conditions the steep gradient slopes of the excavations within the middle and upper pit have a significantly elevated likelihood of a landslide that could impact future development on the lot. The likelihood or probability of a landslide event occurring is estimated as high. A **high likelihood** means that **a landslide is likely** over the lifespan of the proposed development. Quantitatively, the probability of a landslide is estimated as 1/20 to 1/100 annual probabilities. **As a result, the hazard of a damaging landslide event initiating within the active gravel extraction areas on Proposed Remainder Lot 1 under present conditions greater than the 1:475 level of landslide safety suggested by the MOTI.**

1. While the gravel pit is in operation a setback must be maintained from the top of the excavated face of the middle pit (see Figure 5). A 2H:1V line should be projected down from the slope crest. No development may occur upslope (east of) the set back until the excavated face is sloped back as indicated in recommendation 2 below.
2. Following completion of gravel pit operations within Remainder Lot 1, the excavated faces of the middle pit and the upper pit within Remainder Lot 1 must be sloped back to an angle no steeper

than 1.5H:1V. Once this recommendation has been completed, the setback detailed in recommendation 1 above is no longer applicable and development can occur up to the toe of the re-contoured slope.

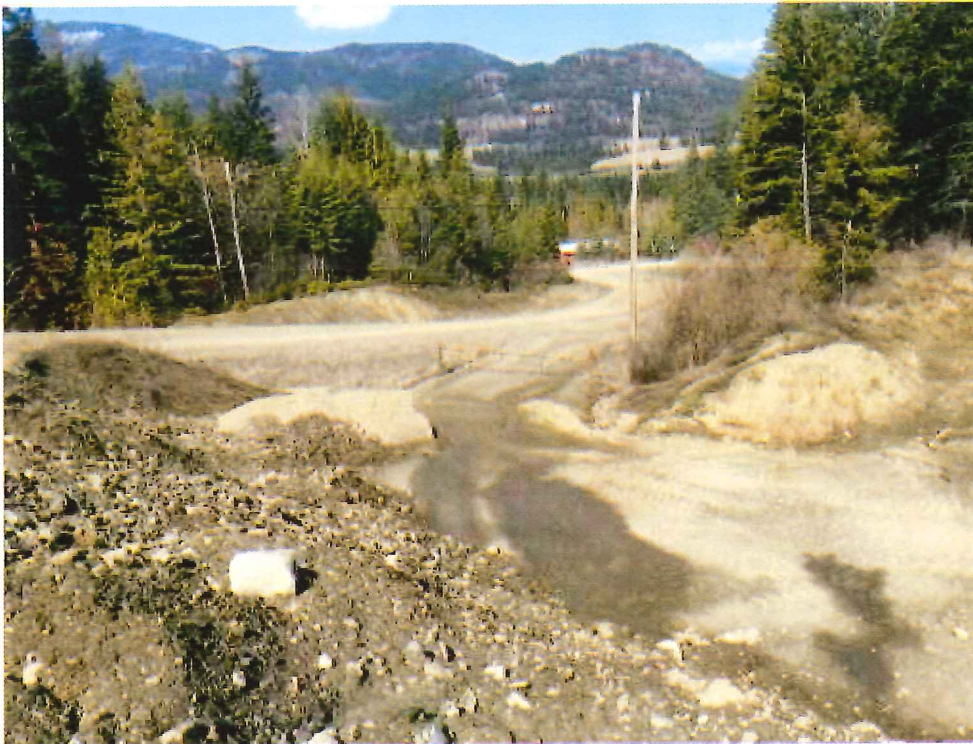
Photo 1 Gate 3 accessing the salt shed in the northwest corner of the property to be decommissioned, looking northwest.

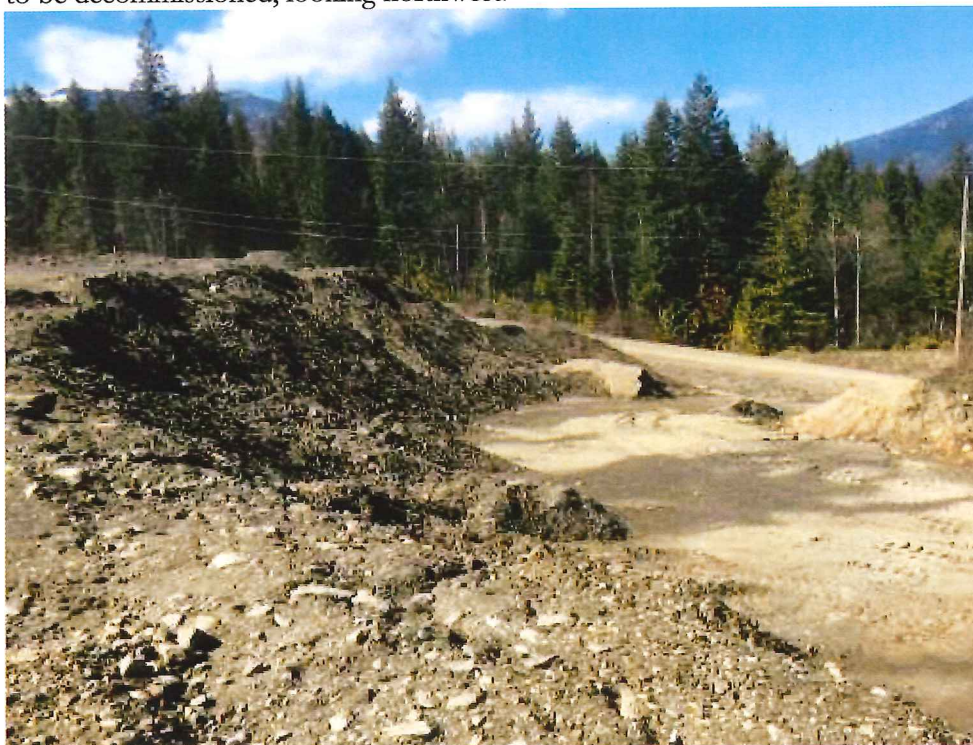
Lot 1 is currently accessed by Gates 2 and 3. Gate 3 provides access to the salt shed, while Gate 2 provides access to the lower pit. The ditchline of Ford Road flows under Gate 2 via a plugged and partially crushed 500mm diameter culvert to a crushed 400mm diameter culvert under Gate 3. Gate 3 is proposed to be decommissioned and the existing crushed 400mm diameter culvert will be removed and Gate 2 will be the only access to the proposed lot. Significant erosion and sediment deposition was observed in the ditchline and is likely the result of the lack of drainage measures in the gravel pit area within the property. A drainage ditch is present around the north and west side of the salt shed to drain water away from the structure and carry it down to Ford Road.

Photo 2 Gate 2 accessing the lower pit in the central portion of the property, looking west.

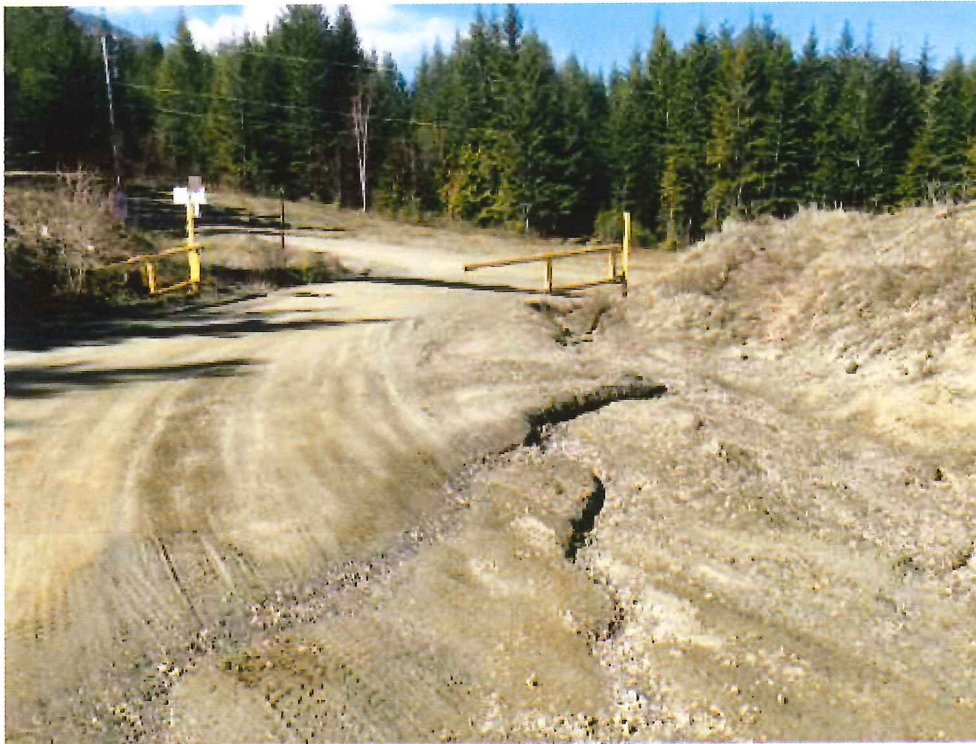
Photo 3 Erosion from surface runoff on the access road at Gate 1, looking west.

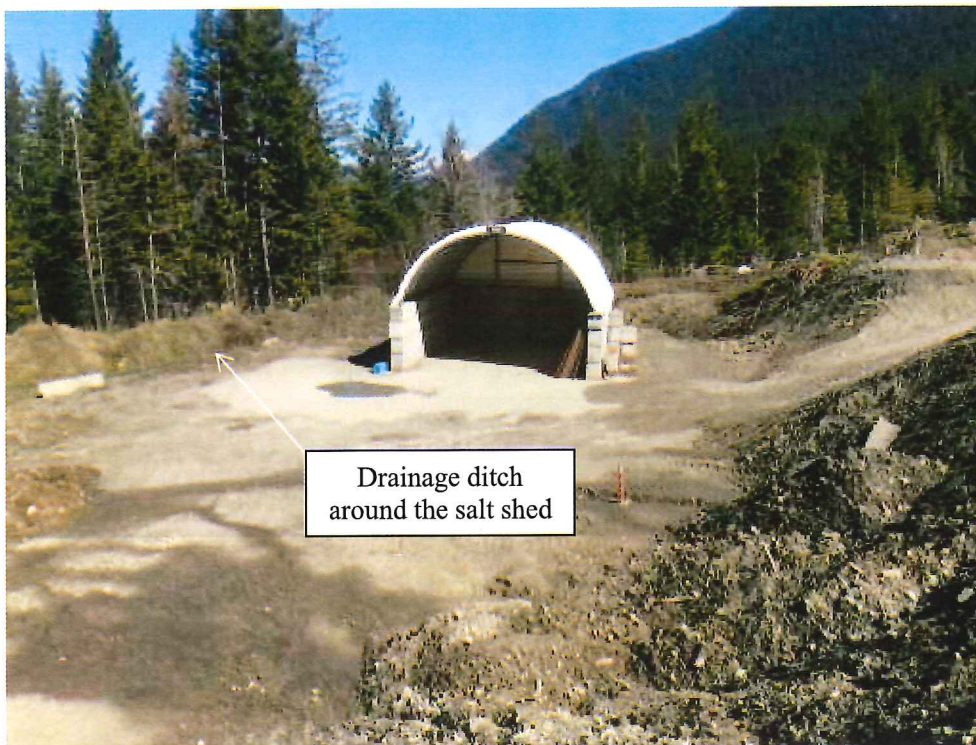
Photo 4 The salt shed on proposed Lot 1 and the access road from the salt shed to the lower pit, looking north.

- 1. All slopes bordering Proposed Lot 1 will be sloped back to an angle no steeper than 1.5H:1V.**
- 2. The salt shed is removed and the area is filled in to create a 1% slope extending from Ford Road to the back of the property.**
- 3. Drainage swales will be constructed along the northern and southern property lines to drain surface runoff towards the ditchline of Ford Road.**

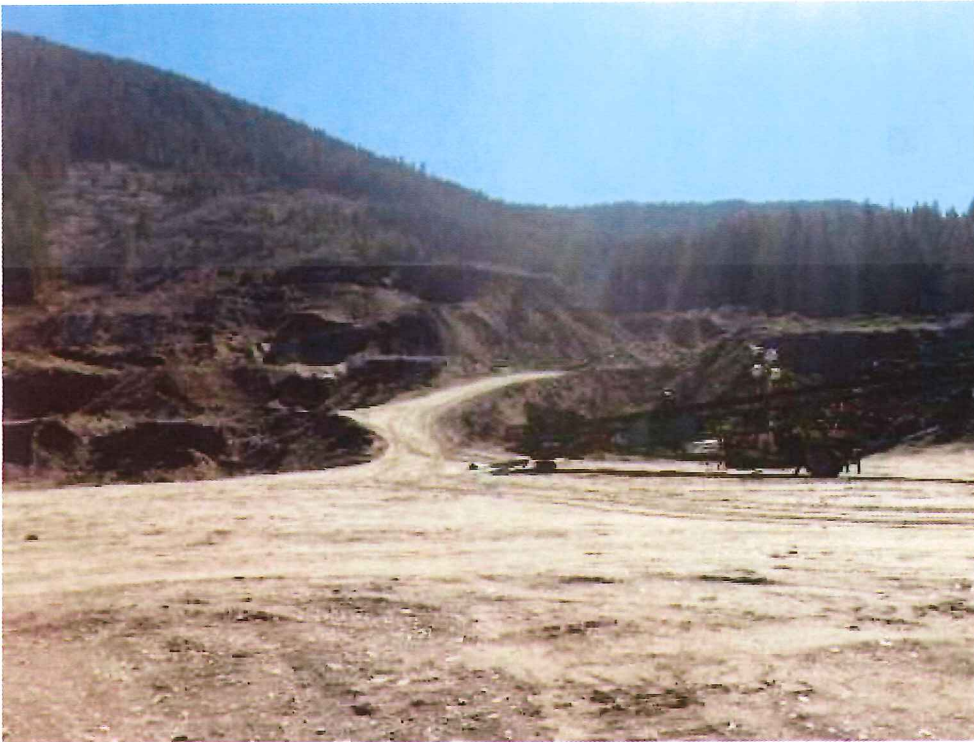
Photo 5 The lower pit on proposed Lot 1, looking east. Note: The ground will be excavated to be level with the terrain within the salt shed and the slopes will be sloped back to 1:5V:1H.

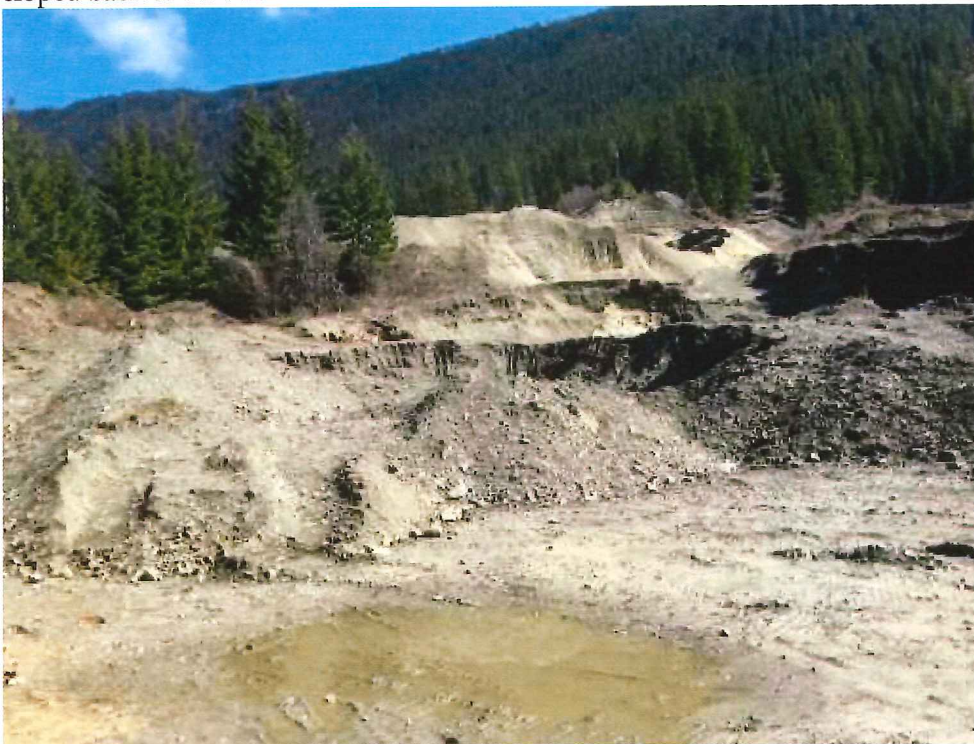
Photo 6 Piled material within proposed Lot 1 to be removed and/or sloped back to 1.5V:1H, looking northeast.

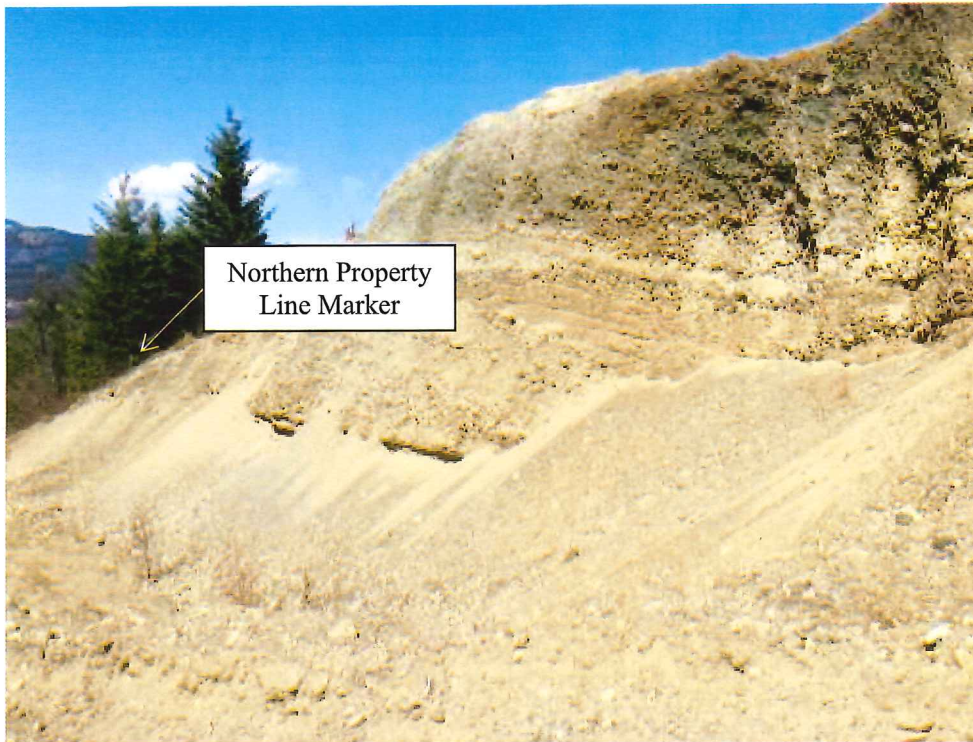
The terrain coming down into the property from the Turner gravel pit to the north features slope gradients of 120% to near vertical for 10 to 12m that decrease to 60% for 7 to 10m. The slope is composed of sandy glaciofluvial deposits with abundant cobbles.

Photo 7 Steep terrain extending down from adjacent gravel pit into proposed Remainder Lot 1.

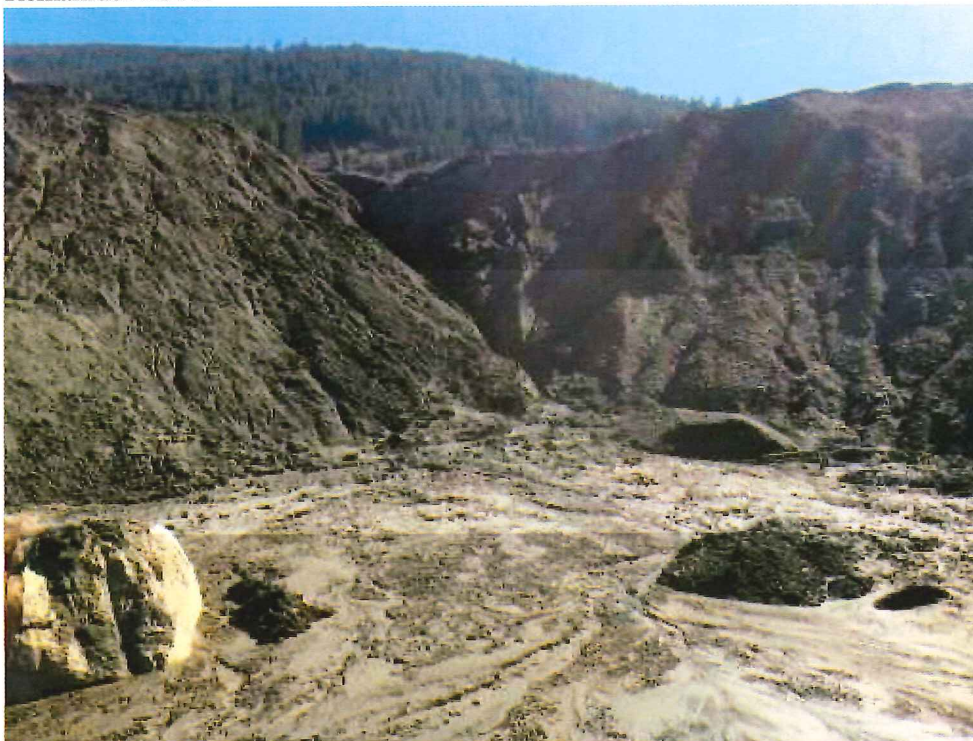
It is our understanding that the terrain within the upper gravel pit will be sloped towards the north as to direct runoff from the upper gravel pit north to the swale constructed along the northern boundary of proposed Lot 1 and is to be carried to the ditchline of Ford Road. This will prevent runoff from flowing over the excavation of the middle pit and the deposition of sediment within the middle pit.

Photo 8 Runoff down coming from the upper pit to the middle pit causing a slurry of deposition, looking east.

3. The terrain within the upper pit must be sloped to the north to carry runoff from the upper pit to the swale around proposed Lot 1 in order to prevent runoff from flowing over the excavated face of the middle pit.

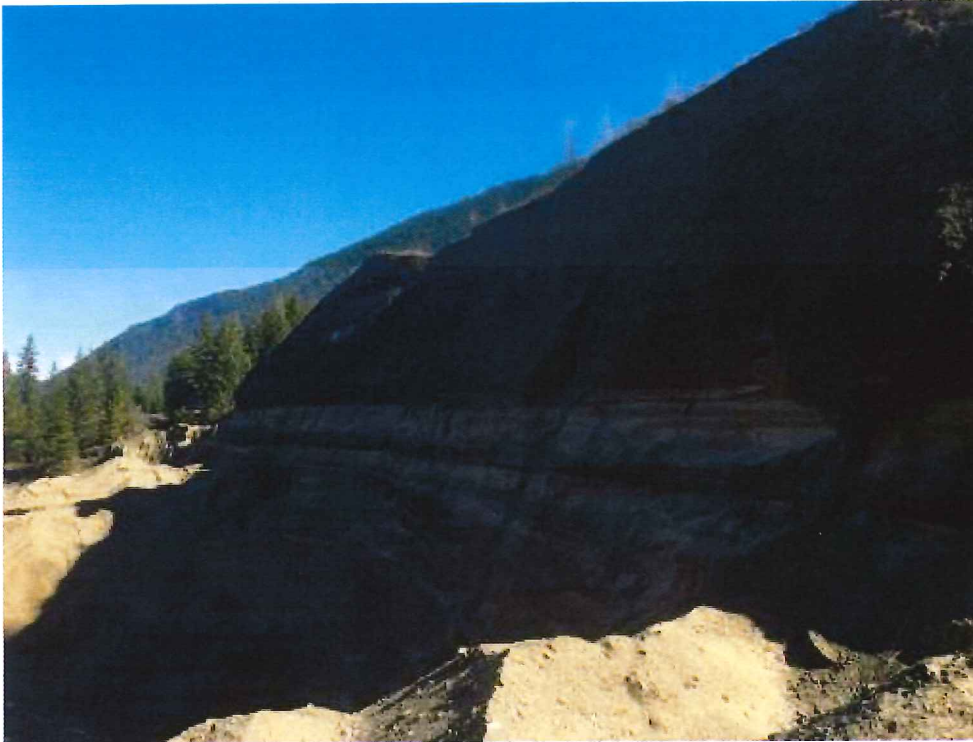
Terrain at the base of the upper pit is generally flat extending to the excavated face which is sloping at a gradient of 160% for approximately 27m. Due to the lack of drainage or sediment control measures, runoff from the upper pit is flowing over the excavated face of the middle pit and depositing a slurry of material on the flat to gentle gradient terrain within the middle pit. Although the excavated slopes are over-steep, they are composed of relatively compact materials and do not appear to show any signs of instability.

Photo 9 Excavated face of the upper gravel pit, looking north.

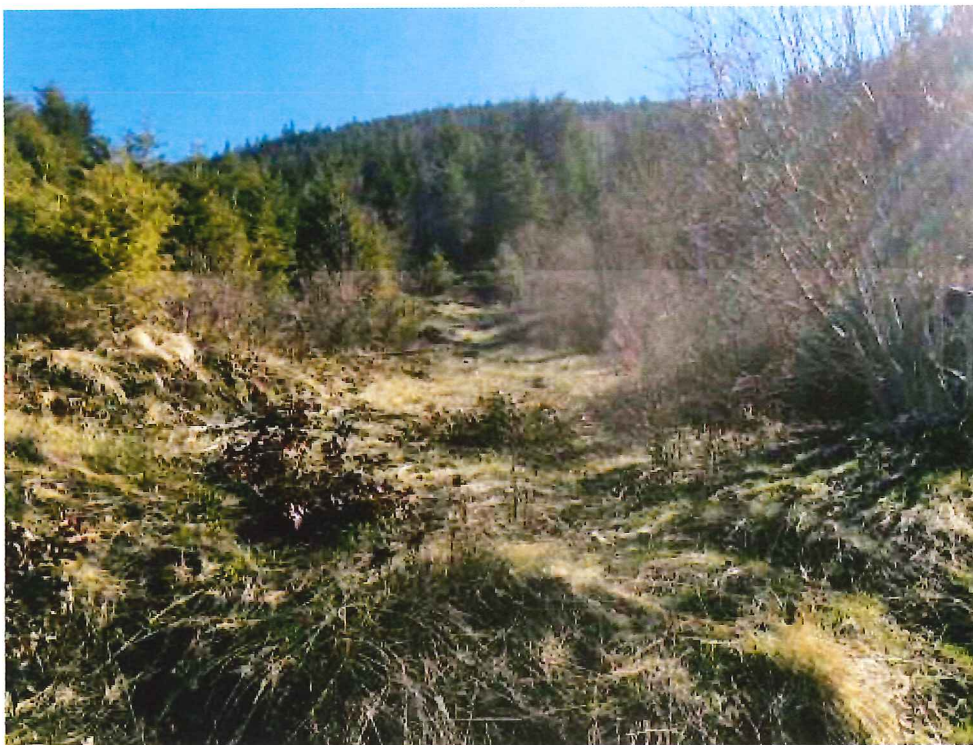
Photo 10 Broad, low gradient swale in the location of the mapped drainage feature, looking east.
