June 7, 2019

Derek Sutherland
Columbia Shuswap Regional District
555 Harbourfront Drive NE
PO Box 978
Salmon Arm, BC V1E 4P1

**RE: Newsome Creek Erosion Mitigation Options
Our File 3234.013**

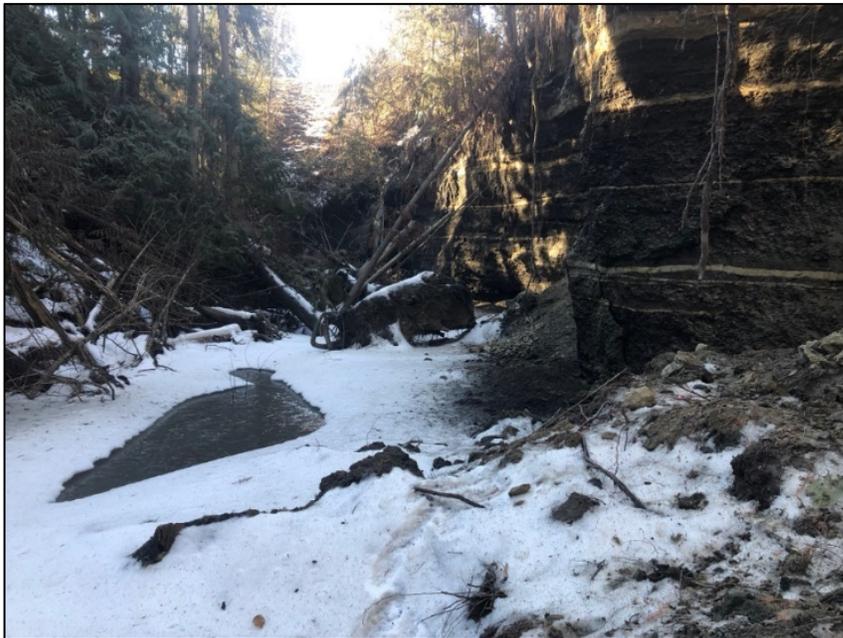
Bank toe erosion is leading to undercutting and slope failure with earthen blocks falling into the creek along a reach of 40 m downstream of the Highway 1 culvert outlet. A recent slope failure caused a channel blockage, with ponding of the creek and an outlet drop of 1.2 m. Photo 1 below shows the conditions looking upstream from the channel blockage.

Photo 1: Looking upstream at culvert outlet and erosion.

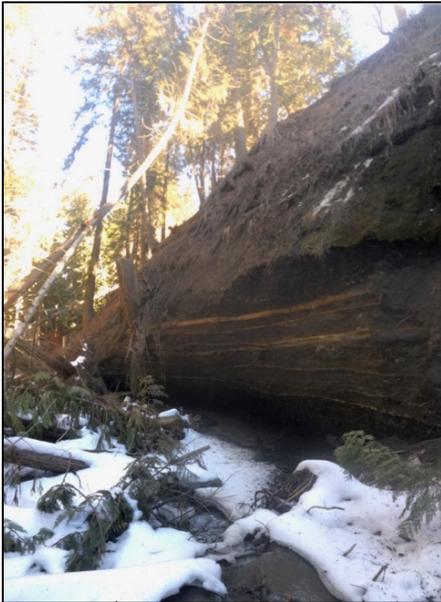
In the ravine below 2809 Caen Road, bank erosion has progressed to cause bank undercutting. Debris, including trees, shrubs, and sloughed material has obstructed the channel and pushed the flow to the right bank. Recent sloughed material was observed on snow piles at the slope toe with audible and active slope failure occurring. Photo 2 depicts the flow undercutting the right bank below the eroded slope.

Photo 2: Erosion below 2809 Caen Road (looking downstream).

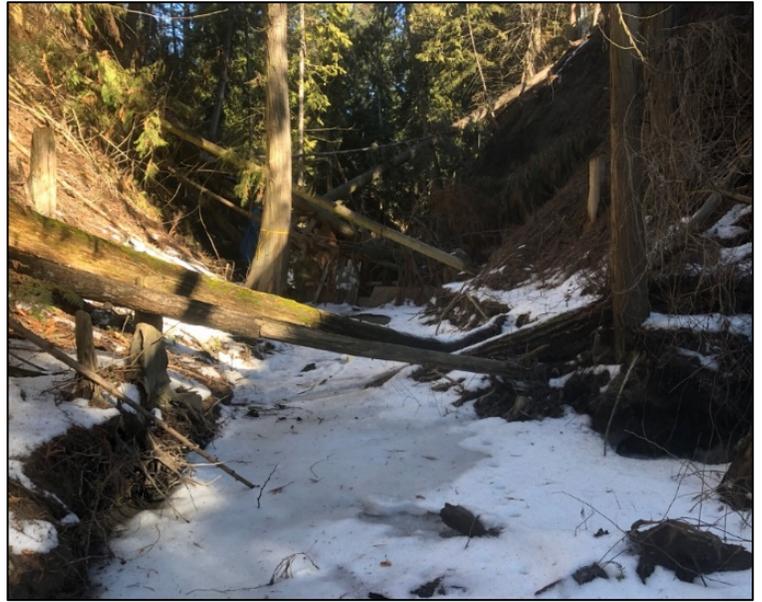
Overall, debris including fallen trees and an old tree fort litter the gully bottom causing deflected flow and ponding water. In 2018, Forsite Forest Management Specialists flagged danger trees throughout the reach². Photo 3 shows flagging tape for danger trees, along with a man-made structure on some of the toppled trees.

Photo 3: Looking downstream near 2817 Caen Road at toppled trees and manmade structures.

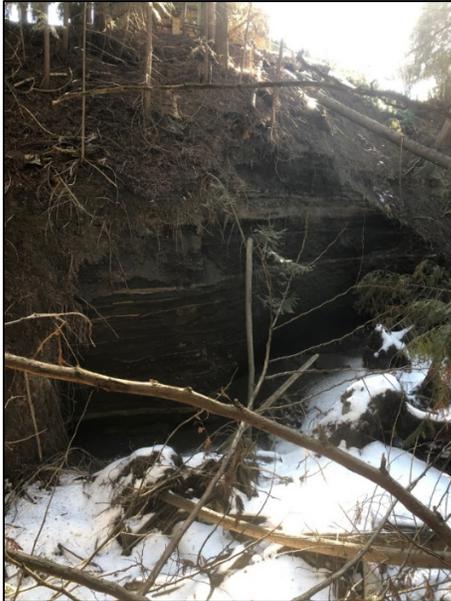
The right bank below 2819 Caen Road is affected by erosion along a reach of approximately 42 m. A portion of the bank is undercut by 2 m for 15 m at the apex of the erosion. A mature cedar located 30 m downstream is anticipated to imminently fall. The gully becomes more defined and narrows to approximately 4 m at the downstream extent of the erosion. Photo 4 shows the right bank erosion and the outbuilding (woodwork shop) at the top of the bank.

Photo 4: Looking across at undercut bank and high erosion at Civic address 2819.

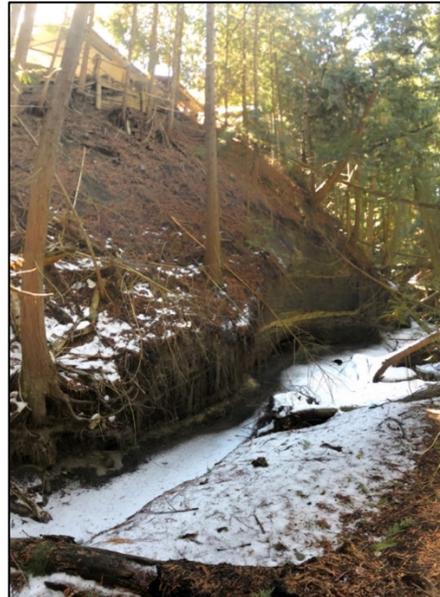
Below 2827 Caen Road, 20 m of erosion along the creek at the gully bottom is flanked by a steep 6 m high bank. Sedimentary layers are evident through the erosion with varying sizes and colours. Photo 5 indicates the layers of material and channel.

Photo 5: Looking across at erosion below property No. 2827 from bench across.
