EXEMPTION NO. 701-23

Schedule 'C'  
Flood Hazard Assessment Report

**Re: Flood Hazard Assessment for the Residence at 1585 Blind Bay Road, Sorrento, BC (Revision 1); Legal Address: Lot 1, Section 15, Township 22, Range 11, W6M, KDYD, Plan EPP19912.**

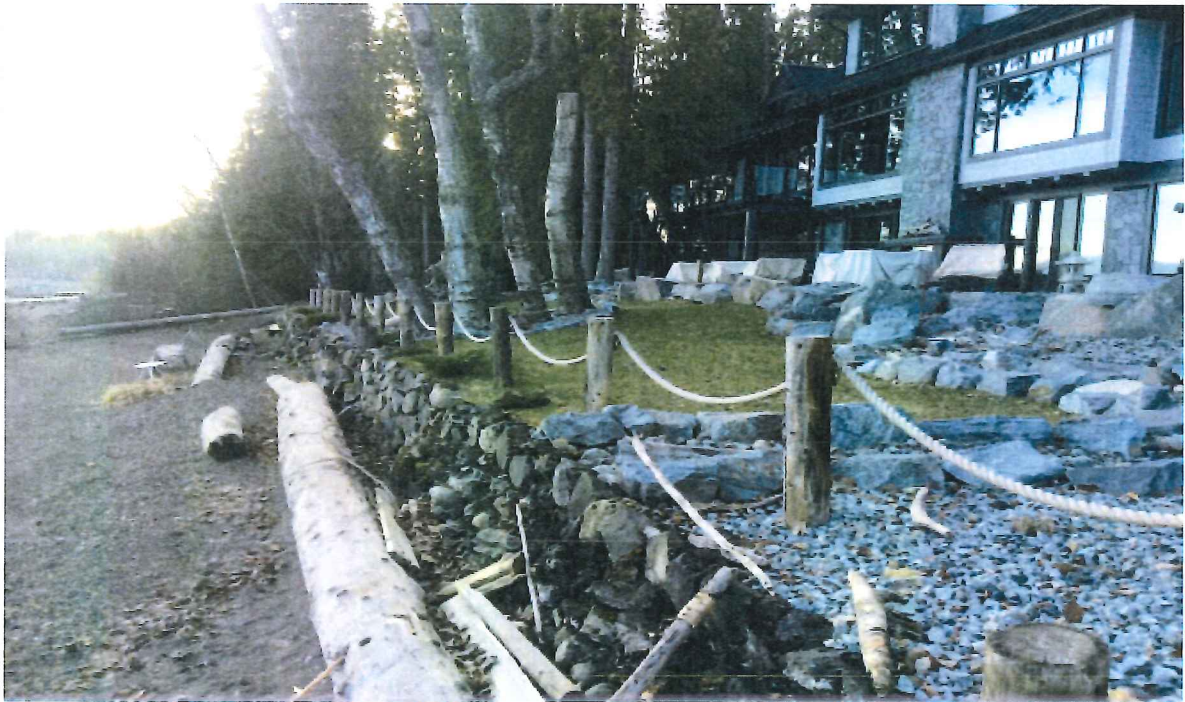
A rock retaining wall has been constructed across the foreshore of the property, presumably to retain the landscaped yard area and to protect against shoreline retrogression. The wall predates the current residential structure and was in place when Mr. LeClair purchased the property. The wall is constructed out of 0.2-0.5m diameter clasts of competent metamorphic rock and is placed at a slope gradient ranging from 85% to close to vertical. No signs of instability were noted associated with the rock wall during the field review. The wall also appears to be adequately preventing shoreline erosion and retrogression.

The living space of the house is constructed behind the 15.0m setback of the 348.3m contour and above the flood construction level of 351.0m asl. The cantilevered portion of the house and chimney extend into the 15.0m setback; however, they are situated above the flood construction level. The attached deck on the house extends into the 15.0m setback and the steps are completely within the 15.0m setback; however, these structures do not contain any habitable space and the footings of these structures are constructed below frost depth. In addition, the surface of the deck is raised above the flood construction level. As a result, the house is unlikely to be affected by flooding or erosion on Shuswap Lake. Shoreline retrogression at the site is unlikely to occur due to the presence of the rock wall structure along the foreshore of the property.

**Therefore, it is our determination that the existing house on the property can be considered safe for its intended use with respect to flooding hazards presented by Shuswap Lake.**

Photo 1 – Existing residence built behind a rock wall structure. Shoreline erosion or retrogression is not expected to occur.

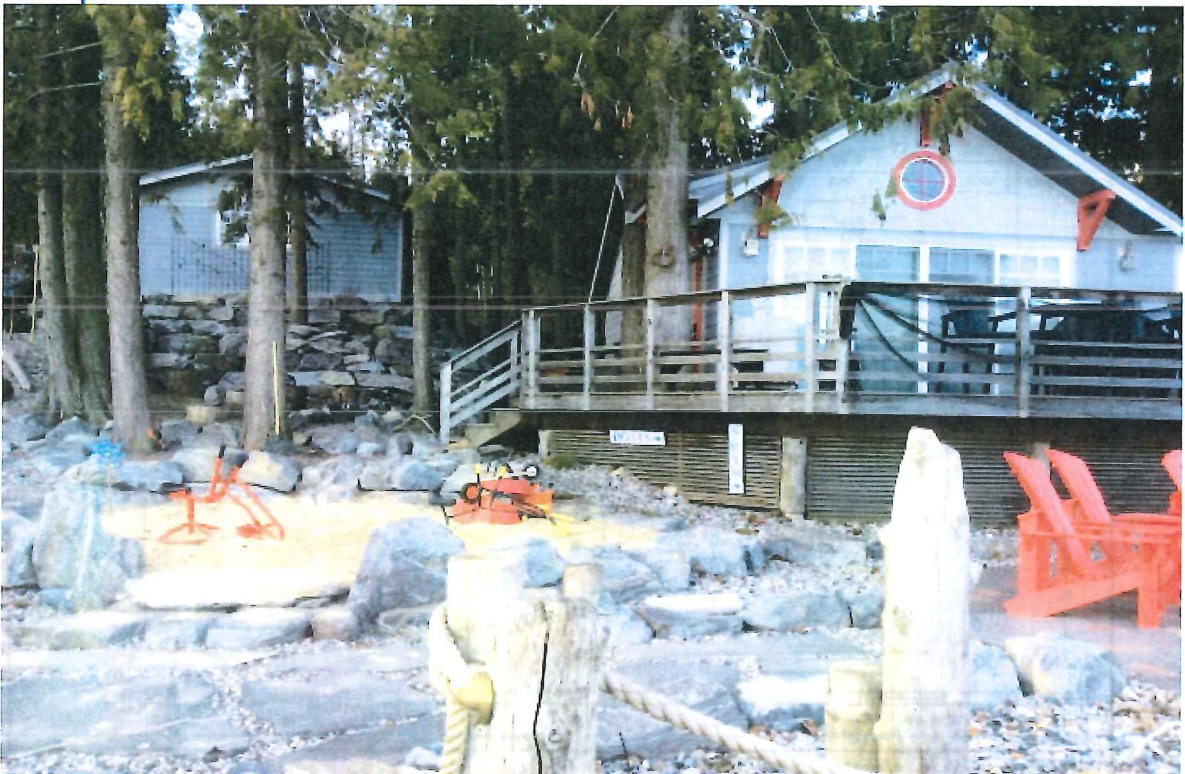
Surficial materials underlying the subject property were not observed in the field due to extensive landscaping. However, surficial materials observed in the general area surrounding the subject property consist of loose coarse sand and gravel beach deposits overlying silty till deposits. Bedrock was not observed in the field. Bedrock mapping of the area indicates that the local lithology is Lower Paleozoic fine clastic sedimentary rocks of the Mount Ida Assemblage.

Photo 2 – Extensive landscaping downslope of the garage (left) and the cabin (right).

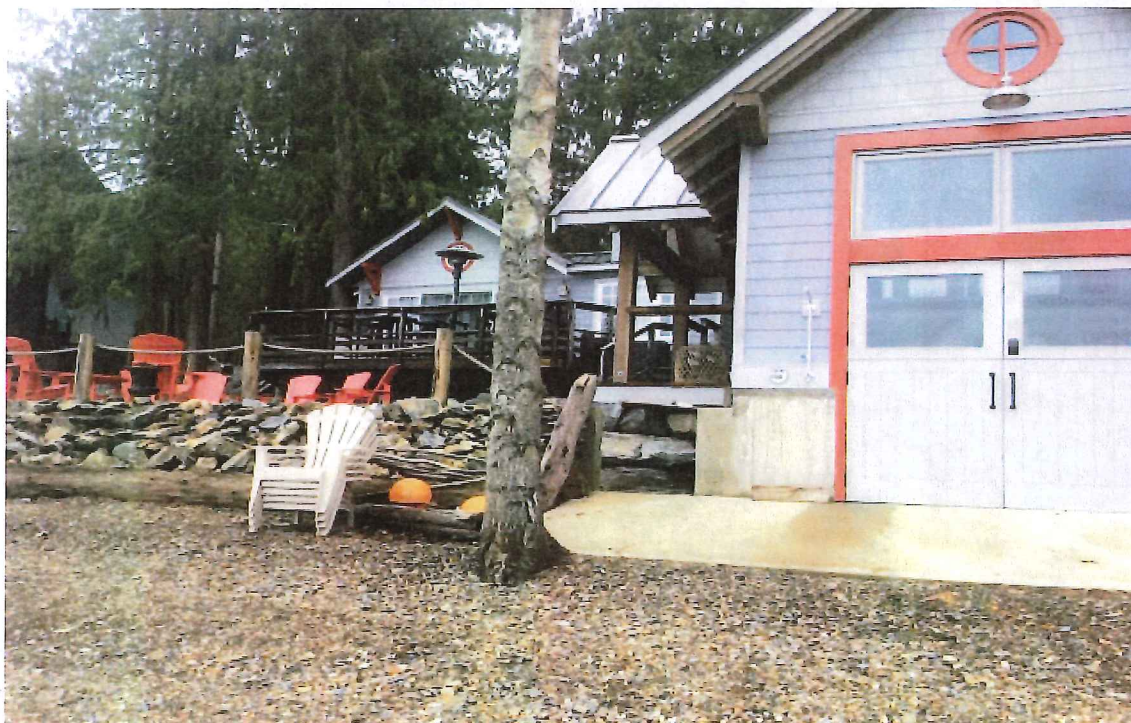
The boathouse is situated directly adjacent to Shuswap Lake. The foundation of the boathouse consists of a concrete slab cast directly on the native beach materials present at the site. The structure, including the concrete pad on the north and the attached decks on the south and east

sides of the structure, are entirely within the 15.0m setback of the 348.3m contour and the lower level of the structure is situated at an elevation of 350.48m asl (i.e. below the flood construction level of 351.0m asl).

The boathouse structure is situated adjacent to the foreshore of Shuswap Lake and is completely within the 15.0 setback of the 348.3m contour. The foundation of the structure appears to be built directly on the beach materials and is situated below the flood construction level of 351.0m asl. The attached concrete pad and decks are also within the 15.0m setback and below the flood construction level. As a result, the lower level of the structure and attached deck and steps could be inundated during a highwater event on Shuswap Lake. However, damage to the boathouse structure will likely be restricted to minor water damage. The boathouse does not contain any habitable space and as a result, no threat to human life is conceivable.

Photo 3 – Location of the cabin (left) relative to the boathouse (right). Note the concrete slab foundation built directly on the beach materials.

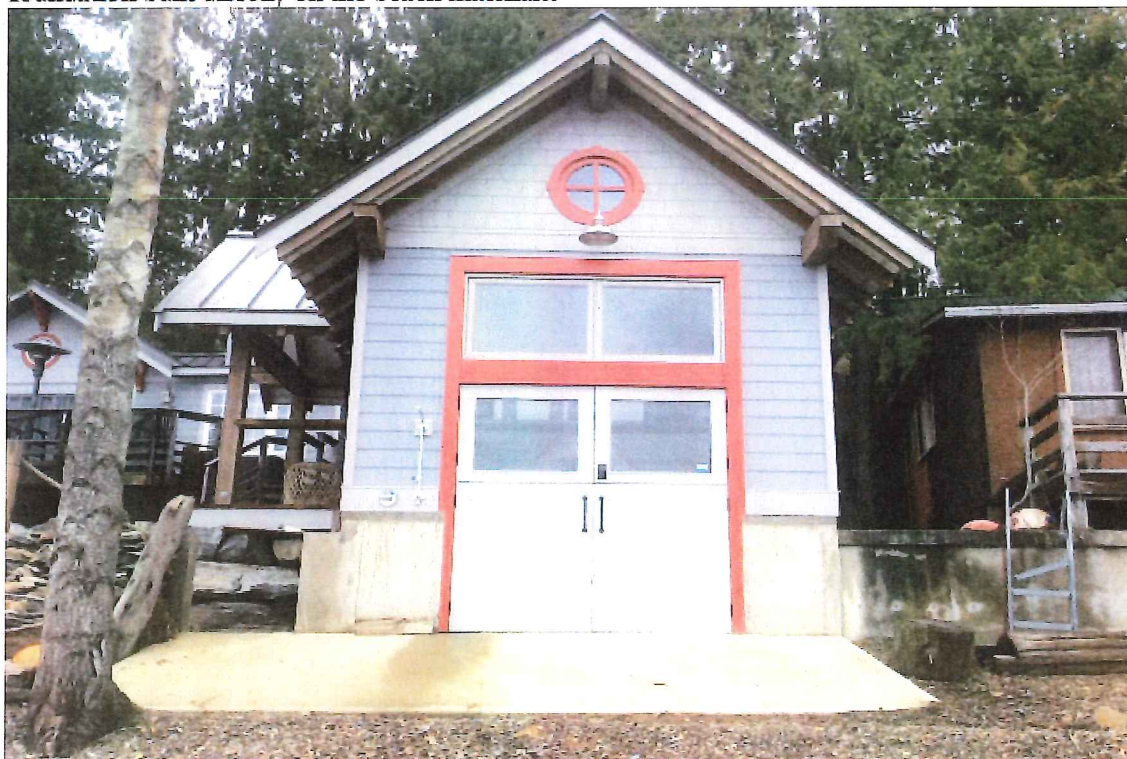
The boathouse structure, decks, and concrete pad are located within the 15.0m setback of the 348.3m contour and situated below the flood construction level of 351.0m asl. As a result, flooding events on Shuswap Lake could conceivably inundate the boathouse. However, the boathouse does not contain any habitable space and flooding events are typically slow moving, low energy events. As a result, flooding could cause minor property damage, but is not considered a life threatening event.

**Therefore, it is our determination that the existing boathouse on the property can be considered safe for its intended use with respect to flooding hazards presented by Shuswap Lake.**

Photo 4 – The boathouse built on the beach materials.

No recommendations are suggested as the existing structures are not expected to be impacted by flooding on Shuswap Lake with the exception of minor water damage to the boathouse structure.

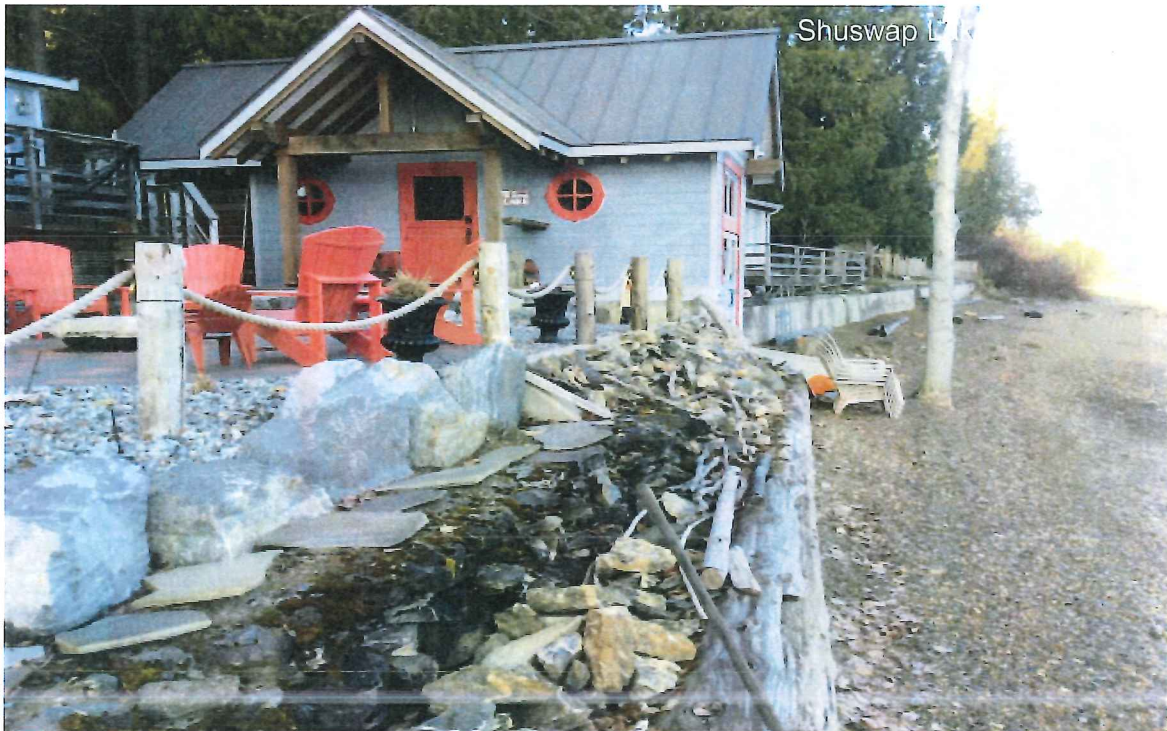
The rock wall present along the foreshore of the property was in place prior to the summer of 2012 when a highwater event occurred on Shuswap Lake. This highwater event recorded a peak water elevation of 349.588m which was the highest level since 1972, indicating that the event was on the order of a 1 in 40 year event. While previous flooding on Shuswap Lake likely inundated part of the rock wall, the structure appears to resist erosion and shoreline retrogression during this event.

Photo 5 – Side view of the boathouse and the rock wall where the property meets the beach.
