British Columbia Timber Sales – Vernon Office

***CUTBLOCKS K0WG, K5M7, AND K5M8
BASTION CREEK AREA
TERRAIN STABILITY ASSESSMENT***

AZIMUTH FORESTRY & MAPPING SOLUTIONS LTD.

APRIL 3, 2020

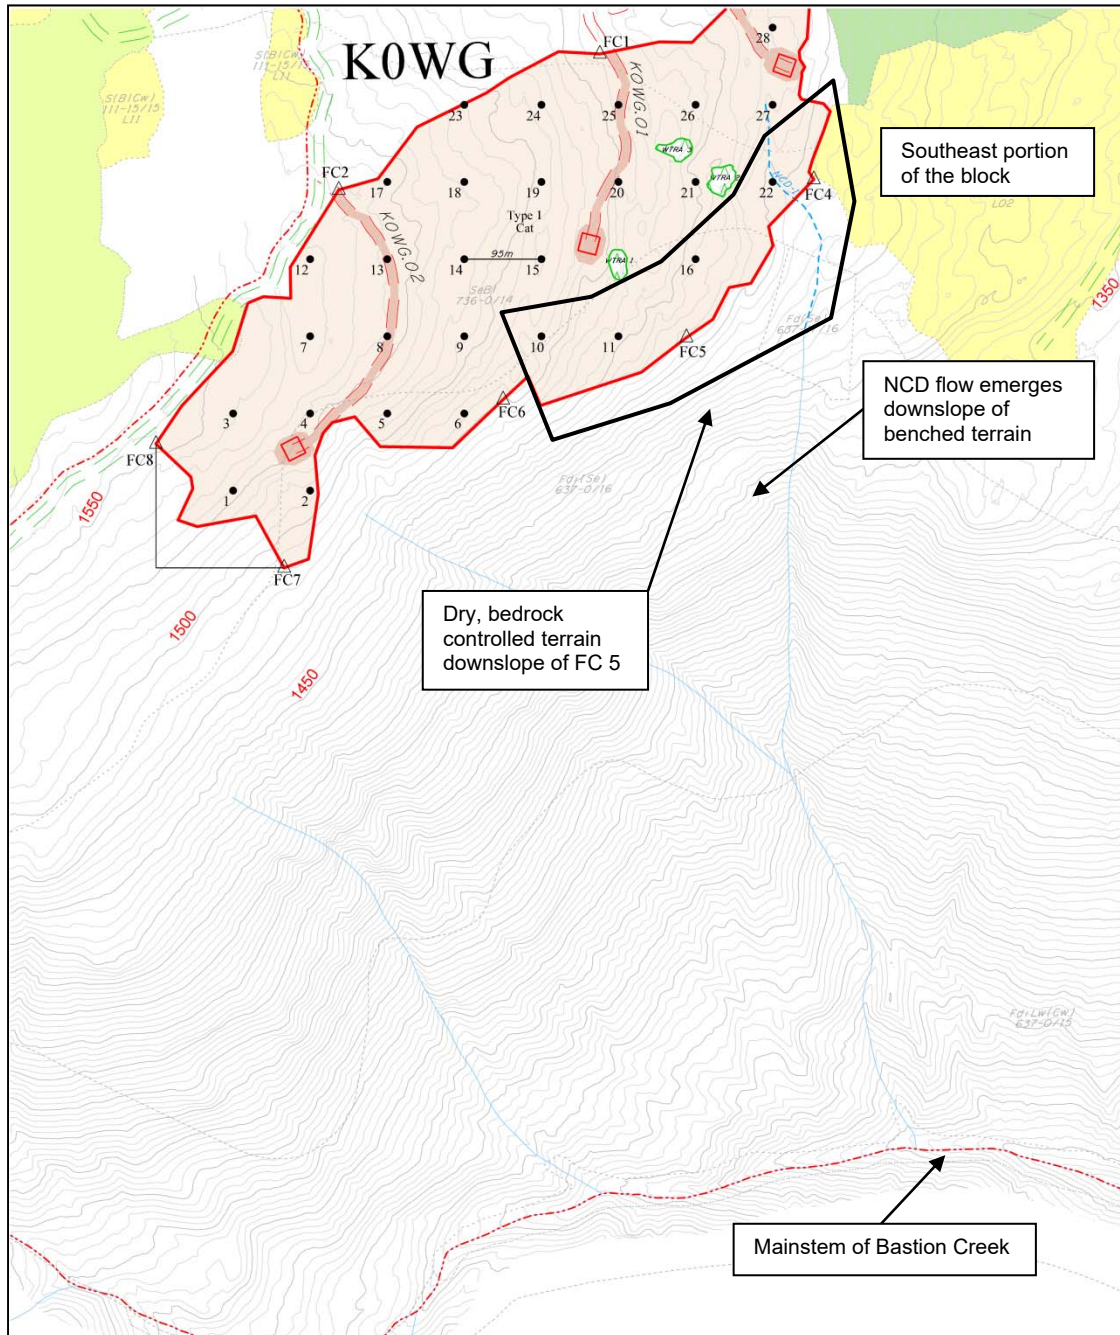
Figure 5 – Detailed view of block K0WG and the downslope area. The original map scale was 1:5,000.

The southeast portion of block K0WG is situated at the crest of the slope break to the Bastion Creek sidewall. Terrain within this portion of the block is irregular and somewhat benched with mainly gentle slope gradients and some isolated moderate gradient pitches. Downslope of this portion of the block, moderately steep to steep gradient slopes extend for approximately 150m down to a broad bench. Downslope of the bench an incised gully with moderately steep to steep slope gradients forms and extends down to Bastion Creek.

Surficial material in this portion of the block consists of a veneer of gravel sized rubble in a silt and sand matrix. Deeper deposits of silt and sand with some gravel till are located in topographic lows. These materials are moderately well to well drained for the most part aside from a pocket of imperfectly drained surficial material adjacent to NCD-1 in the eastern corner of the block.

Bedrock was noted throughout this portion of the block and immediately downslope and consisted of interbedded weak to medium strong schist and black shale.

Extensive natural landslide activity was noted on the sidewall slope downslope of the southwest portion of the block. The landslide activity ceases downslope of the southeast portion of the block and the downslope area is bedrock controlled. The landslide activity is discussed in detail in Section 5.1.3 of this report.

Implementation of the following recommendations is expected to reduce the incremental increase in the likelihood of a harvesting related landslide occurring downslope of the southeast portion of block K0WG as the result of the proposed harvesting activities to low.

7. **The harvest area must be inspected by a Qualified Registered Professional (QRP) representing BCTS concurrent with the completion of harvesting activities to ensure that the above recommendations are correctly implemented and natural drainage patterns are maintained in the harvest area.**

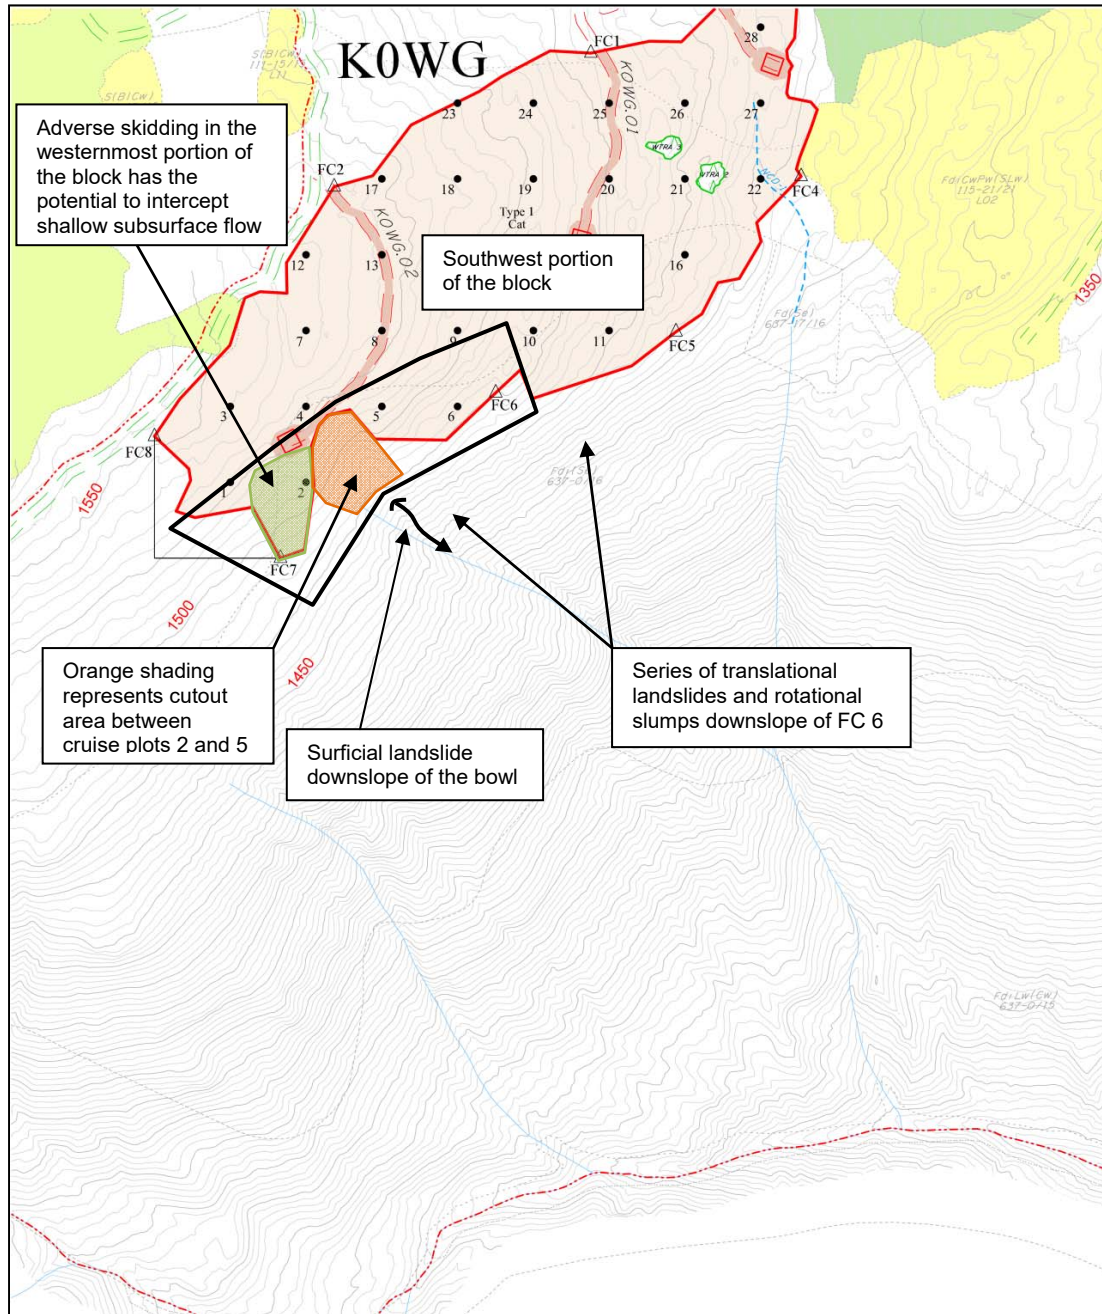
Figure 6 – Detailed view of block K0WG and downslope area. The original map scale was 1:5,000.

The southwest portion of block K0WG contains irregular and somewhat benched terrain with mainly gentle to moderate slope gradients. Immediately downslope of the block, terrain breaks over into moderately steep gradient, planar to somewhat irregular terrain. A cutout is present between cruise plots 2 and 5 around a broad, moderately steep gradient bowl feature. This cutout was recommended by Azimuth at the time of fieldwork due to geotechnical concerns in the area. The various portions of this section of the block are discussed below.

The westernmost portion of the block (end landing of the K0WG.02 road extending downslope to FC 7) consists of a broad gentle to moderate gradient bench. This portion of the block is imperfectly drained and while no water was noted at surface, extensive hydrophilic vegetation is present. This indicates that the local groundwater table is close to surface and could be intercepted by trails constructed to facilitate harvesting operations.

Surficial materials in this portion of the block consist of a veneer (0.5-1.0m) of gravel sized rubble in a silty matrix. This material was moist to the touch at the time of fieldwork and hand dug test pits revealed that black shale bedrock underlies the surficial material. The surficial material appears to have formed out of insitu weathering of the local bedrock. The imperfectly drained nature of the surficial material is likely a product of the shallow bedrock as the bedrock forms a restrictive layer and forces the local groundwater to surface.

Downslope of this portion of the block surficial materials appear to deepen and the composition shifts to sandy silt with some gravel and trace clay till. This material is also moist to the touch and is considered to be susceptible to changes to pre-existing drainage patterns in the upslope area. Slope gradients in this downslope area are moderate for approximately 150m before gradually breaking over into moderately steep to steep gradients via a broad convex roll.

Surficial material within the bowl feature consists of moist, imperfectly drained silt with some sand and trace gravel till deposits. Sweep is present on timber in the area and an ephemeral NCD channel is present at the base of the bowl.

Downslope of the bowl area a steep draw complex is present. A recent surficial landslide was noted on the sidewall slope of the draw. The surficial slide originated on 80% slopes in deep deposits of silt and sand with trace to some gravel till deposits. The slide track was approximately 10m across and extended 30m downslope into a small S6 stream at the base of the draw. A small subsequent debris pulse event occurred on the stream but terminate after approximately 50m on 60% slopes. There are no obvious signs of water input to the surficial slide from the upslope area and as a result the surficial slide appears to be a natural product of steep slopes, fine grained surficial materials, and imperfectly drained surficial materials. It is likely that instability in the area is an ongoing phenomena and any sort of major disturbance to the area such as a forest fire, wind throw event, or insect infestation is expected to result in further instability.

The landslides occurred on 60-70% terrain in deep silt with some sand and trace gravel till deposits. No signs of water inputs to the landslides from the upslope area are apparent. The landslides appear to be natural events and likely occurred as a product of one of the proceeding stand rotations on the hillside. The last stand rotation appears to be the result of a large forest fire event. It is possible that this forest fire event lead to the initiation of the observed landslides. Note that impact of a large forest fire on the hillside would have a much larger impact on hillside hydrology and ground disturbance than the proposed harvesting.

Implementation of the following recommendations is expected to reduce the incremental increase in the likelihood of a harvesting related landslide occurring downslope of the southwest portion of block K0WG as the result of the proposed harvesting activities to low. Note that this applies to the incremental increase in the likelihood of a landslide only, a residual moderate natural likelihood of a landslide will persist downslope of this portion of the block. This natural likelihood will be present regardless of whether or not harvesting occurs in the upslope area.

1. **The area between cruise plots 2 and 5 must be excluded from the harvest area (note that this recommendation has already been implemented and the current cutblock mapping reflects the excluded area).**

8. **The harvest area must be inspected by a Qualified Registered Professional (QRP) representing BCTS concurrent with the completion of harvesting activities to ensure that the above recommendations are correctly implemented and natural drainage patterns are maintained in the harvest area.**

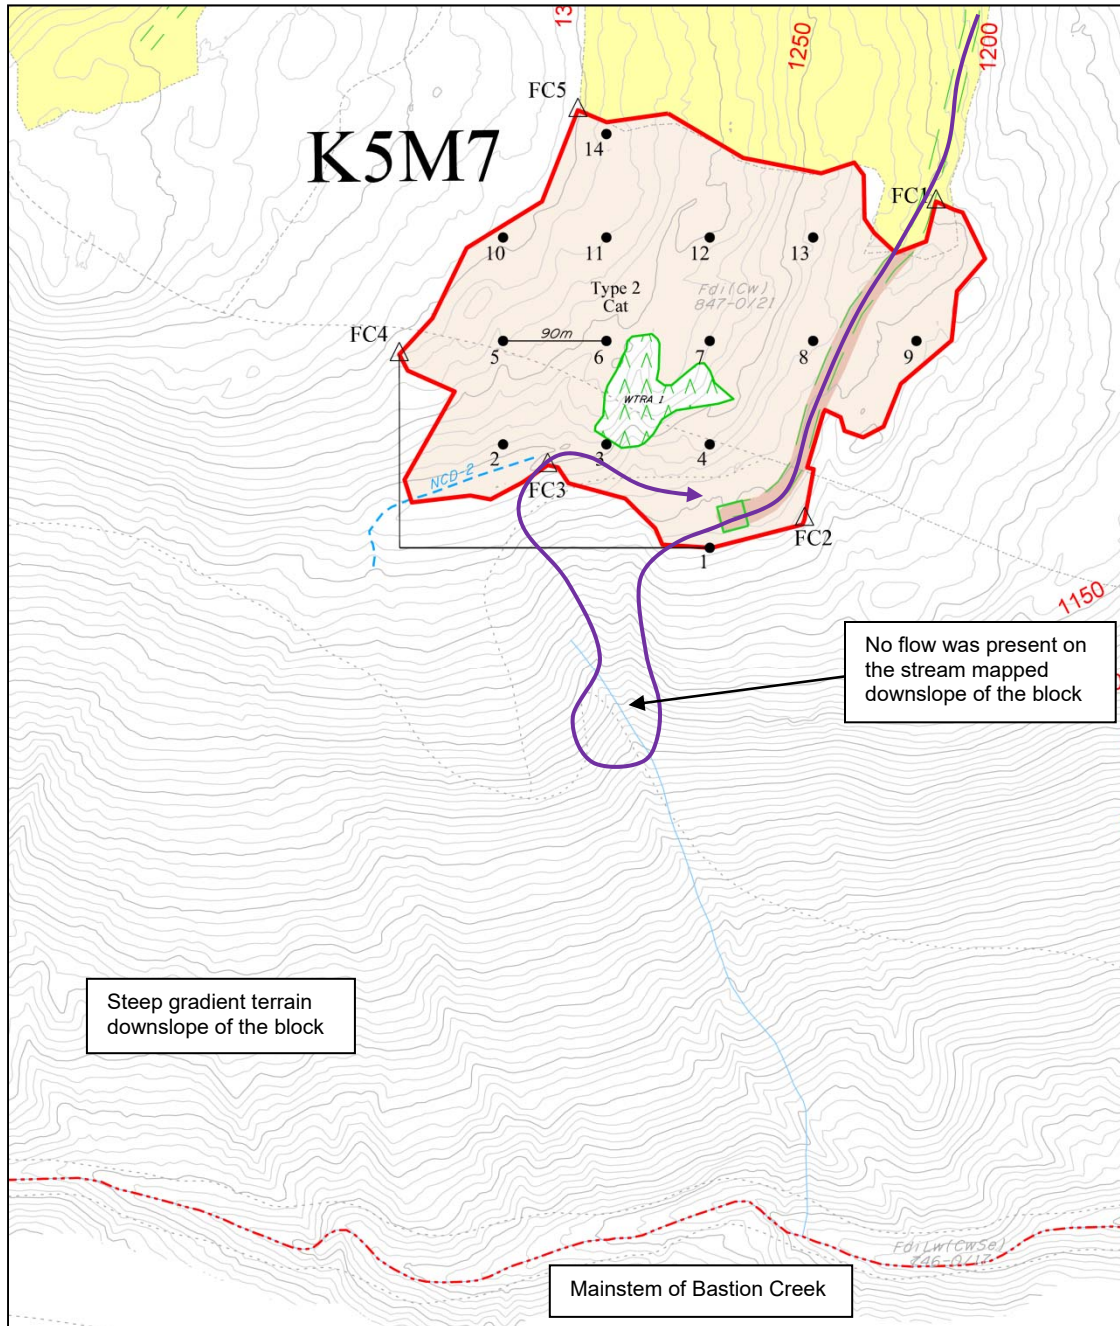
Figure 7 – Proposed Cutblock K5M7. The original map scale was 1:5,000. The traverse route is depicted by the dark purple line.

Terrain in the block is irregular with a series of bedrock knobs, outcrops, and ridges. Slope gradients in the block are gentle for the most part with some short moderate gradient pitches (10-40%). Terrain downslope of the eastern boundary of the block is irregular and bedrock controlled with gentle to moderate slope gradients.

Surficial materials within the block consist of well drained gravel sized rubble in a silt and sand matrix. This material is well drained, <1m in depth, and appears to have formed out of insitu weathering of local bedrock. Similar material was noted downslope of the block on the Bastion Creek valley sidewall.

Bedrock outcrops were noted throughout the harvest area and consist of weak to medium strong black shale.

Surface flows in the block are confined to a single small NCD that was dry at the time of fieldwork in the western corner of the block. This NCD is poorly confined and is susceptible to diversion; however, the flow volume in the stream is minimal. Base mapping of the area indicates that a stream also originates in the bowl downslope of the southern boundary of the block. The stream location was reviewed in the field and no evidence of surface or shallow subsurface flow was noted.

Implementation of the following recommendations is expected to reduce the likelihood of a harvesting related landslide occurring downslope of the southern boundary of block K5M7 to low:

6. **The harvest area must be inspected by a Qualified Registered Professional (QRP) representing BCTS concurrent with the completion of harvesting activities to ensure that the above recommendations are correctly implemented and natural drainage patterns are maintained in the harvest area.**

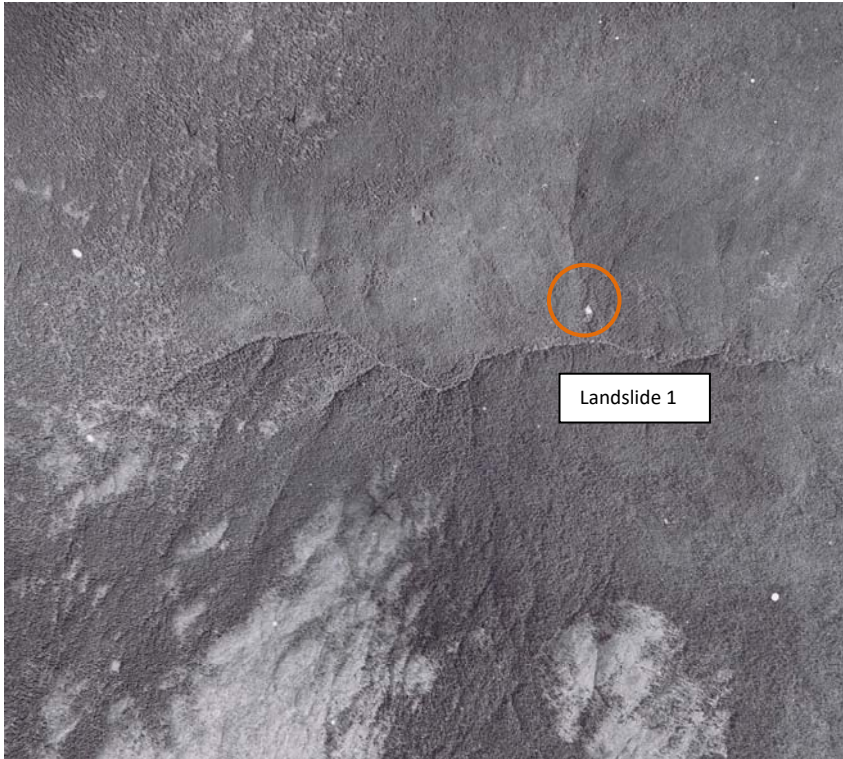
Starting in 1951, no roads, trails, or harvested areas are apparent within the Bastion Creek watershed or in adjacent areas. Development has yet to occur on the Bastion Creek fan. Timber in the area appears to be second growth. Historic wildfire records for the area available on iMapBC do not show a fire polygon overlapping with the proposed development area. However, a circa 1939 fire polygon is present on the south side of the Bastion Creek valley. Judging by the difference in timber size between the 1939 fire polygon and the north side of Bastion Creek, it appears that the development area likely burnt in the late 1800's or early 1900's.

Landslides visible on the 1951 airphotos within or downslope of the development consist of a single slump or slide (Landslide 1) on the lower portion of the Bastion Creek valley sidewall adjacent to a tributary stream which forms immediately downslope of proposed block K0WG.

Photo 1 – 1951 airphoto of the study area. Note the 1939 forest fire to the south of Bastion Creek valley and the relatively young timber on the north side of the valley.

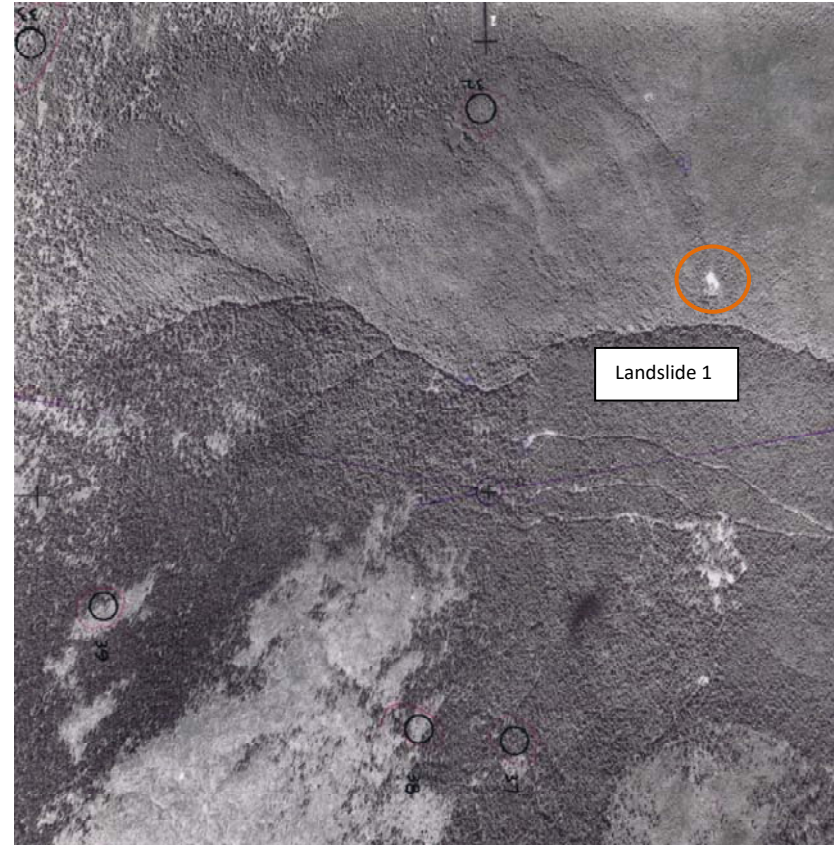
In the 1959 airphotos a road network is visible traversing the midslopes of the south sidewall of the Bastion Creek valley and patchy selective harvesting begins to be visible. No development is visible at the headwaters of the valley or on the north sidewall of the valley. The precursor to Sunnybrae-Canoe Point road is also visible on the Bastion Creek fan. The landslide noted downslope of block K0WG on the 1951 airphotos is also present on the 1959 airphotos and shows no changes in shape, size, or vegetation coverage. In addition, a large rotational slump begins to develop on the south sidewall of the Bastion Creek valley approximately 1km upstream of the confluence with Shuswap Lake.

Photo 2 – 1959 airphoto of study area. Landslide 1 remains similar in size, shape, and vegetation cover. Note the trails beginning to extend across the south sidewall of the valley.

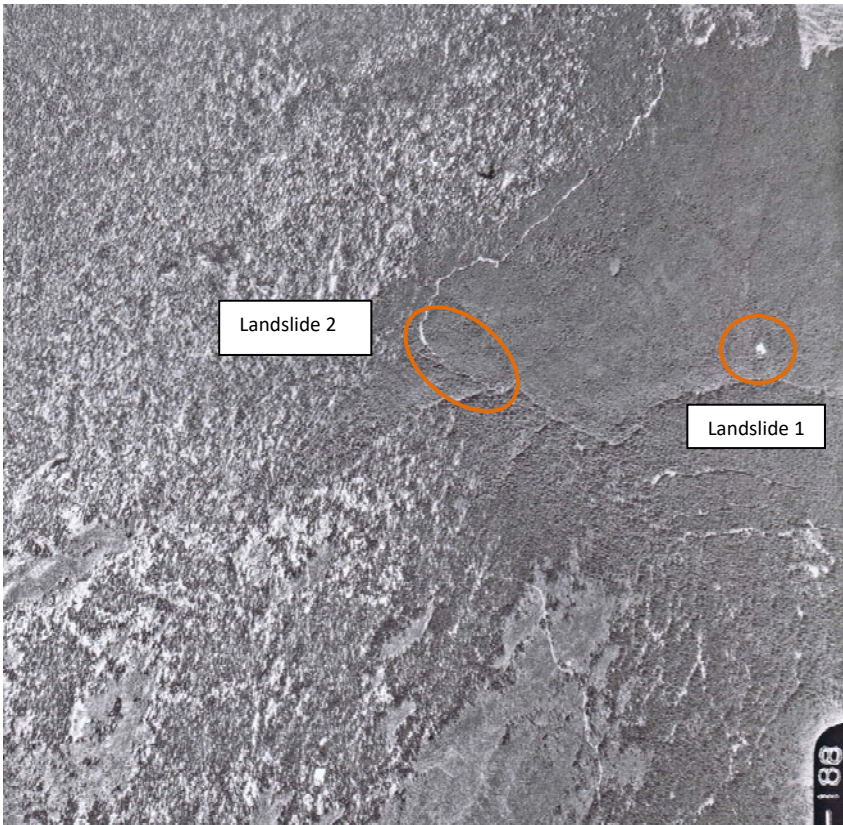
Photo 3 – 1967 airphoto of the study area. Note that Landslide 1 remains static in size, shape, and vegetation cover. Landslide 2 originates on a recently constructed road near the headwaters of Bastion Creek.

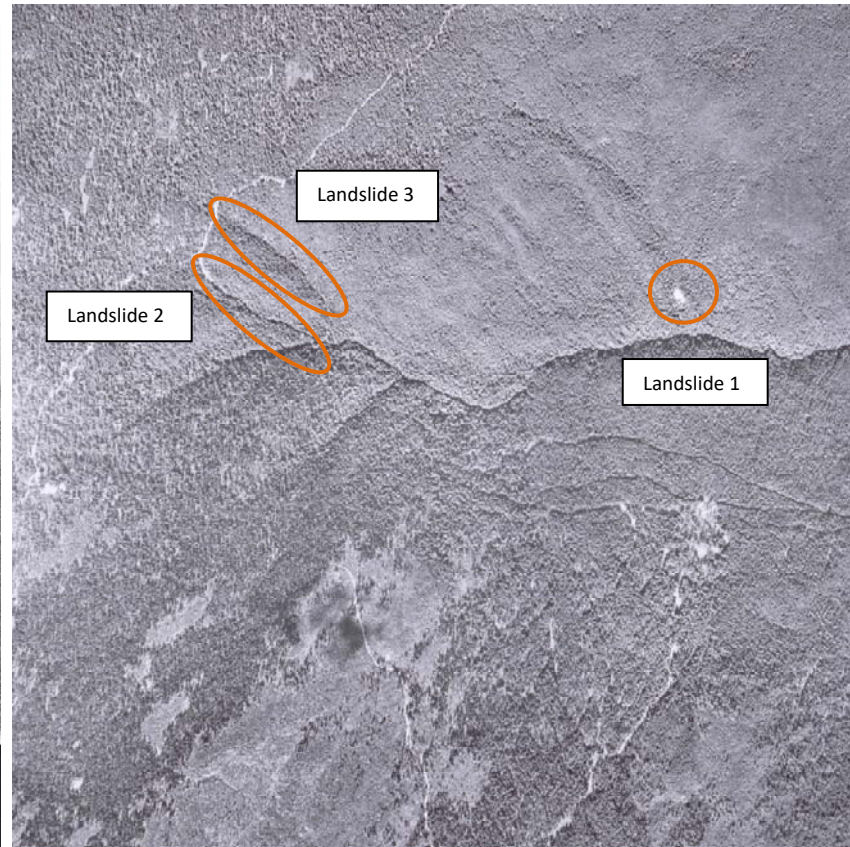
The 1974 airphotos reveal a third landslide (Landslide 3) originating in a tributary stream draw immediately to the north of Landslide 2. No fill slope failure is apparent originating on the

Photo 4 – 1974 airphoto of the study area. Landslide 1 remains static in size, shape, and vegetation cover. Landslide 2 is clearly visible and vegetation has not begun to regrow. Landslide 3 originates immediately downslope of the precursor to the 450.000 road.

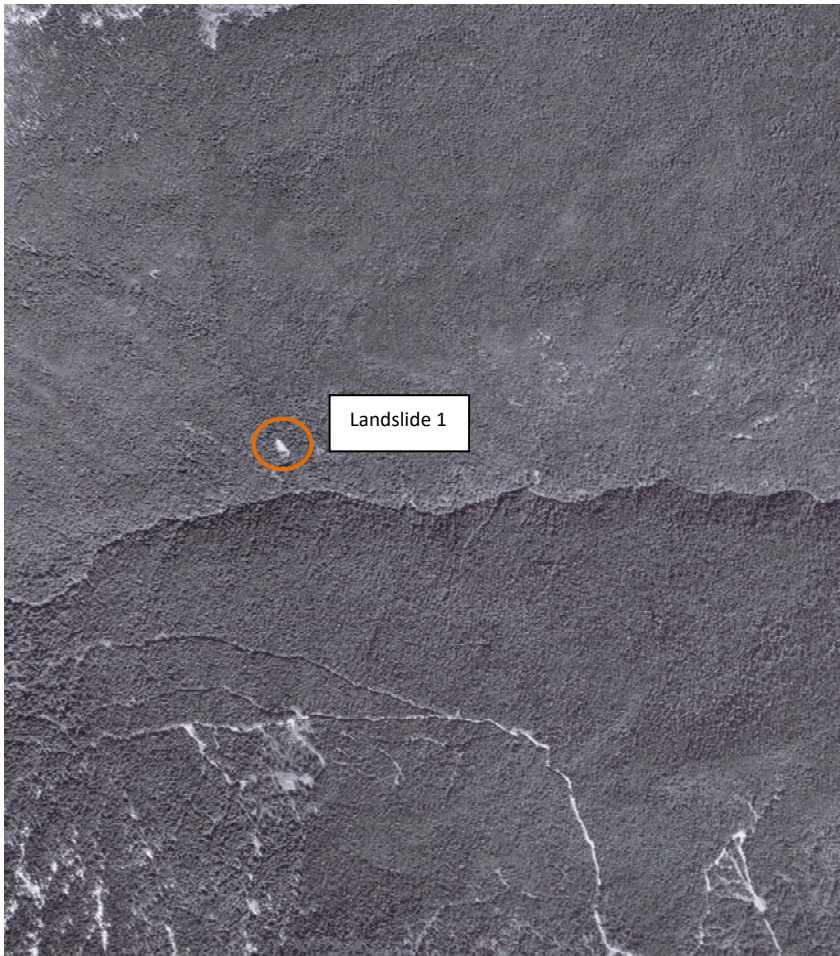
The 1978 airphoto set is incomplete and does not include the headwaters of Bastion Creek. No new landslides are visible and Landslide 1 has not changed in shape, size, or vegetation cover.

Photo 5 – 1978 airphoto of study area. Landslide 1 has remains static in size, shape, and vegetation cover. The headwaters of Bastion Creek as not included in the airphoto set.

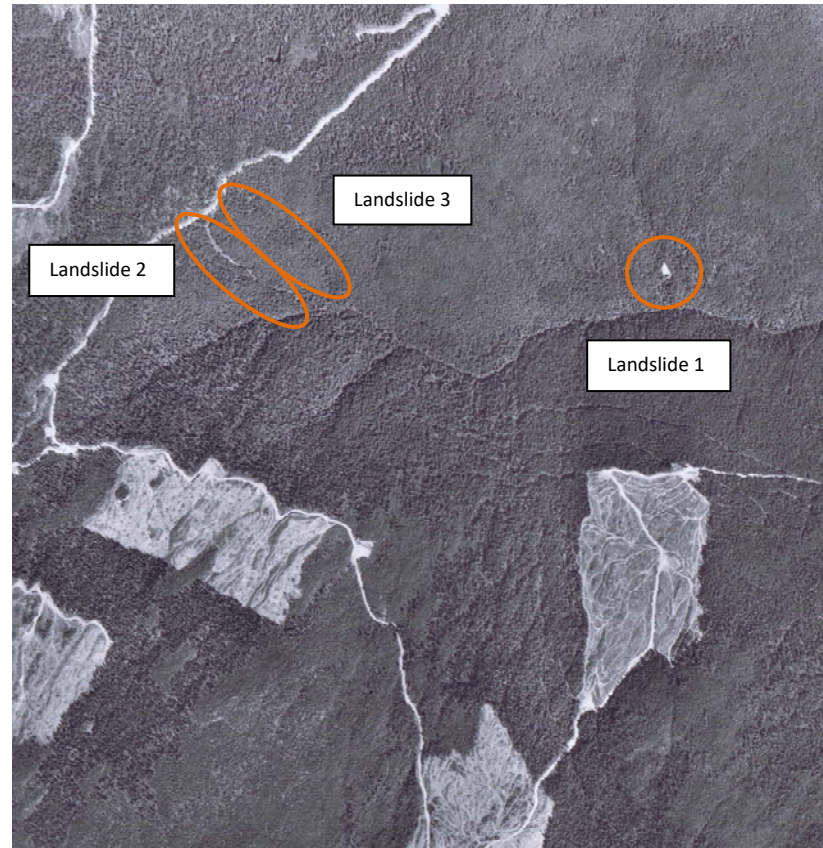
Photo 6 – 1984 airphoto of study area. Landslide 1 has remains static in size, shape, and vegetation cover. Landslides 2 and 3 are visible in the headwaters area. A series of large cutblocks begin to appear throughout the headwaters area.

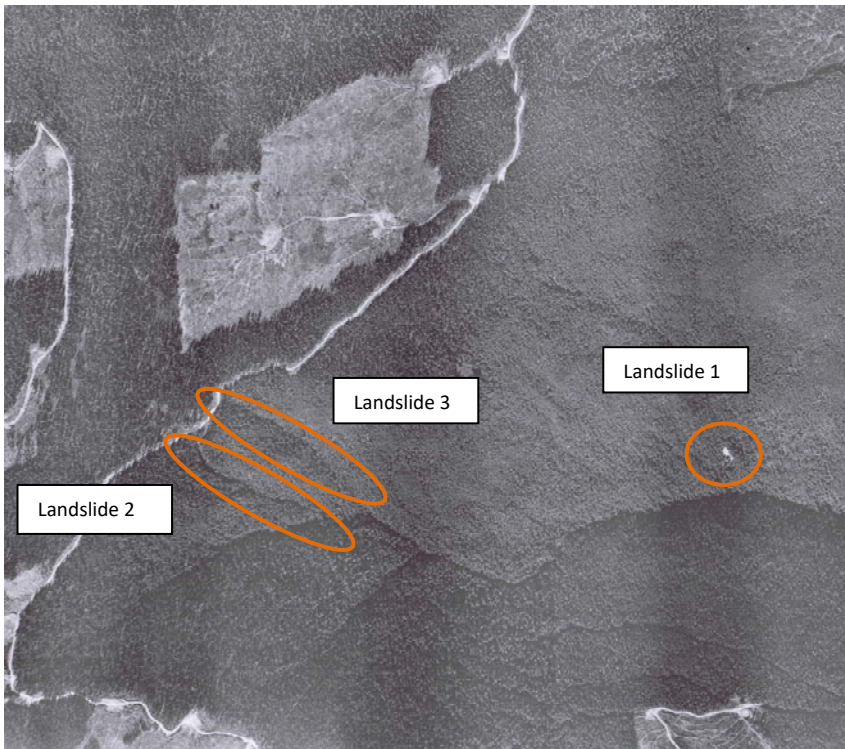
Photo 7 – 1989 airphoto of study area. Landslide 1 remains static in size, shape, and vegetation cover. Landslide 2 and 3 are visible in the headwaters area but are beginning to revegetate.

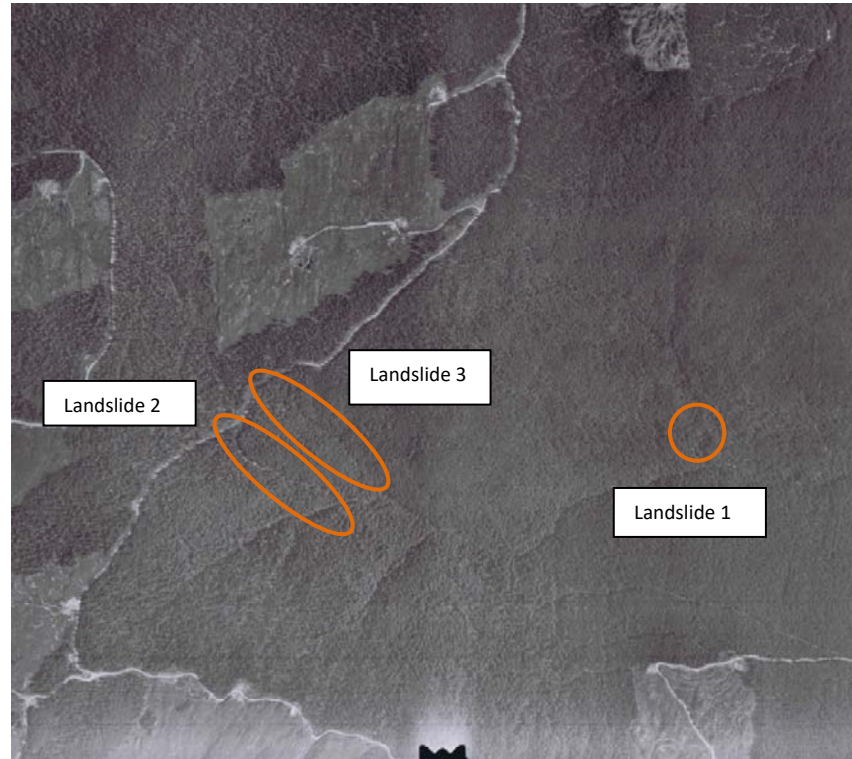
Photo 8 – 1994 airphoto of study area. Landslide 1 remains static in size, shape, and vegetation cover. Landslide 2 and 3 are visible in the headwaters area but are beginning to revegetate.

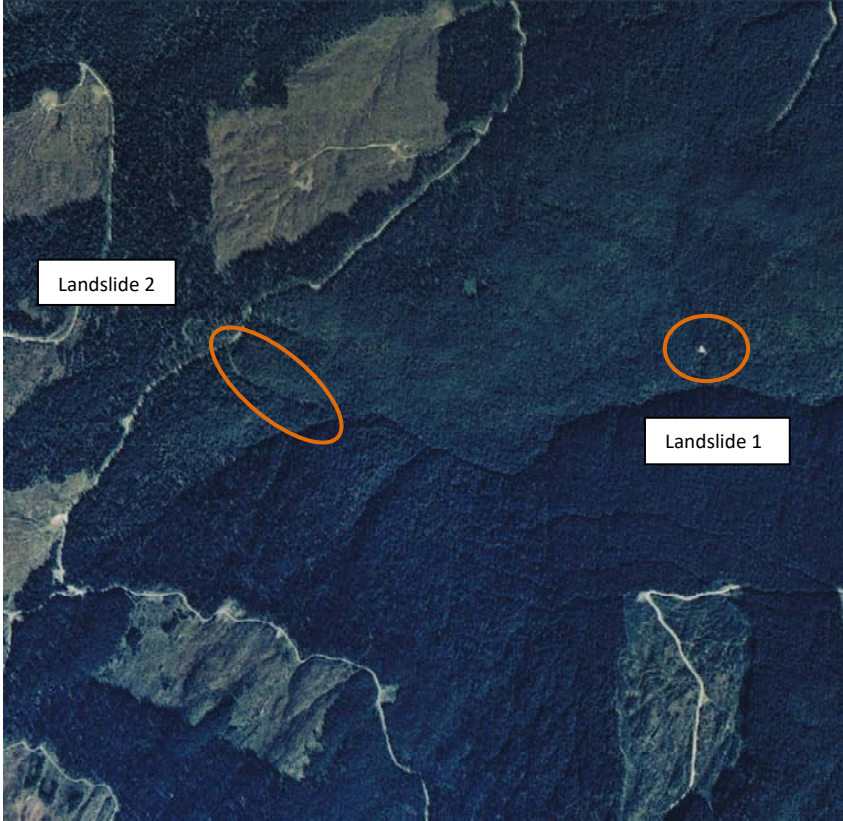
Photo 9 – 2001 airphoto of study area. Landslide 1 and 2 are visible but Landslide 3 appears to have fully revegetated.

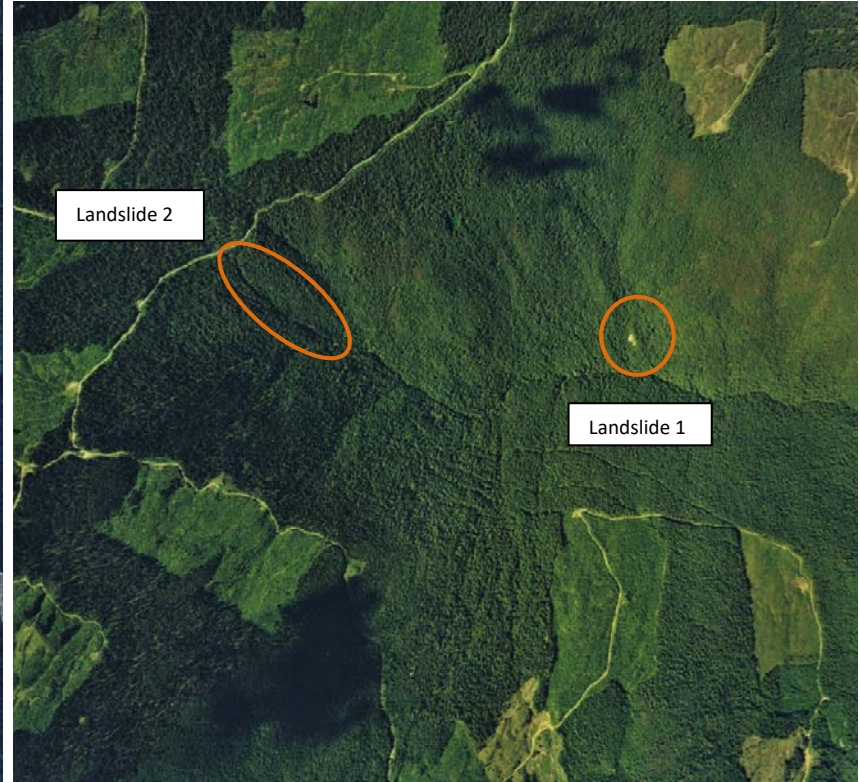
Photo 10 – 2007 airphoto of study area. Landslide 1 and 2 are visible but Landslide 3 appears to have fully revegetated.
