May 30, 2017

Re: Steep Slope Assessment for 2465 Waverly Drive, Blind Bay, BC; Legal Address: Lot 39, Section 18, Township 22, Range 10, Plan 25579, W6M, KDYD.

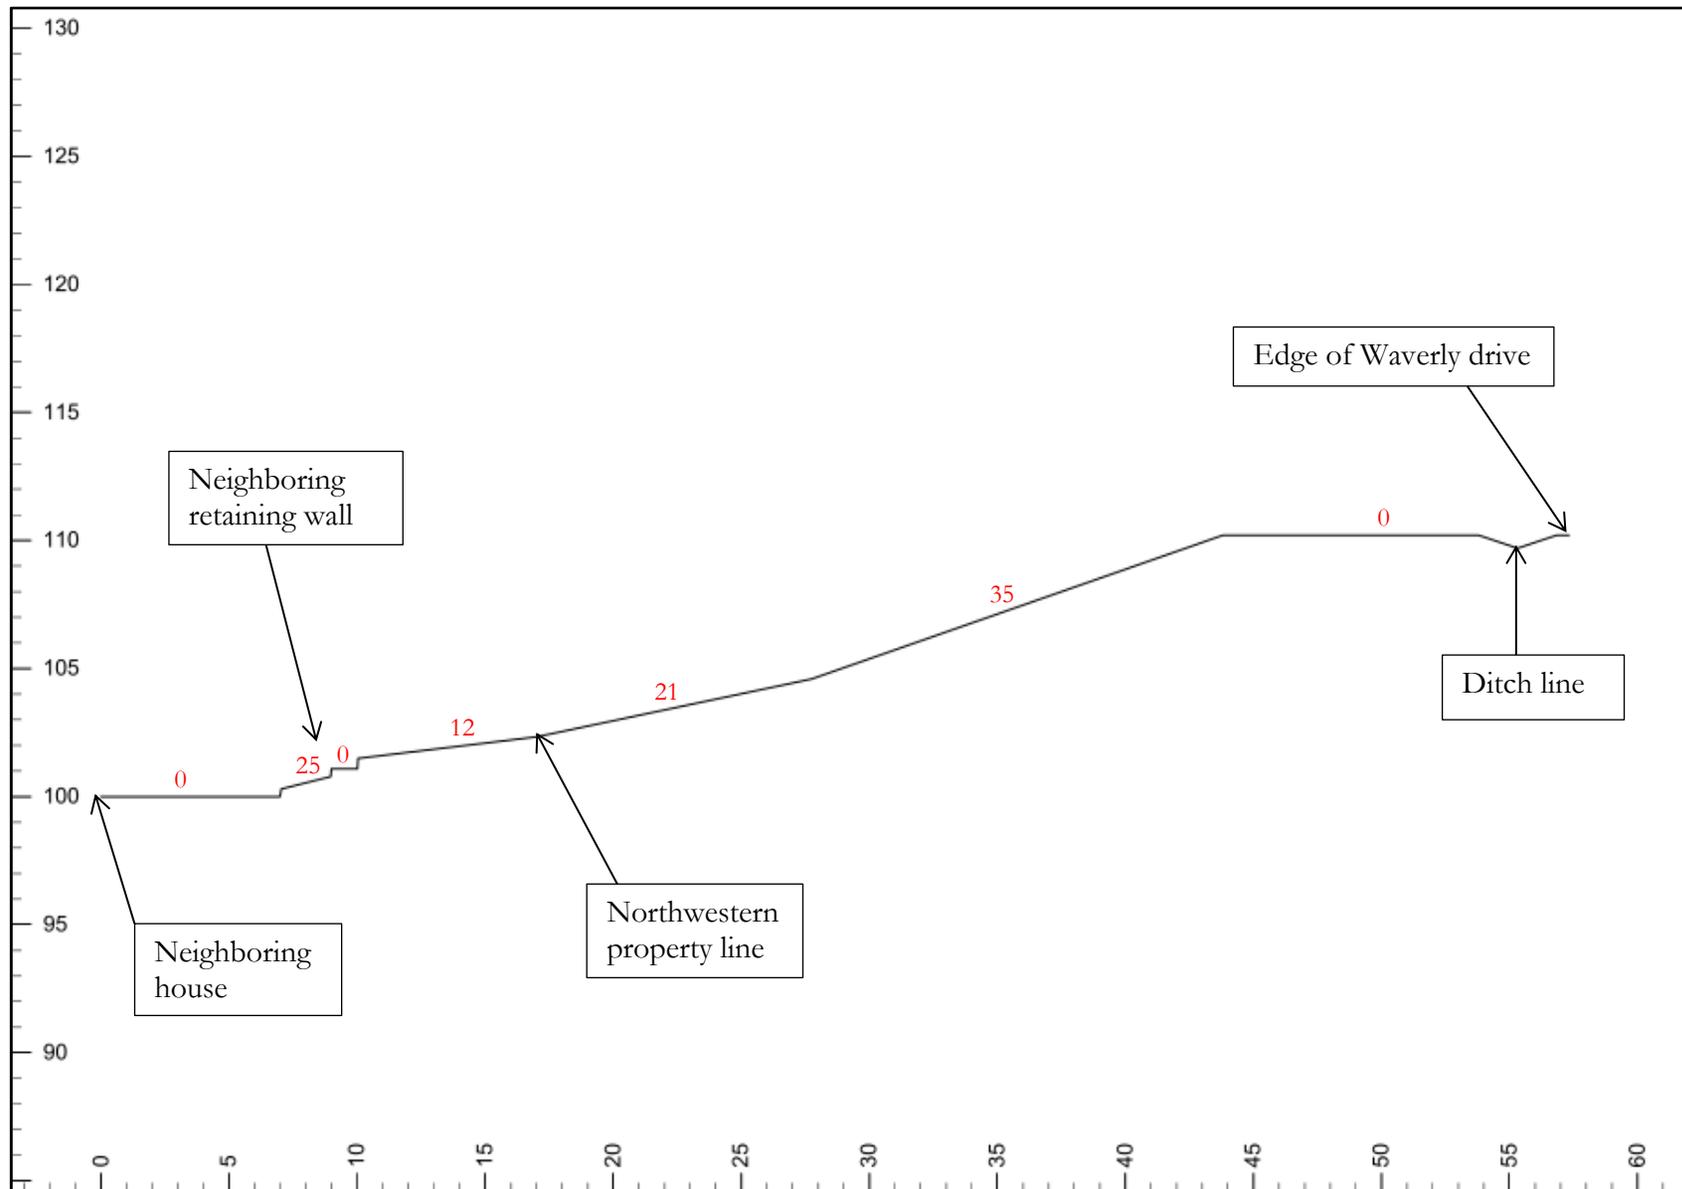
Figure 3 Slope Profile. Distances along both axis are in meters and slope gradients are in % gradient.

The slope profile down the middle of the property starting from the edge of Waverly Drive contains a ditch approximately 3m wide by 0.5m deep, follow by gentle slopes of 0-5% gradient for approximately 10m, the terrain then breaks over to 35% for approximately 17m before transitioning to a 21% slope for 11m which continues to the northwestern edge of the property. Carrying onto the adjacent property the slope continues at a grade of approximately 12% for 7m before encountering a stepped landscape wall. A slope profile is shown in Figure 3.

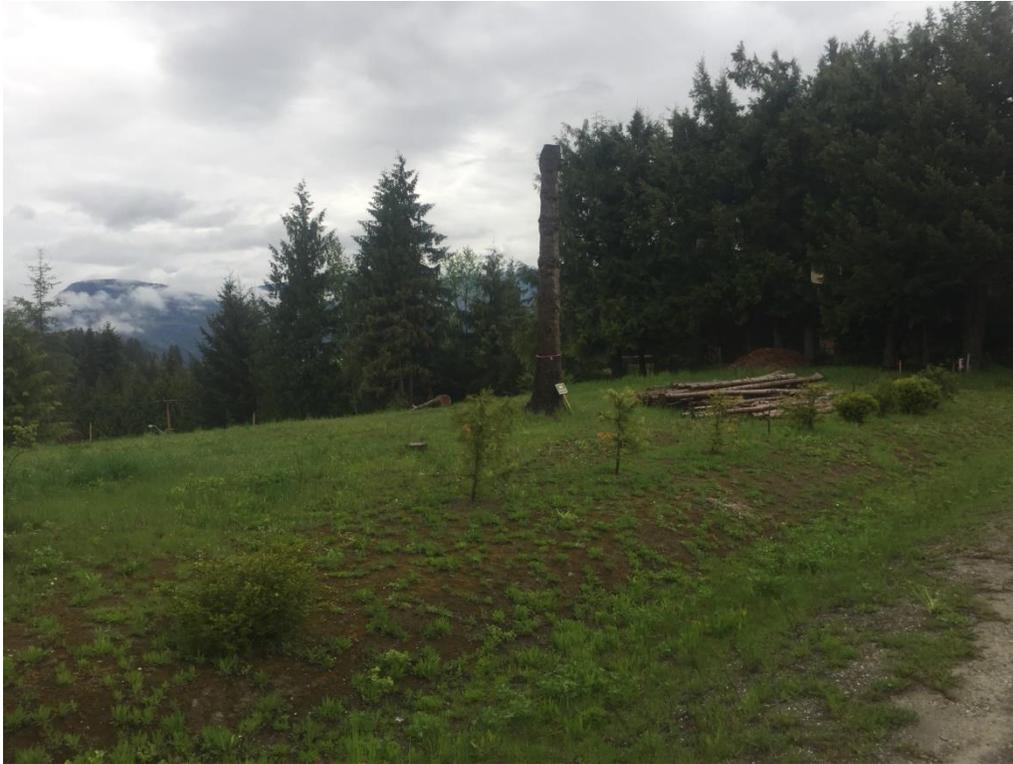
It is our understanding that the property owner intends to construct a single family residential structure with an attached garage. A rough layout of the house overlain the topographic survey has been provided by Blackburn Surveying Ltd. and shows the house partially situated over the sloping area. The site is suitable for a daylight basement design with the lower level on the slope. At the time of writing this report no detailed design of the building has been provided showing size or elevation views of the footings.

Photo 1 The proposed building site, looking northeast.

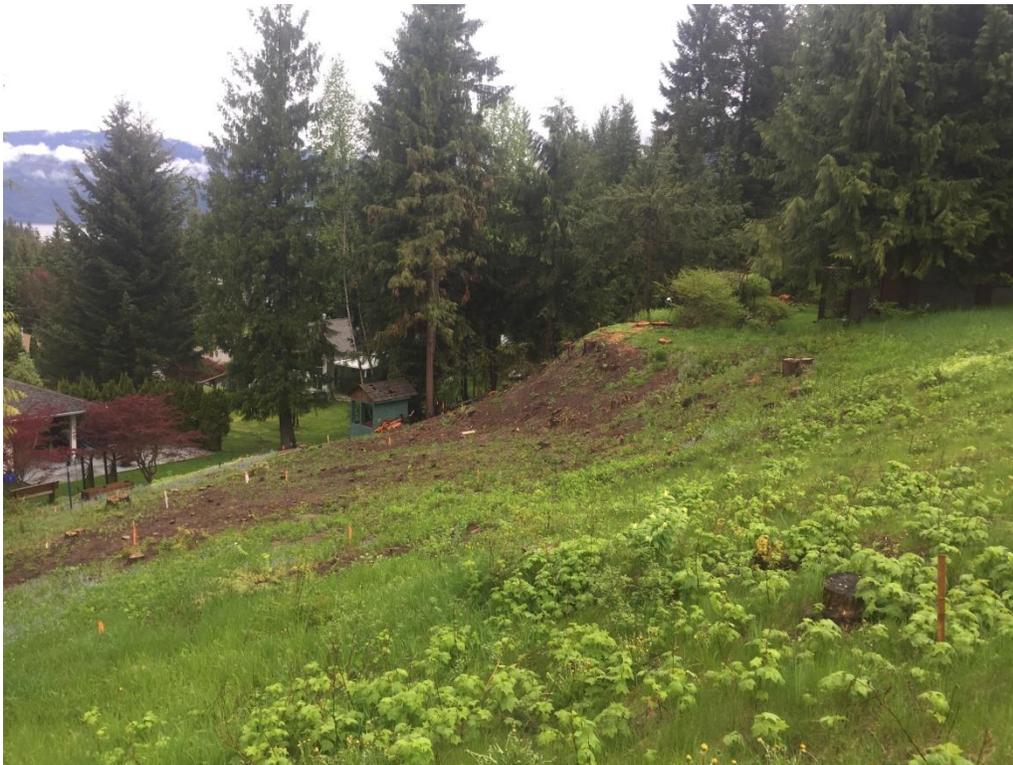
Photo 2 Northwestern edge of proposed building site and lower slopes of the property, looking southeast.

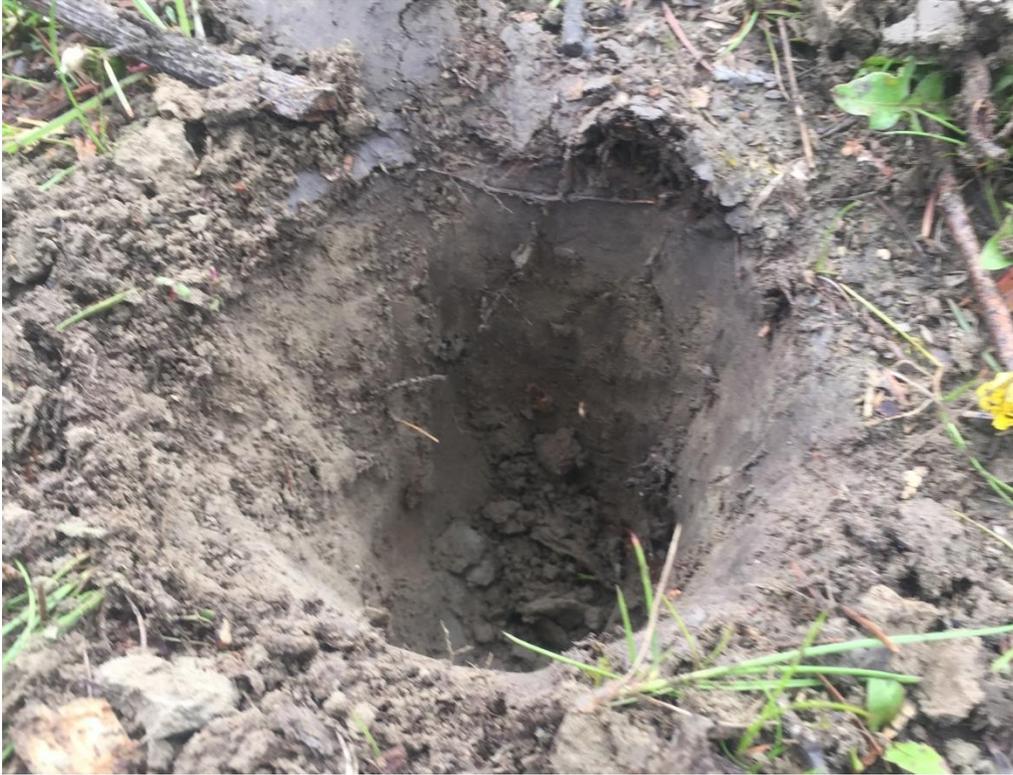
Surficial geology mapping for the area indicates that the surficial materials should consist of lacustrine deposits of silts, sand, and gravel which represent a mixture of deep-water and shoreline depositional environments. Surficial materials observed in several hand dug test pits on the property consist of a grey, firm, moist SILT some fine sand, (**ML**) which is consistent with the mapped surficial materials of the area.

Photo 3 Soil profile on the property consisting of firm SILT some fine sand

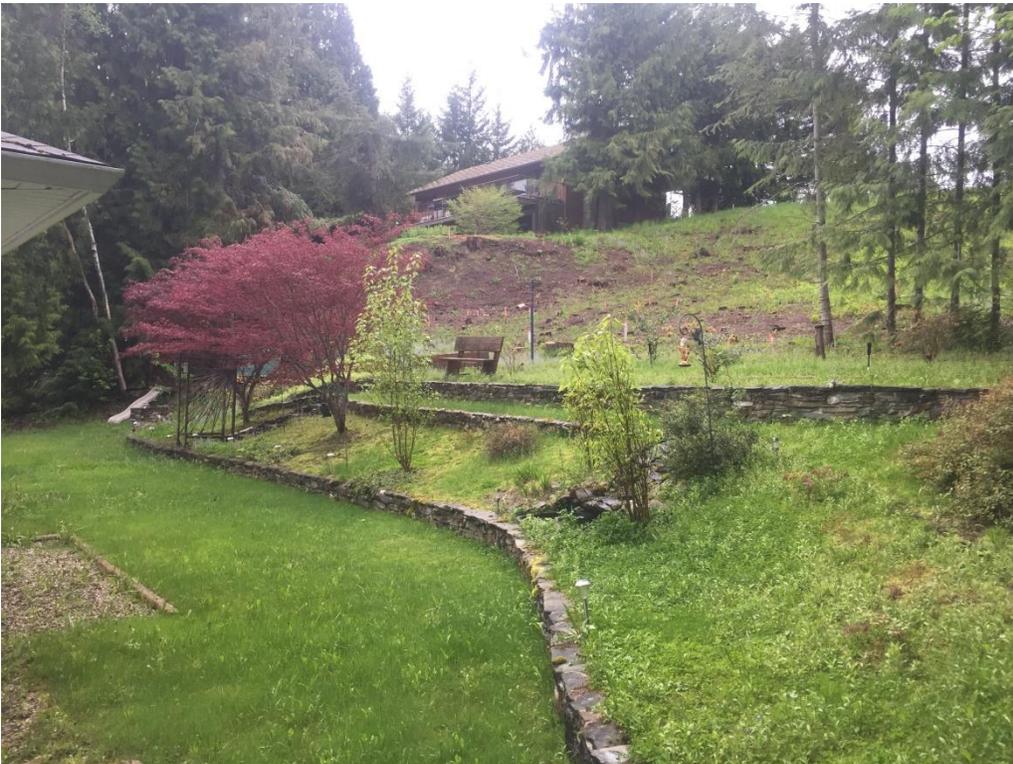
Photo 4 View of the lower slopes of the property from the neighboring lot
