September 25, 2017

**Re: Capri Cabins – 1541 Blind Bay Road legally described as Lots 1 to 6, Plan EPS162, Section 15, Township 22, Range 11, W6M KDYD. Development Variance Permit No. 701-32**

**B.C. LAND SURVEYOR'S BUILDING LOCATION CERTIFICATE**

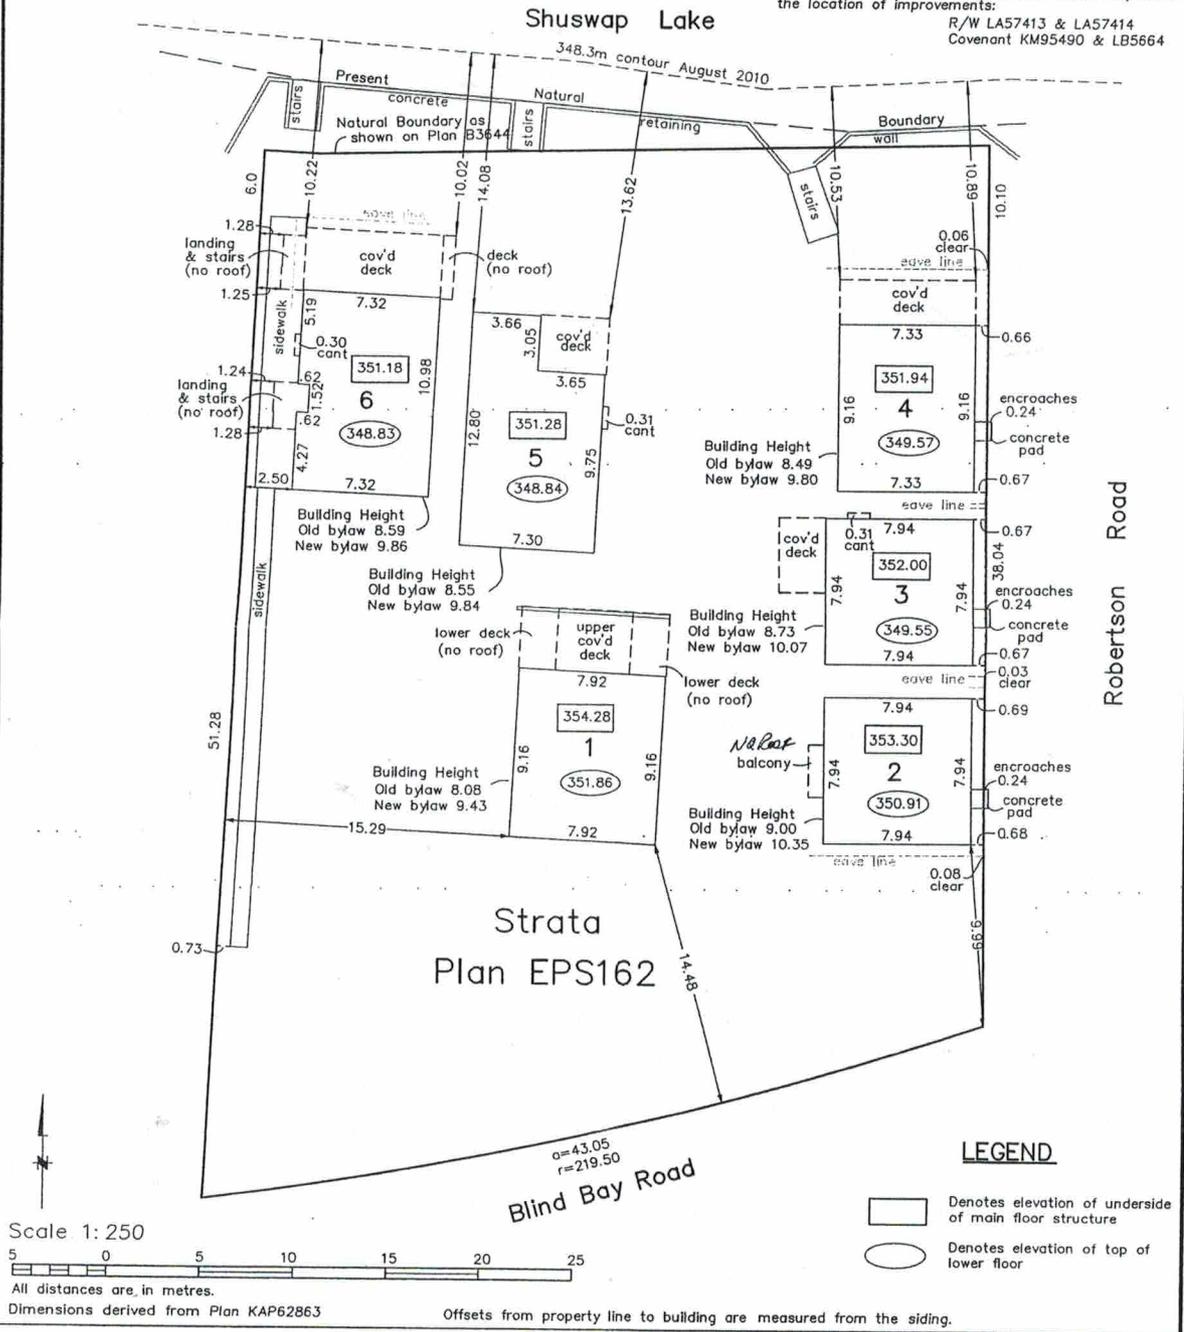
The attached survey plan shows basement floor and main floor elevations for the newly constructed cabins. The basements are unfinished and are not used for living space, however they do house the furnace and hot water tanks for the units. It is my understanding that furnaces have been built on above-floor platforms of unspecified height. The following table summarizes the cabin floor elevations:

Main floors in all of the cabins are above the 351m FCL. Basement floor elevations are below the FCL for all the cabins except Cabin #1. The tops of the foundation walls are likely close to the FCL. Assuming these walls are not overtopped by floodwaters, water can only enter the basements through seepage and/or backing up through the basement drains. It will be important to keep any water in the basement below the level of the elevated furnaces. To mitigate flood risks, automatic (float-switch) under-slab and outside perimeter sump pumps have been installed for each cabin. According to residents, sump pumps did not activate during high lake levels in 2012 or 2017, two relatively high water years (349.588m and 349.072m respectively). The 2017 lake level exceeded the basement floor levels in Cabins #5 and #6 with no reports of water/moisture problems. Installed sump pumps should be able to keep up with any basement seepage.

In summary, based on the surveyed information and the assumptions outlined, the improvements made to the Capri Cabins have not significantly increased the risk of flood damage on the property. The site remains suitably protected/elevated from flooding and/or foreshore erosion and may continue to be used safely. To mitigate potential damage for the new basements below the FCL, these areas should not be used as living space or for the storage of valuables. Sump pumps should be annually inspected and maintained to ensure functionality when lake levels rise in each May.
