November 29, 2016

DTC File No: J16-01416

**Re: Sewage Dispersal System Assessment  
3401 Catherwood Road, Revelstoke, B.C.**

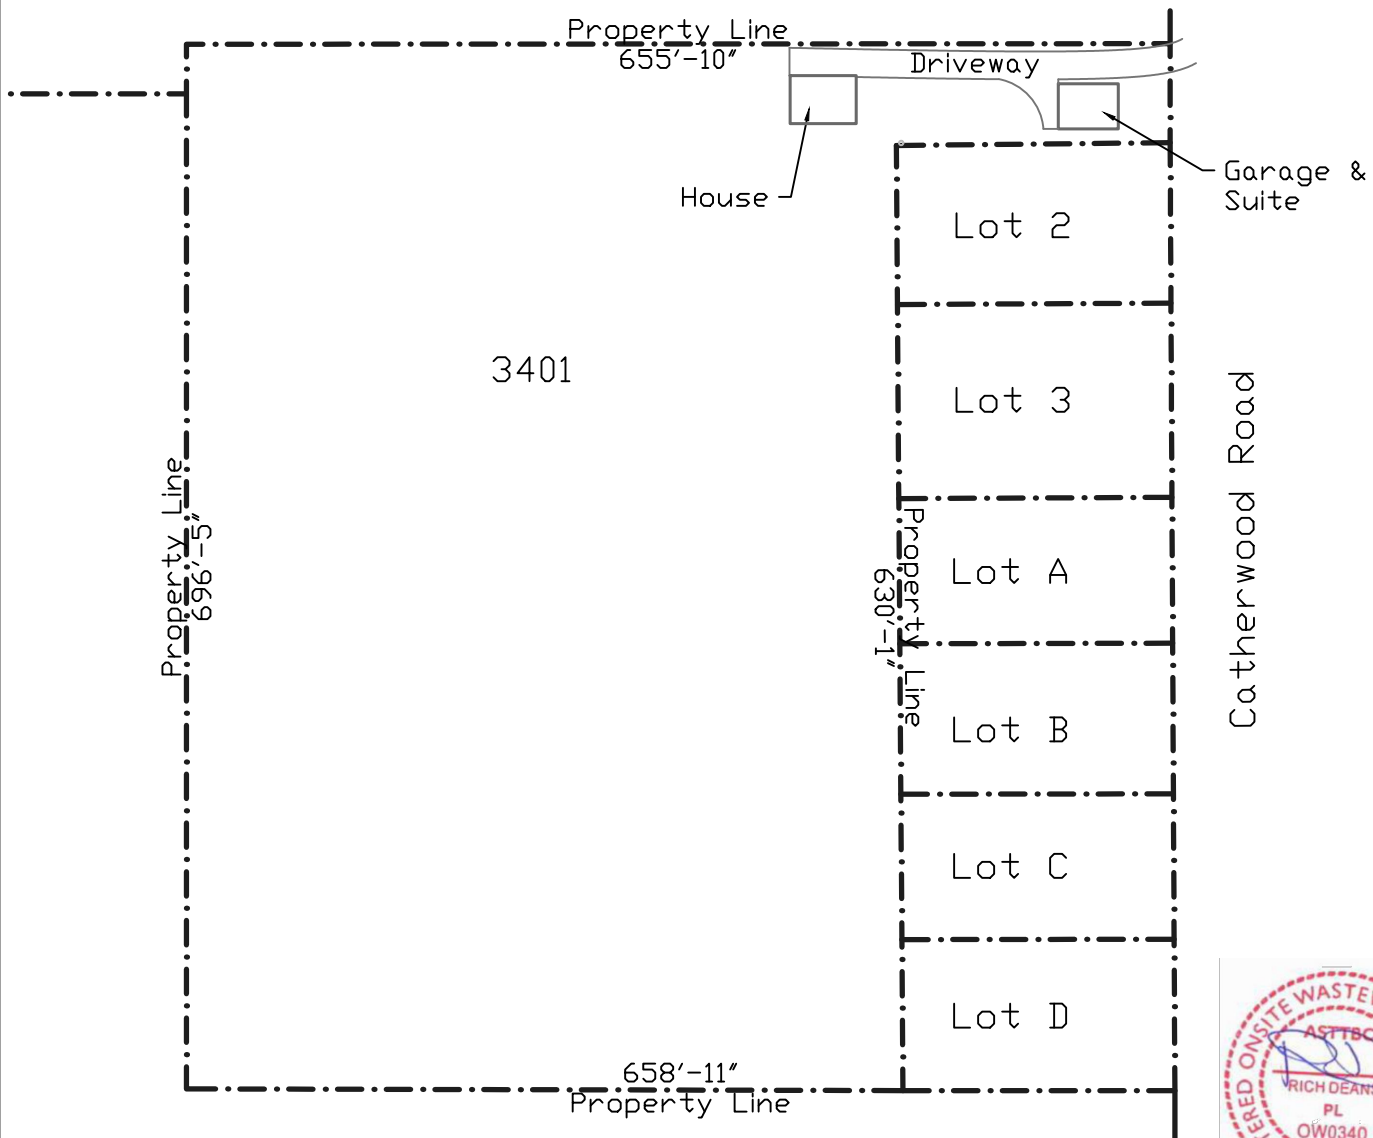
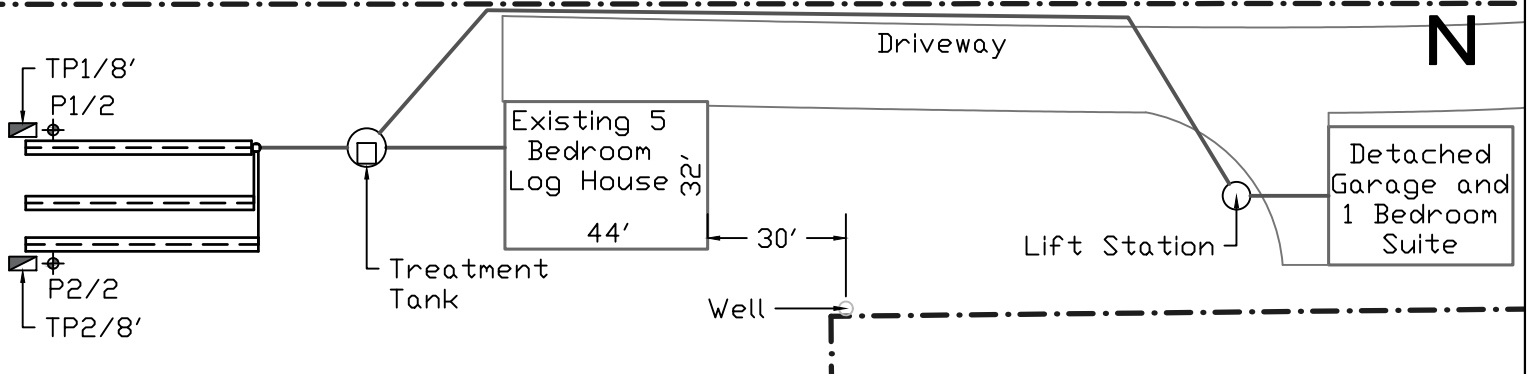
| Drawing Name: Figure 1 | | | |

- The slope in the proposed dispersal area was measured to be 1%.
- Two percolation tests at 3 feet below grade produced results of 2 & 2 min/inch. Based on these results and the soil type a soil hydraulic loading rate of 1.32 Ig/ft<sup>2</sup>/day (65 litres/m<sup>2</sup>/day) for Type 2 effluent has been implemented.

- Soil Texture – sand,
- Soil Structure – single grain,
- Percolation Rate – 2 minutes/inch (average),
- Slope down gradient – 1%,
- Depth of porous soil – 96”,
- Coarse gravel content < 20 %

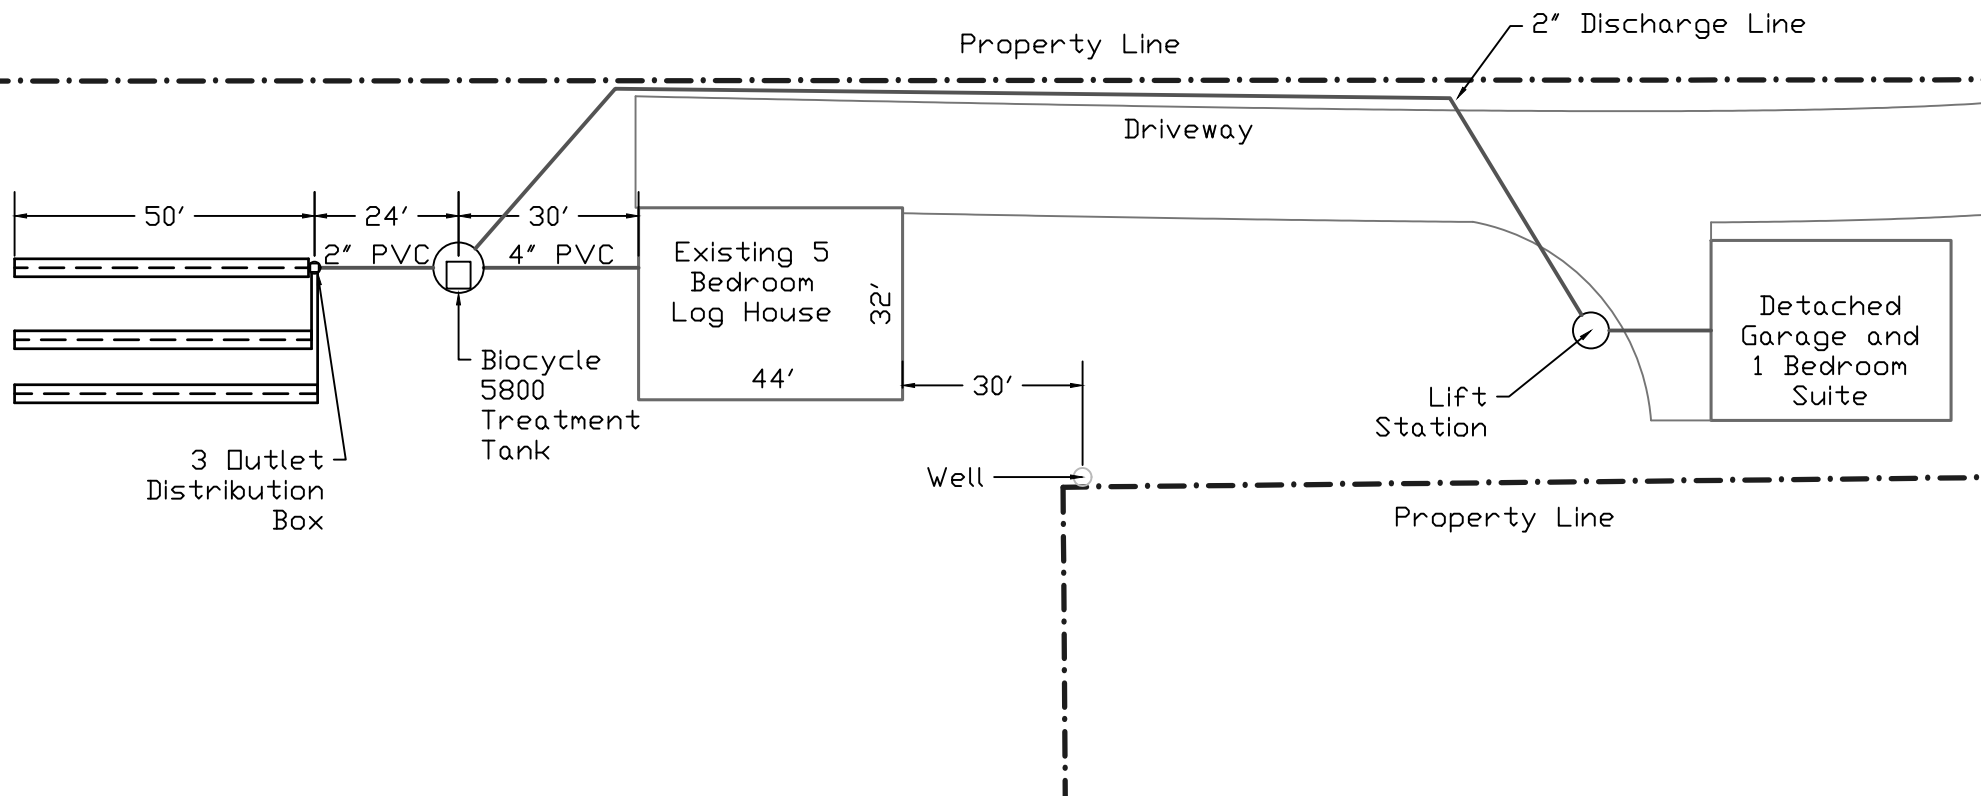
| Drawing Name: Figure 2<br>Treatment Tank and Dispersal Field Layout | | | |

The existing sewage system consists of a Biocycle 5800 Treatment Unit that treats incoming sewage to Type 2 quality before dispersal to ground. DTC contacted Bioharmony owner representative Mr. Barry Rumsey to discuss the operation of the existing onsite treatment unit. Mr. Rumsey advised DTC that the existing unit was capable of handling 2600 L/day (550 Imperial gallons). Mr. Rumsey also advised us that the treatment unit has been serviced on a regular basis and it appears to be functioning normally. Ongoing service of the treatment unit will continue to be provided by Bioharmony.

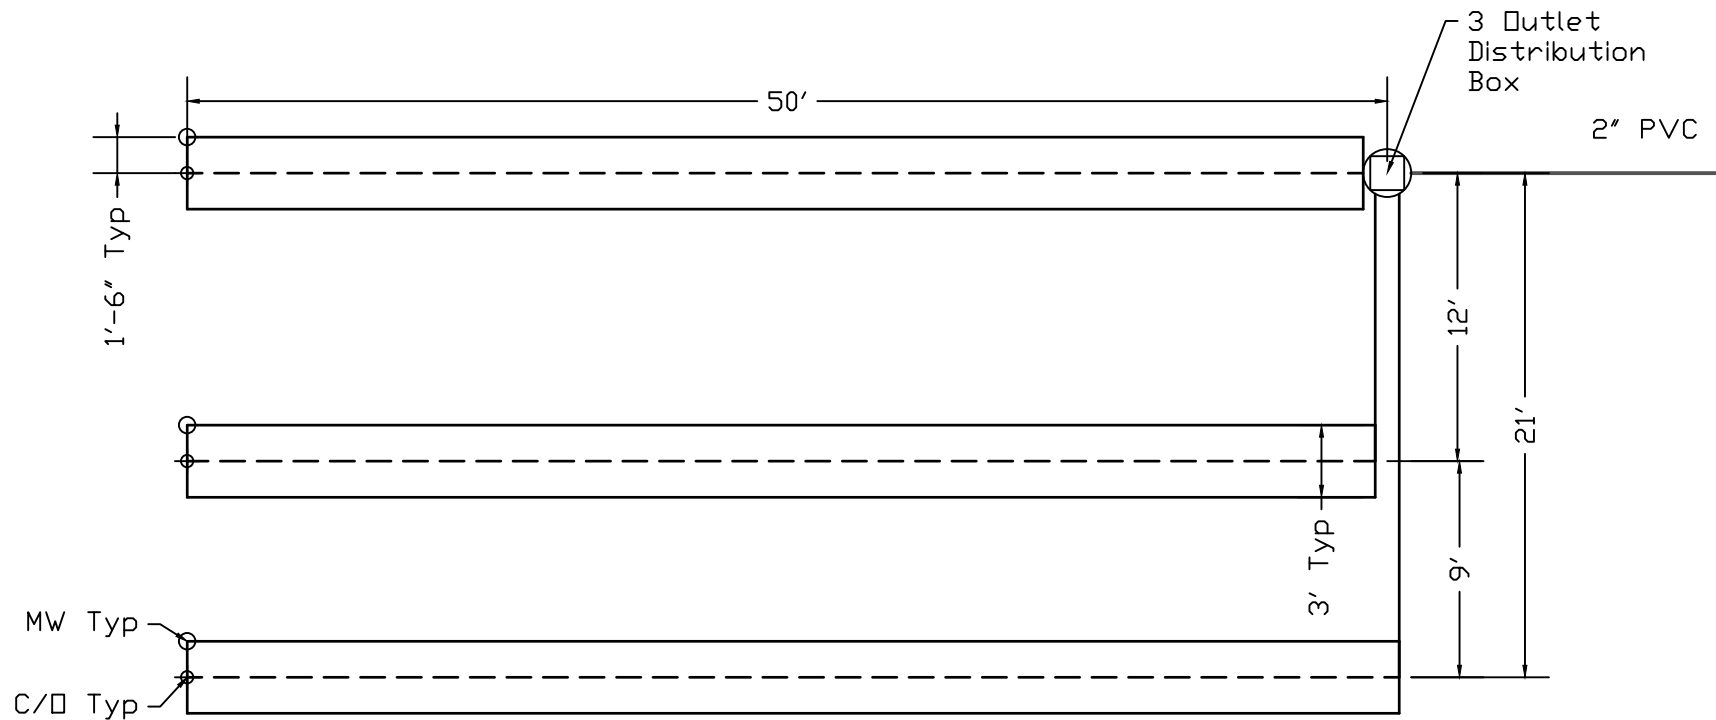
| Drawing Name: Figure 3<br>Dispersal Field Detail | | | |

- During the site assessment DTC inspected the existing dispersal field. An inline camera/transmitter was inserted into the three laterals from the distribution box. The distal ends of the existing laterals were exposed in two locations. The drainrock below the pipe appeared to be relatively clean with very little biomat. The inside of the pipe in the first lateral was observed to be clear with no sludge noted. Minor sludge was noted in the second and third laterals.

The dispersal field consists of 3 laterals that are 3 ft by 50 ft. Flows from the detached suite are collected in a lift station and pumped to the treatment unit. The existing laterals were exposed and appear to be in good operating condition.

- Install cleanouts on the end of each lateral that extend to ground surface.
- Install a monitoring well that extends to the base of the drain rock in each trench.
- Please note that this design does not incorporate the use of a garburator or reverse osmosis water filter.
- No water softener backwash, pool or hot tub drains or roof drains can enter the septic system.
- No condensate from furnaces, appliances, compressors or any other mechanical device can enter the sewage system.
- We recommend the installation of a water meter to assist with determining the daily flow rates and development of a proper long term maintenance plan.

### New Cleanouts and Monitoring Wells

Add at the end of each trench.

- Cleanout 4" solid PVC vertical pipe with C/W PVC cap access to surface thru valve box
- Monitoring well 4" Perforated PVC vertical pipe c/w PVC cap, access to surface through valve box
