MEMORANDUM

RE: Riparian Area Regulation Exemption Letter for the Zappone Property at Lot 1, Sec 22, Twp 21, R10, W6M, KDYD, Plan 38427, near Tappen, B.C.

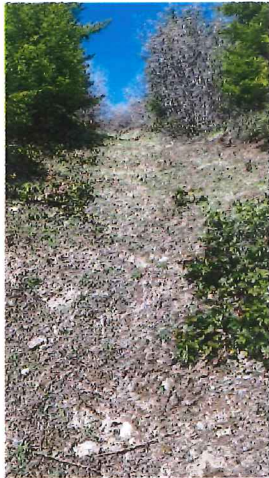
Photograph 1. Draw 1

Ms. Koch explored the mapped channel location. Three separate draws were located along the hillside within about 40 m of the mapped channel location (Photograph 1-3). Each of the three draws were dry and there was no evidence of historical water flow. There were no creek beds, defined channels, rilling, aquatic vegetation or rafted debris in the draws. The gravel pit below was dry in the location of the mapped channel (Photograph 4). No water was observed flowing through the culvert at Ford Road.

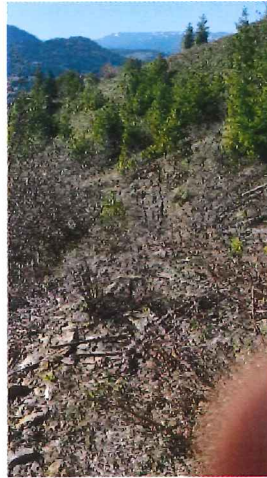
Photograph 2. Draw 2

Draws 2 and 3 appeared to be used as footpaths and Draw 1 as a roadway (Photograph 5). There was no evidence of flow in the draws, rafted debris, defined channel banks, fish habitat, rounded substrate (Photograph 6) or connection to a fish bearing water body.

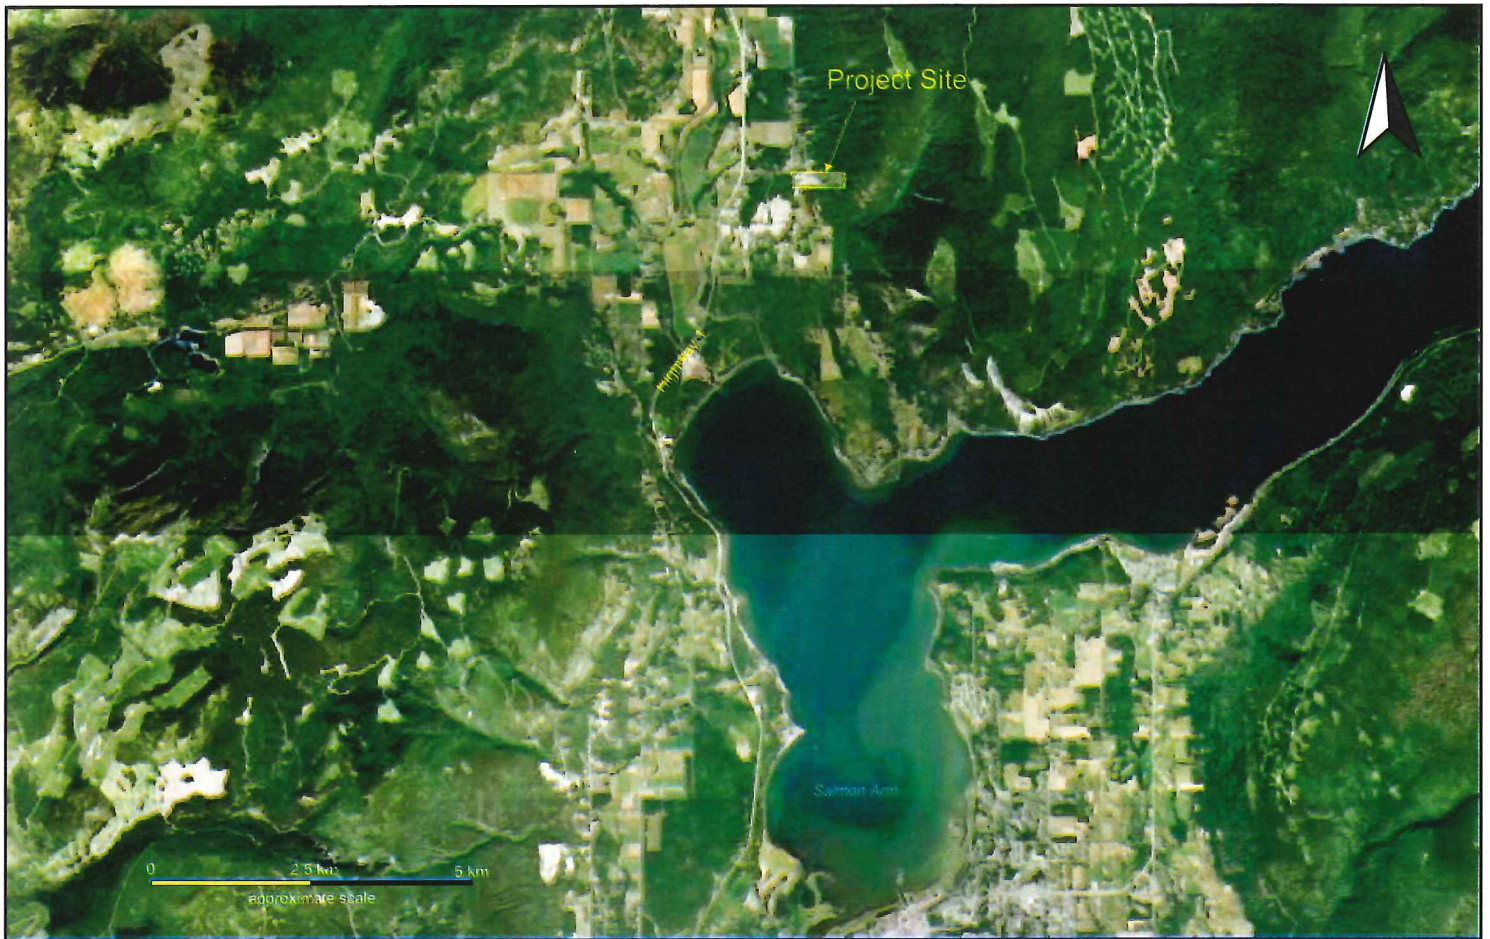
Western Water Associates Ltd. (WWAL) has been retained by Mike and Rhonda Zappone to complete a Riparian Area Regulation (RAR) Assessment for proposed subdivision development at a gravel pit located along Ford Road at Lot 1, Sec 22, Twp 21, R10, W6M, KDYD, Plan 38427, near Tappen, B.C. (subject property) (Figure 1).

Figure 1 - General Location of Project Site

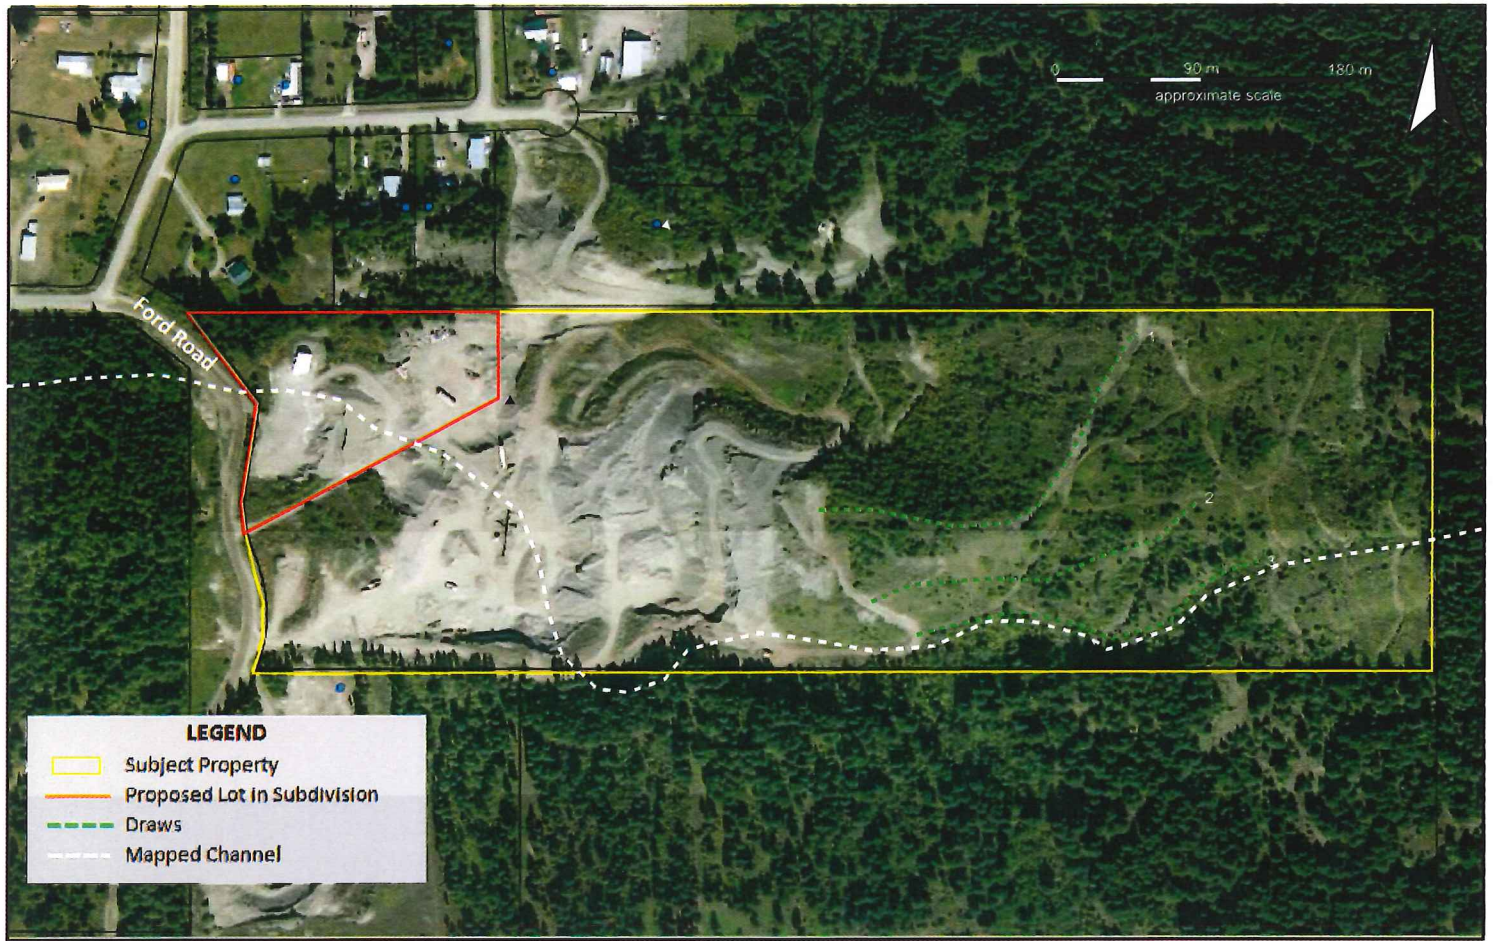
Figure 2 - Detailed Site Orthophoto with Field Investigation Features

Online mapping (iMap 2018) of the subject property shows a water channel flowing from the east into the gravel pit (Figure 2). Because proposed subdivision development is within 30 m of the mapped water body, the CSRD requires a RAR Assessment Report be included with the development permit application.
