DEVELOPMENT PERMIT NO. 725-62

3. This Permit is issued pursuant to Sections 12.3 and 12.4 of the “Electoral Area ‘C’ Official Community Plan Bylaw No. 725” in support of a proposal to install a new sewerage system, construction of a washroom addition onto the existing restaurant building and the construction of a fence occurring within 30 m of Shuswap Lake as more particularly shown on the Sewerage System Design Plan attached hereto as Schedule B-1, and the Site Plan attached hereto as Schedule B-2.

Schedule B-1 - DP 725-62
Sewerage System Design Plan

Riparian Areas Regulation - Qualified Environmental Professional - Assessment Report

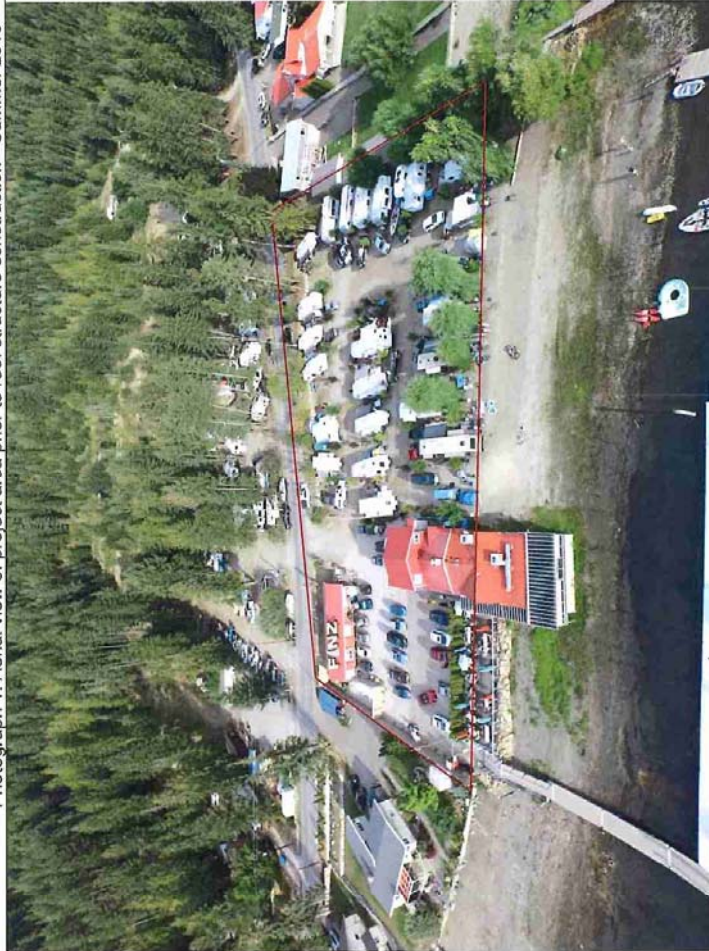
Photograph 1. Aerial view of project area prior to roof structure construction - Summer 2015

The project area is located at Finz Resort, which has the primary address of 2001 Eagle Bay Road in Blind Bay BC (Figure 1, Photograph 1). The Resort also includes 2000 Eagle Bay Rd, which is located directly across the road from the primary address. The entire property (2001 and 2000) is 0.63 HA in size and has a long rectangular-shape. It is located on the southeastern side of Blind Bay and includes 100 m of Shuswap Lake's shoreline. Foreshore land tenures on the property include #13281 and #10444. The property is zoned as foreshore waterfront commercial.

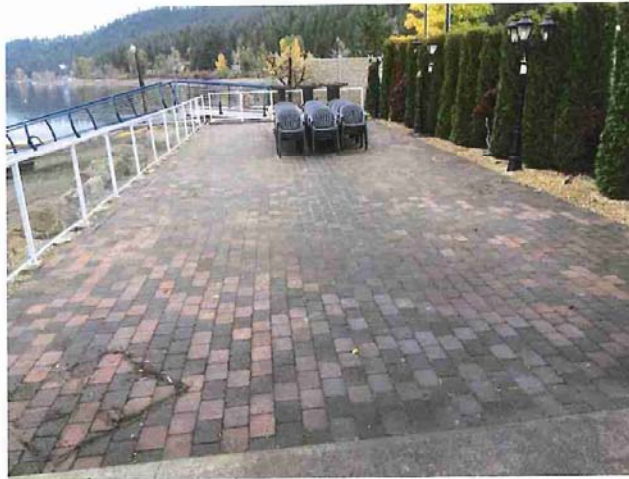
Photograph 2 Pre-development patio conditions – Fall 2015

In 2009, a failing concrete retaining wall was replaced with a retaining wall constructed of large blast rock under a Section 9 *Water Act* notification (Photographs 1 and 4). Because the retaining wall was constructed below the original HWM, its creation established an adjusted HWM as shown in Figures 3 and 4. Within the same year, a brick patio (Photograph 2) surrounded by plexi-glass railings was installed (Photograph 3) between the original HWM and the adjusted HWM. The resulting patio area was 119.5 m² (Figure 3). A row of cedar shrubs lined the patio along its southern boundary (Photograph 2).

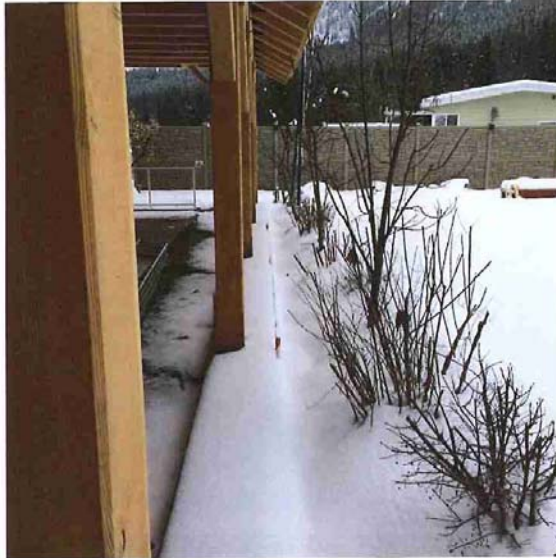
Photograph 10. South side of roof structure – new vegetation has replaced the row of cedar shrubs – January 2016

Riparian vegetation observed included native and ornamental vegetation. A row of ornamental shrubs lined the southern boundary of the roof structure adjacent to the patio (Figure 3 and Photograph 10). Riparian vegetation west of the restaurant had been planted to provide delineation of a pathway to the beach and privacy for camp sites (Photograph 18). Large weeping willows (*Salix x sepulcralis*) lined the shoreline and ornamental maples and cedars lined the boundaries of each site (Photograph 15). Two large cottonwood (*Populus trichocarpa*) overhung the water near the property's western boundary closest to the shoreline (Photograph 16).

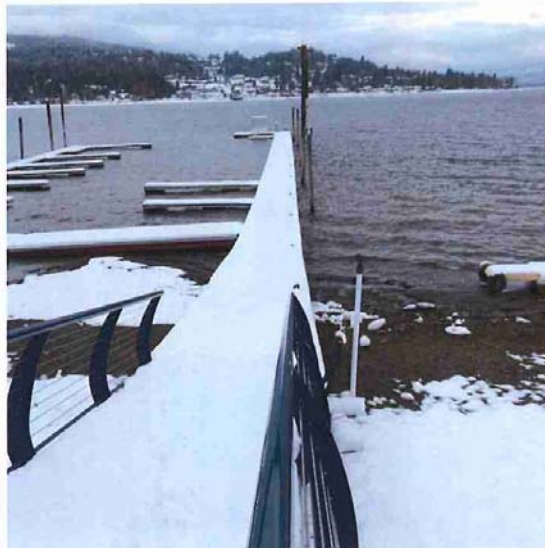
Photograph 11. Foreshore conditions northeast of the patio and restaurant – January 2016

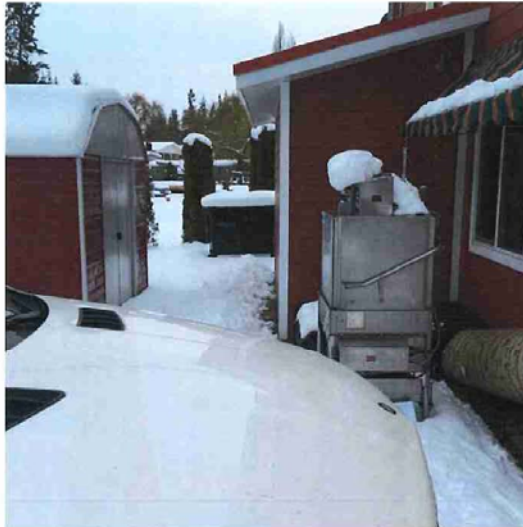
Photograph 13. Area outside the SPEA but within the Riparian Assessment Area: a shed, garbage bin and the back of the restaurant where the new washroom is proposed - January 2016

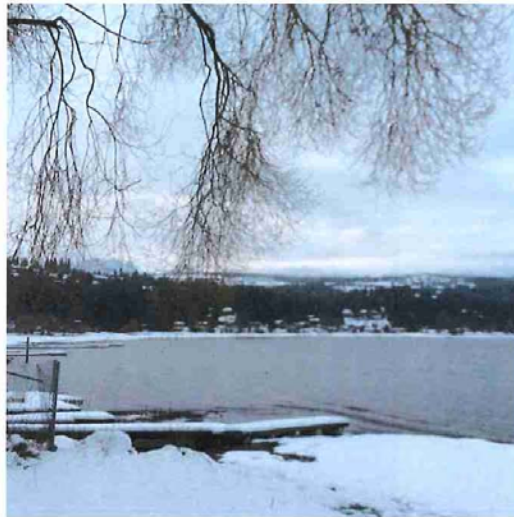
Photograph 16. Black cottonwood overhangs the water at the western property boundary – January 2016
