Report Number: 229229

Spa Hills Farm Inc.
2223 Yankee Flats Road,
Salmon Arm, BC

Re: Warning Letter

On July 16th, 2024, Ministry of Environment and Climate Change Strategy (Ministry) Environmental Protection Officer Rebecca Benham (Ministry Staff) conducted an on-site inspection of the composting facility operated by Spa Hills Farm Inc. (Spa Hills), located at 2223 Yankee Flats Road Southwest, Salmon Arm, BC (Facility). The purpose of the inspection was to verify compliance with the Organic Matter Recycling Regulation (OMRR), under which Spa Hills is registered with authorization 104962 (Authorization), as well as to follow-up on complaints regarding the processing and storage of compost. The Authorization was first issued on June 29th, 2010, and last amended on February 2nd, 2016.

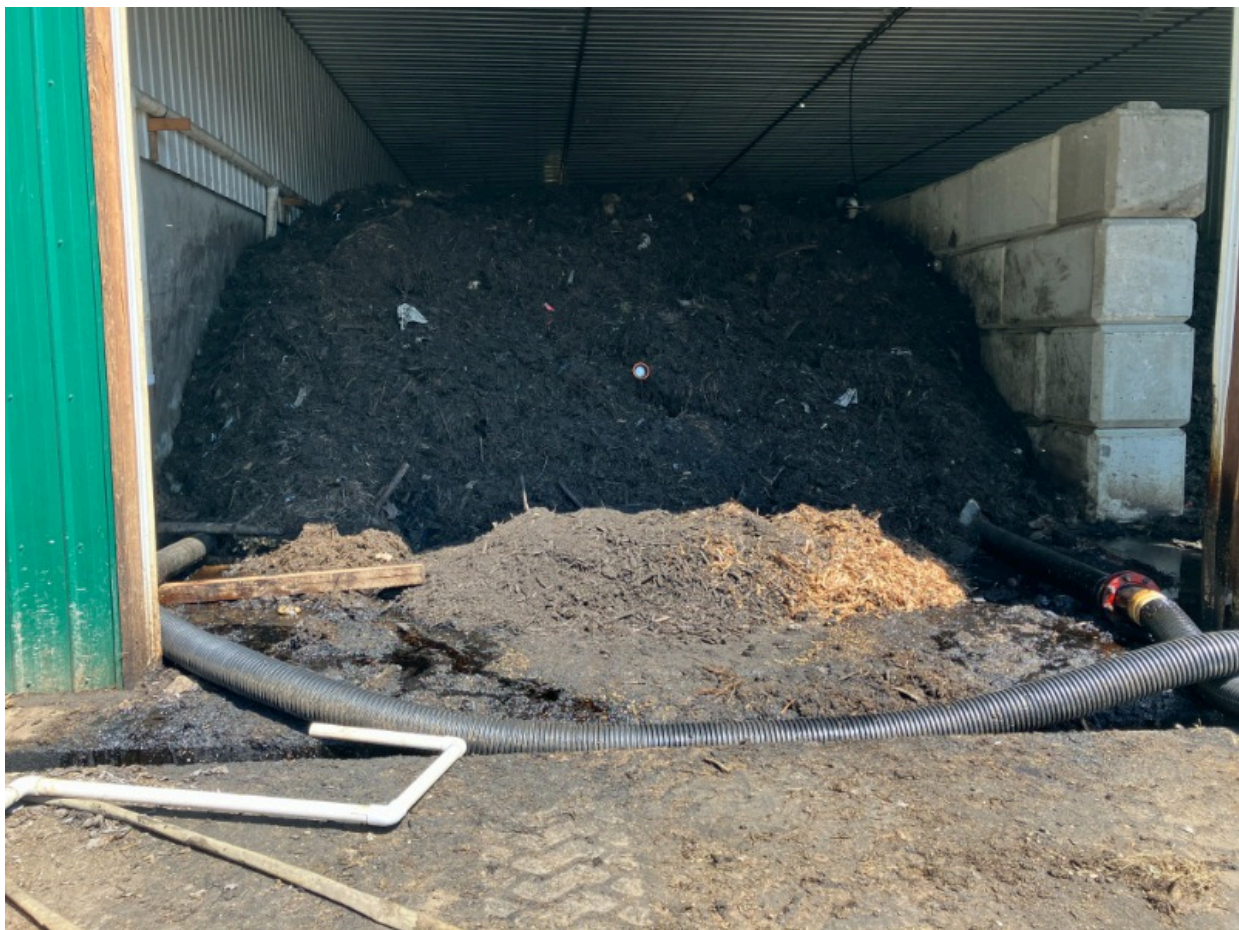
During the on-site inspection, Ministry Staff observed that the receiving, processing and curing areas of the composting facility were located on concrete (Photos 1, 2 and 3). However, Ministry Staff observed that the compost storage area at the Facility was not located on an impermeable surface and did not prevent the release of leachate into the environment.

The Co-Owner informed Ministry Staff that all composting and storage areas were located on a sloped surface. During the on-site inspection, Ministry Staff observed that the receiving, processing and curing areas have a sloped area where leachate drains into a 4500L collection system and the Facility recycles the leachate back into the composting process (Photos 1,2 and 4).

Photo 1. Processing and curing areas of the composting facility, located on concrete and covered with a leachate collection system.

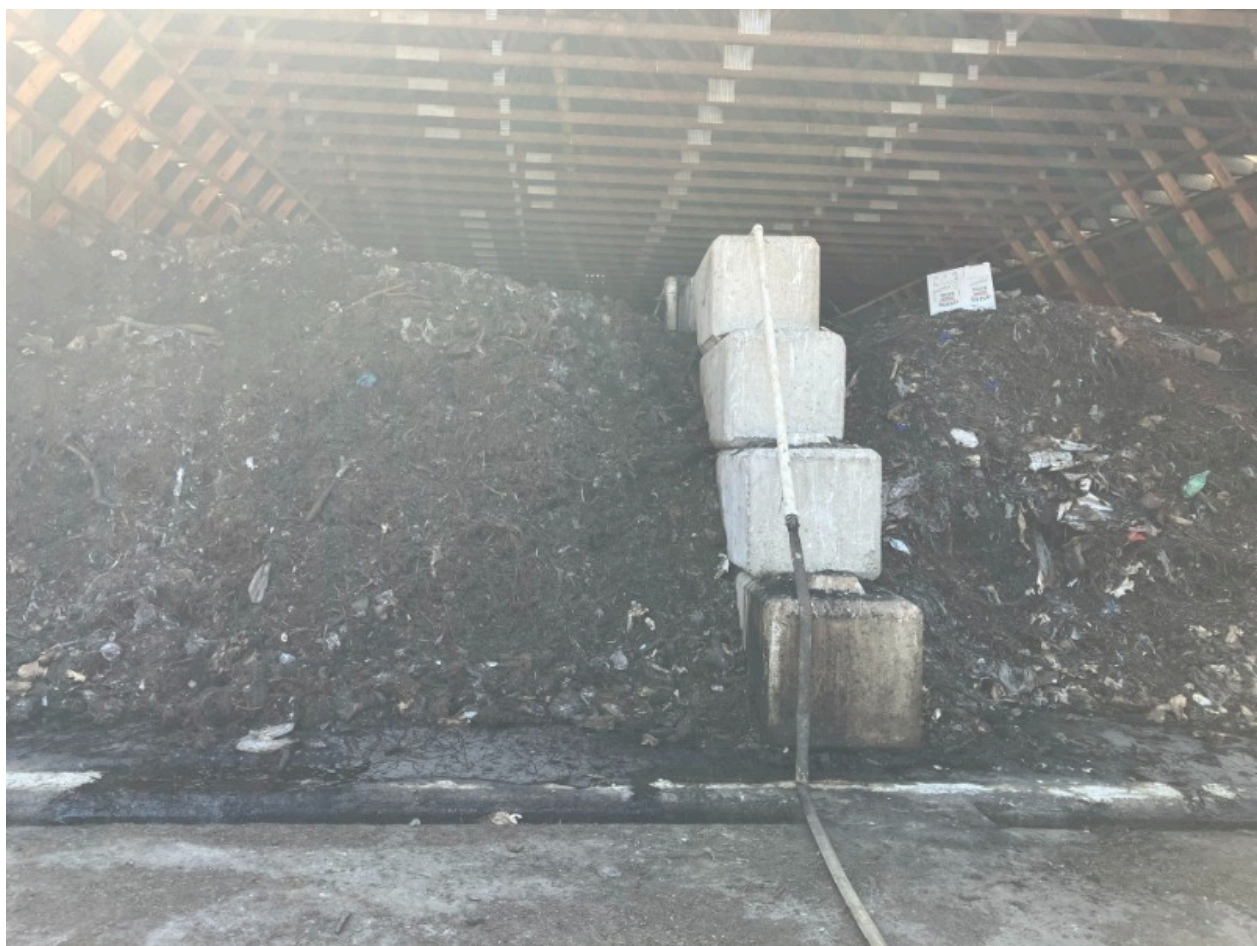
Photo 2. Receiving, processing and curing areas of the composting facility are located on concrete and covered.

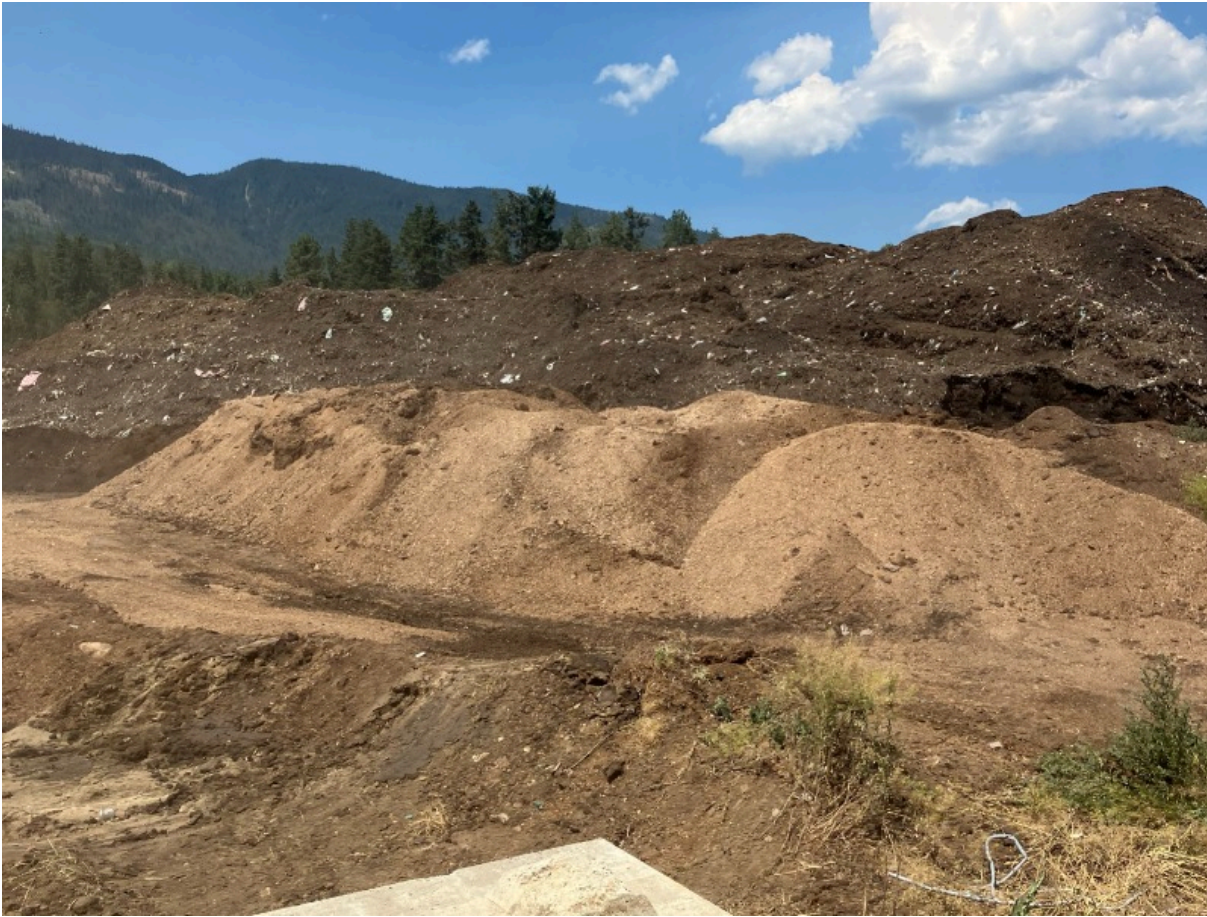
Ministry Staff observed that the receiving, processing and curing areas of the composting facility were covered and sloped to prevent water from collecting around the organic matter and compost. However, the storage area at the Facility did not have a roof, cover or a prepared surface designed to prevent the surface collection of water around the base of organic matter (Photo 3).

Ministry Staff observed that the receiving, processing and curing areas of the composting facility were covered and on a prepared surface to prevent run-off from entering the areas. However, the storage area at the Facility was not covered or on a prepared surface (Photo 3).

Photo 3. Compostable and recyclable materials, that have gone through Schedule 2 and 3 of OMRR, storage area.

Ensure that the receiving, storage, processing and curing areas are located on an impermeable surface that is capable of withstanding wear and tear from normal operations and that will prevent the release of leachate into the environment.

Ensure Spa Hills has a roof, cover or a prepared surface designed to prevent the surface collection of water around the base of organic matter and compost within the storage area.

Ensure Spa Hills has a roof, cover or a prepared surface designed to prevent run-off water from entering the storage area.

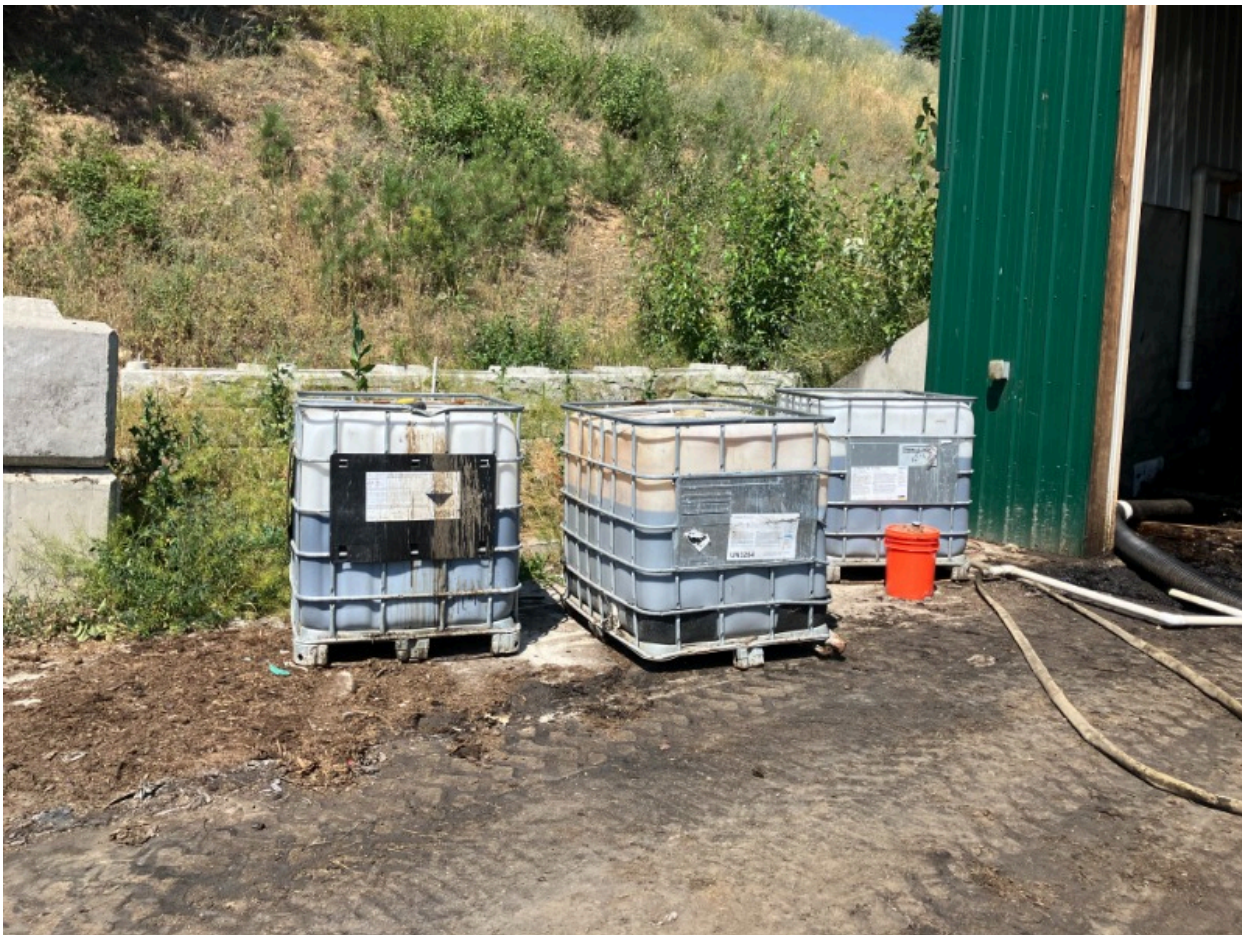
Photo 4. 4500L leachate collection system Facility recycles the leachate back into the composting process.

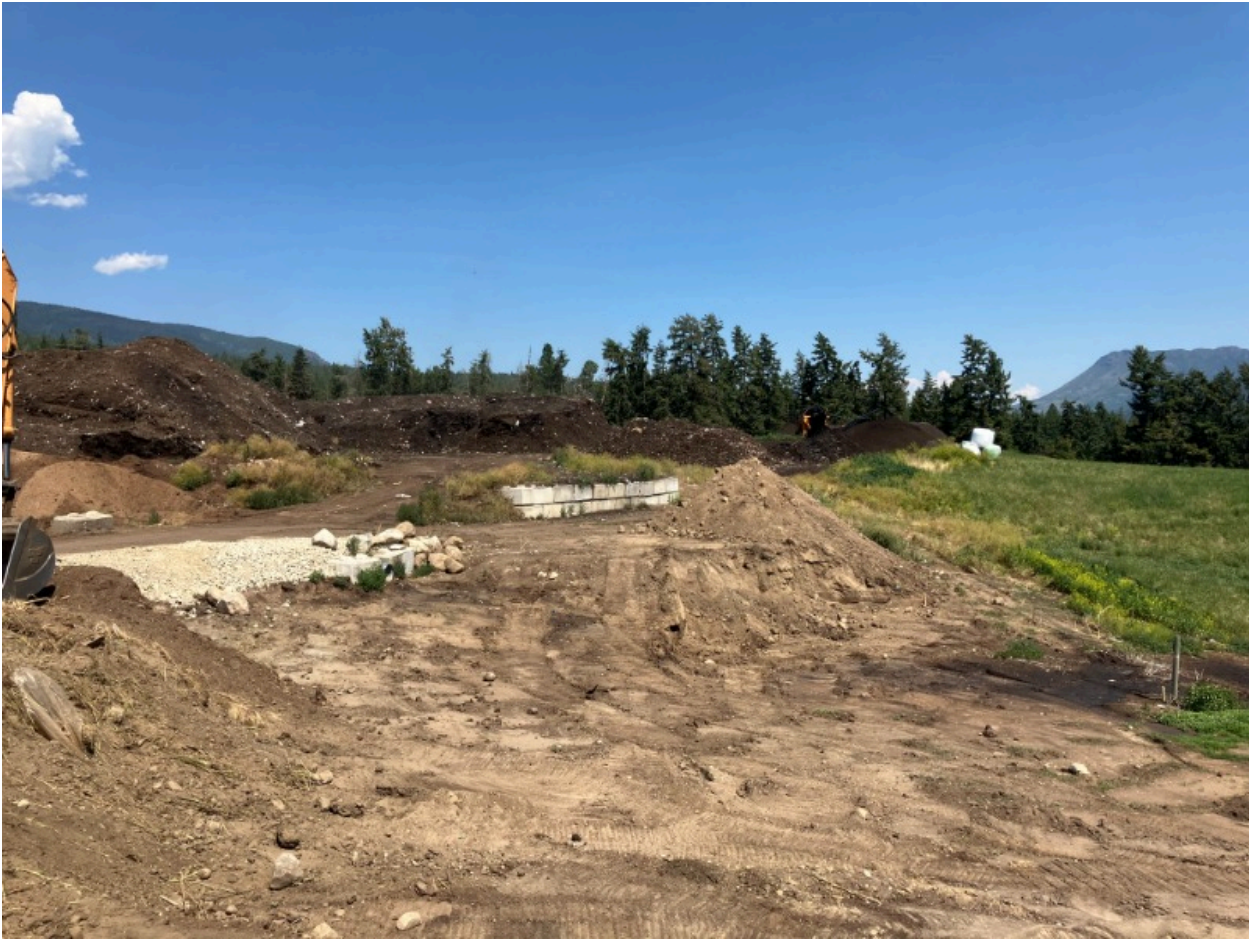
Photo 5. The storage area at the Facility did not have a roof, cover or a prepared surface designed to prevent the surface collection of water around the base of organic matter.

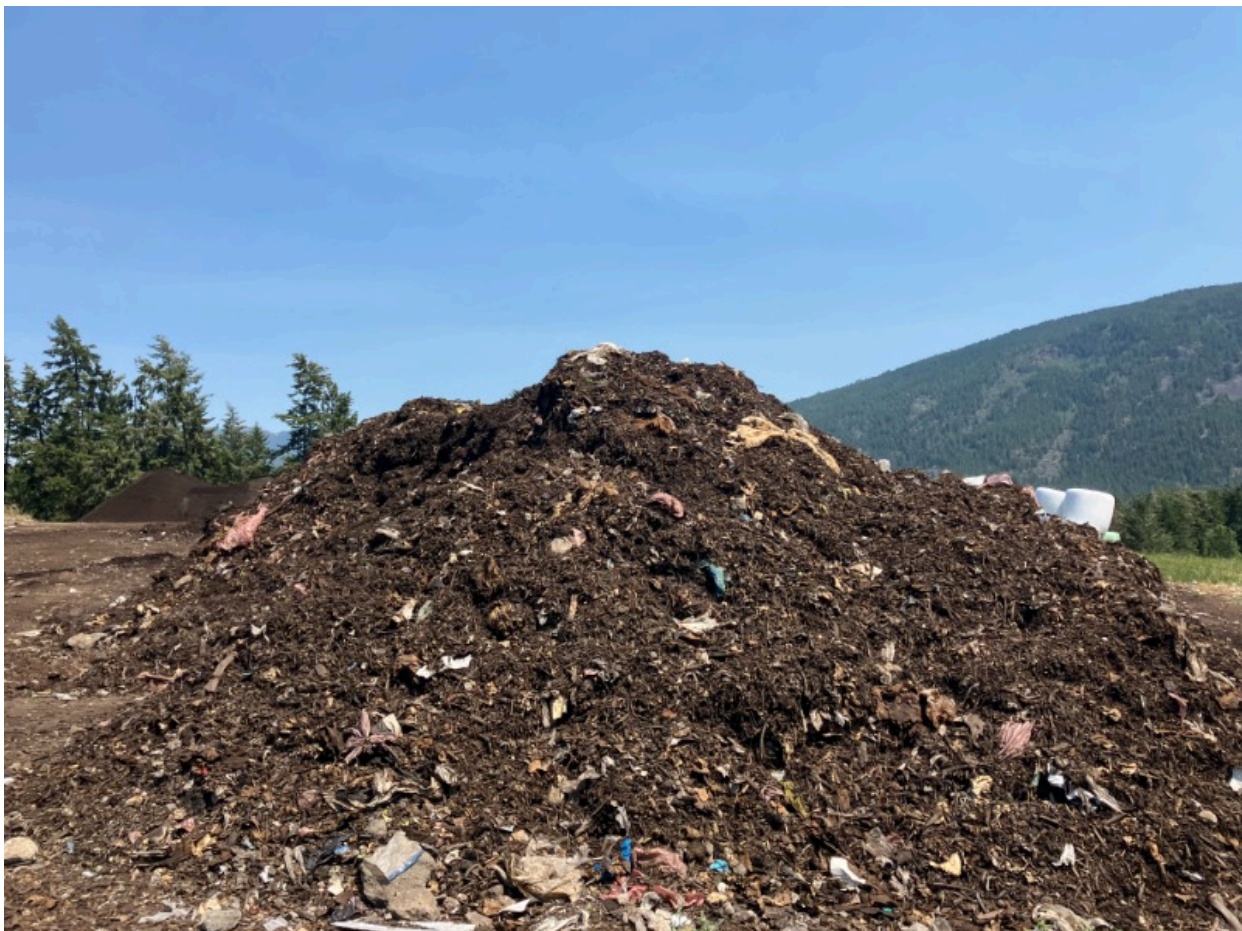
During the on-site inspection, Ministry Staff observed residuals from the composting operation out in the open. No actions or measures to prevent vector attraction were observed.

Photo 6. Residual piles, located north of the Facility exceeding 15 cubic metres.

Ensure residuals from the composting process are stored in a manner that prevents vector attraction.
