Preliminary Septic System Compliance Report

For a Ten-Home Subdivision at 1038 Wharf Road, Scotch Creek BC.

Prepared for Columbia Shuswap Regional District (CSRD) Temporary Use Permit Application

Date of Report: March 07, 2025

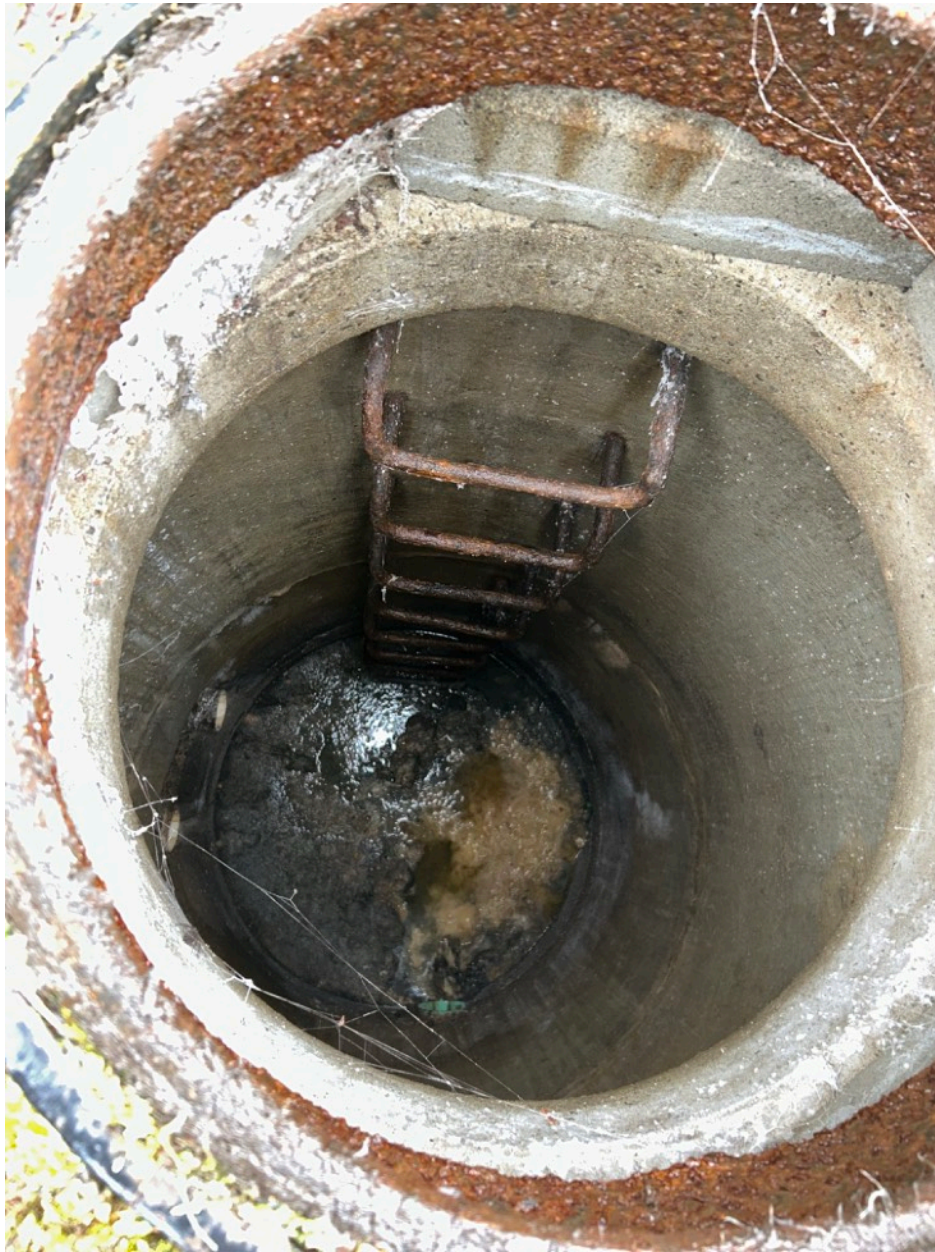
Photo 2. Lift station west

- **Capacity:** Each 1,000 US gallons, total 2,000 US gallons. Adequate as a buffer for peak flows and some settling.
- **Condition:** No cracks or corrosion found.
- **Effluent Transport:** Gravity to settling tanks
- **Compliance:** Meets SPM standards for lift station design and SSR Section 7(1)(c) for treatment method integration.

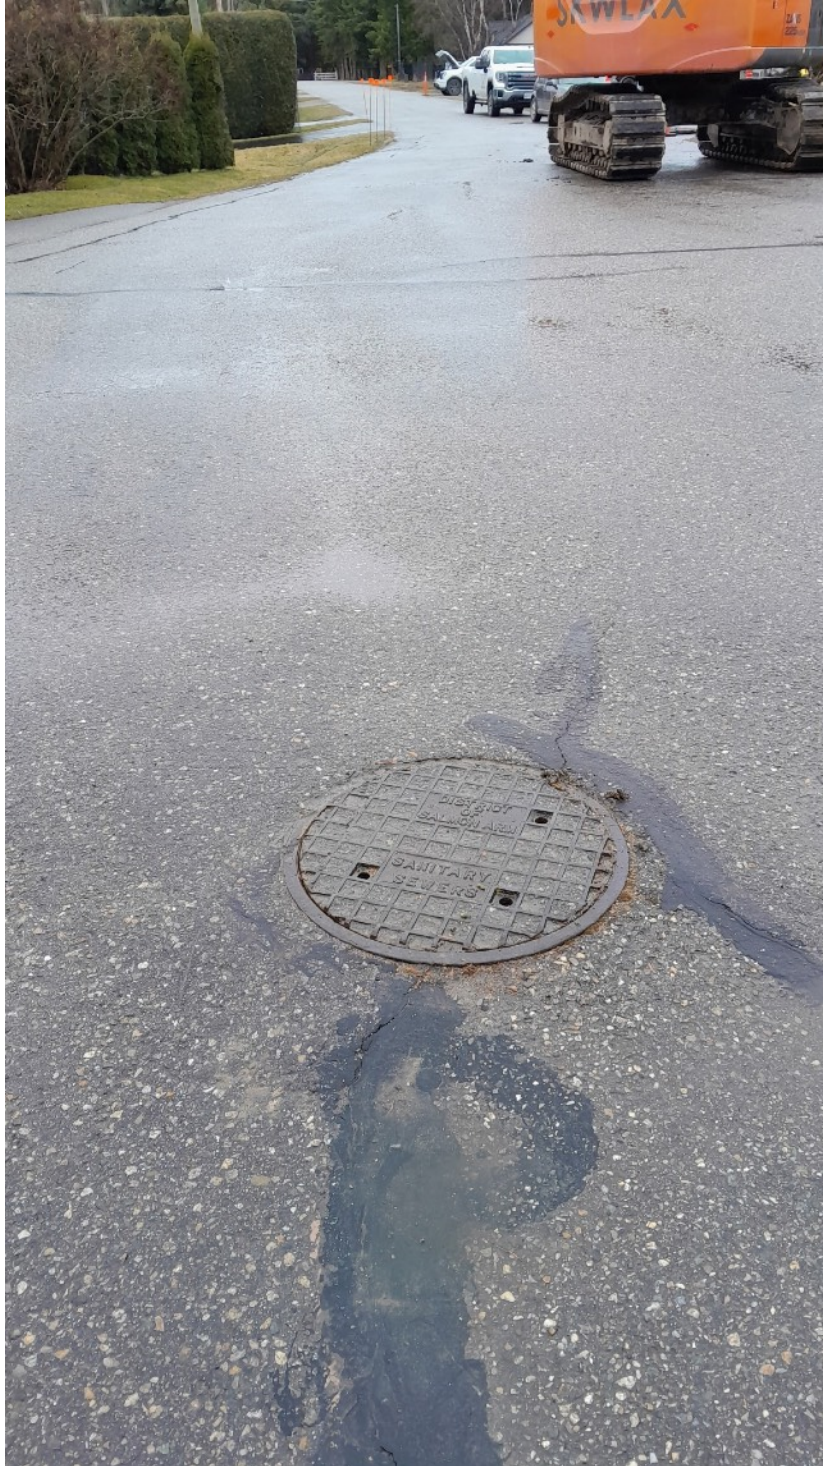
Photo 3. Lift station east manhole access cover.

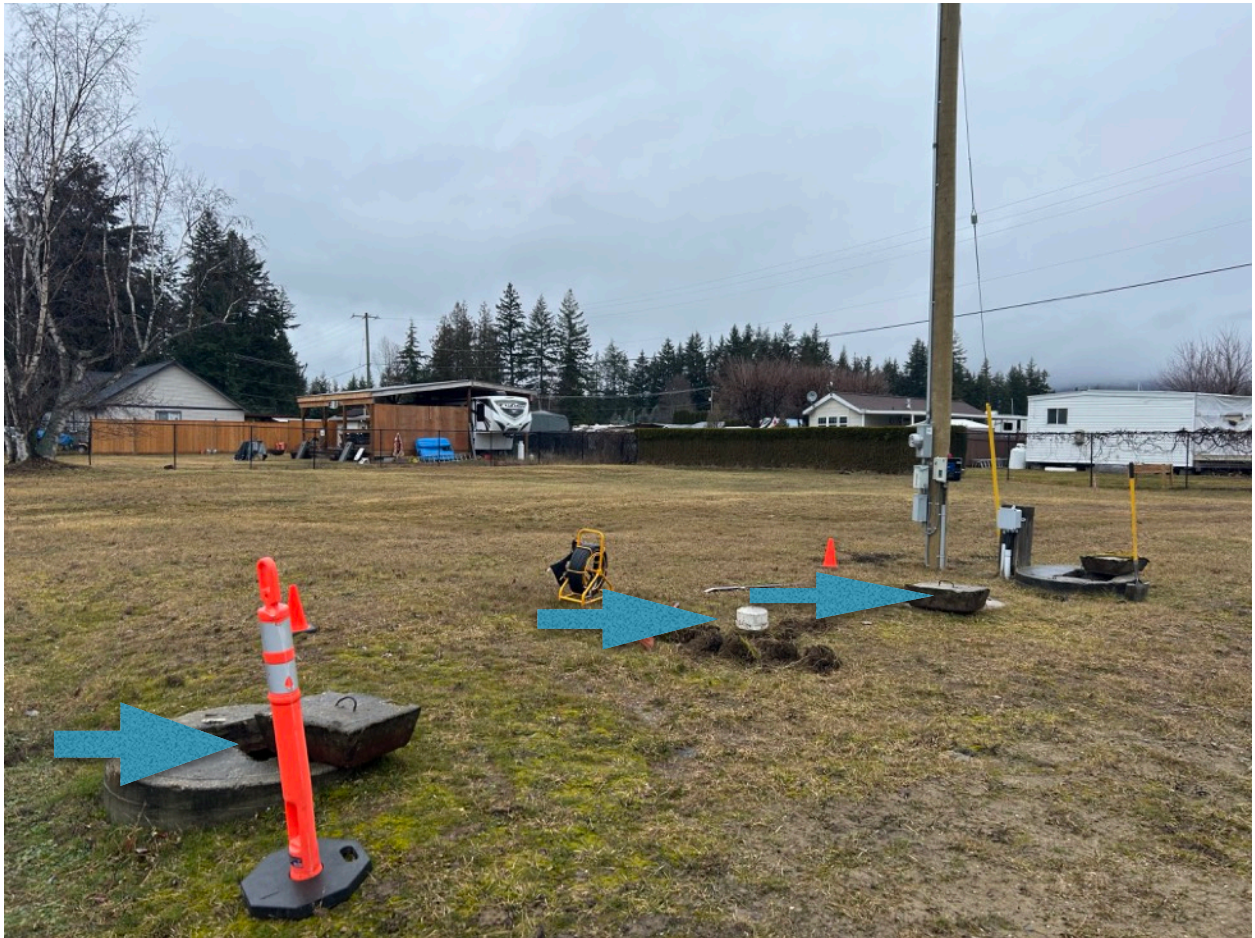
- **Capacity:** 7,000 US gallons settling volume exceeds the minimum SDR requirement for 10-homes, each consisting of 3 bedrooms (e.g., 2727 l or 600iG tank). Adequate for Type 1 treatment.
- **Condition:** No visible cracks, watertight seals intact; baffles found to be adequately sized and straight.
- **Maintenance History:** Last pumped 2023. Recommended pumping every 2 years per SPM.
- **Compliance:** Meets SSR Section 7(1)(b) for watertight construction and sufficient capacity and SDR Daily Design Flow wise

Photo 5. Settling tanks.

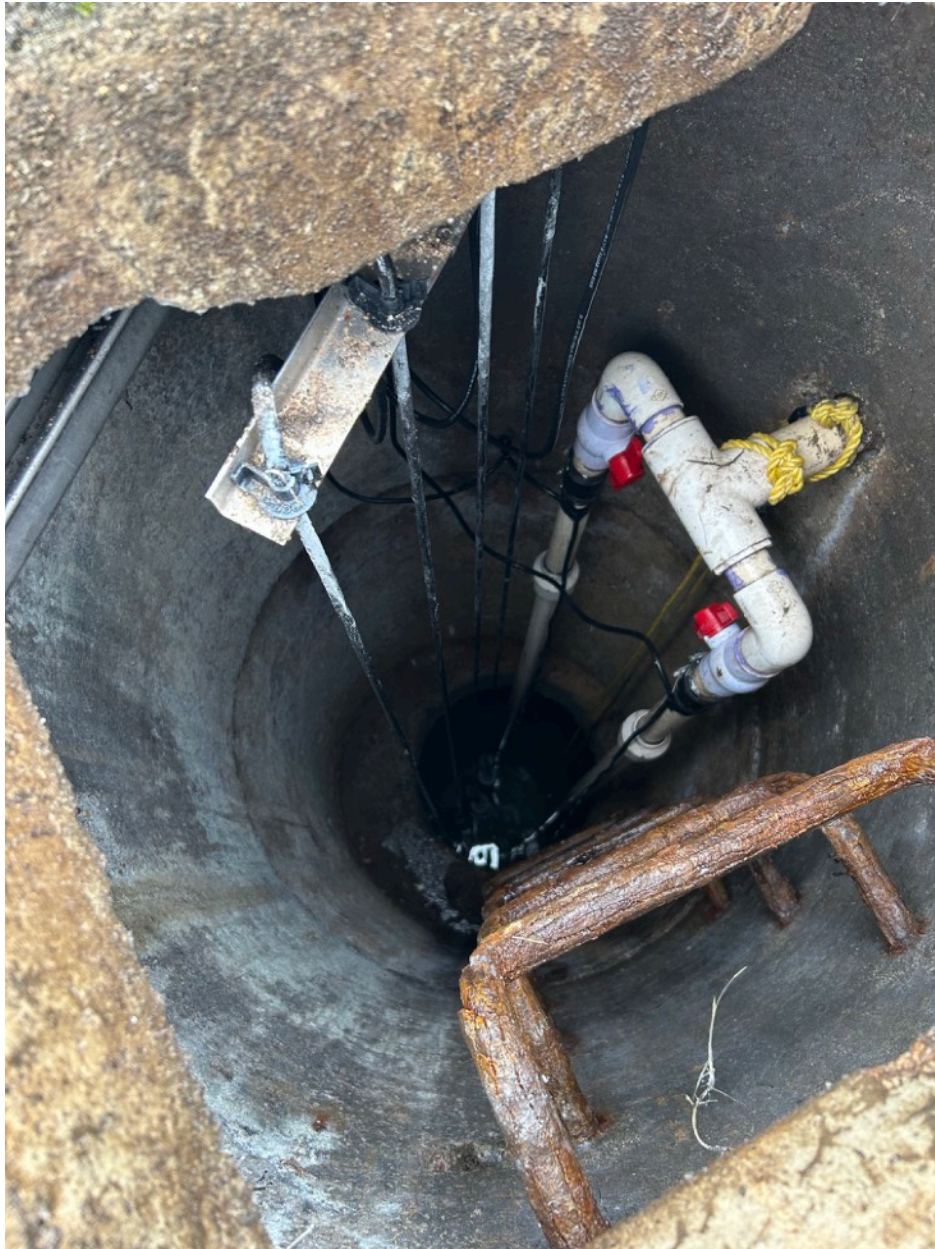
- **Type:** Pressure distribution field, exact dimensions to be confirmed if required.
- **Size:** approx. 75 feet by 105 feet
- **Condition:** No ponding or surfacing observed. No diversions found.
- **Setbacks:** >30 meters from surface water.
- **Compliance:** Pending soil assessment and verification of setbacks per SPM.
- **Pump chamber:** approximately 600usg. Duplex pump system controlled by a Rhombus IFS control panel.

Photo 6. Inside the pump chamber. Duplex pumps/high level alarms.

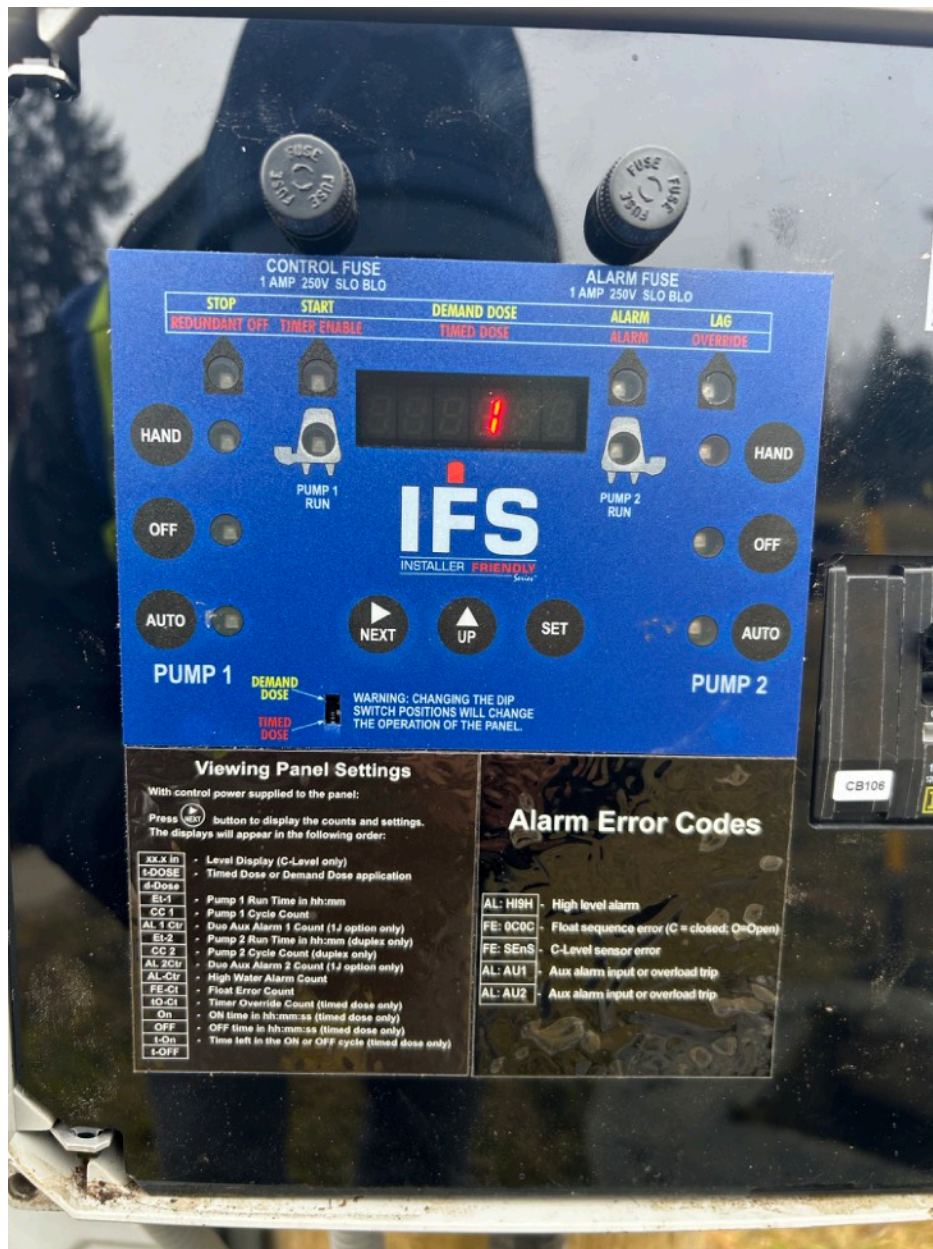
Photo 7. Rhombus control panel. Pump A: 3200 doses. Pump B :3250 doses. Average of 253h of run time each. Audible and visual alarm operating normally.
