## Septic System Compliance Report

For Short Term Rental TUP Application - 3 bedroom 7655 Squilax-Anglemont Rd, Anglemont BC

Prepared for Columbia Shuswap Regional District (CSRD)

Date of Report: March 12, 2025

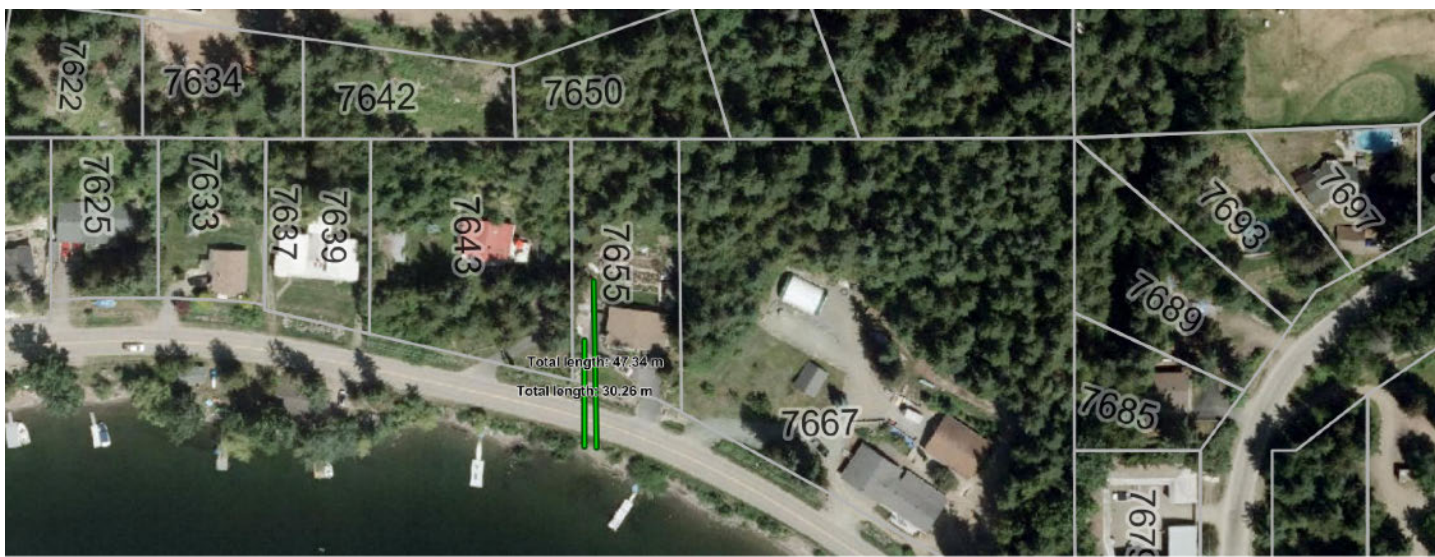
*Photo 1. Site plan. Approximate distance to pump chamber and dispersal area are highlighted.*

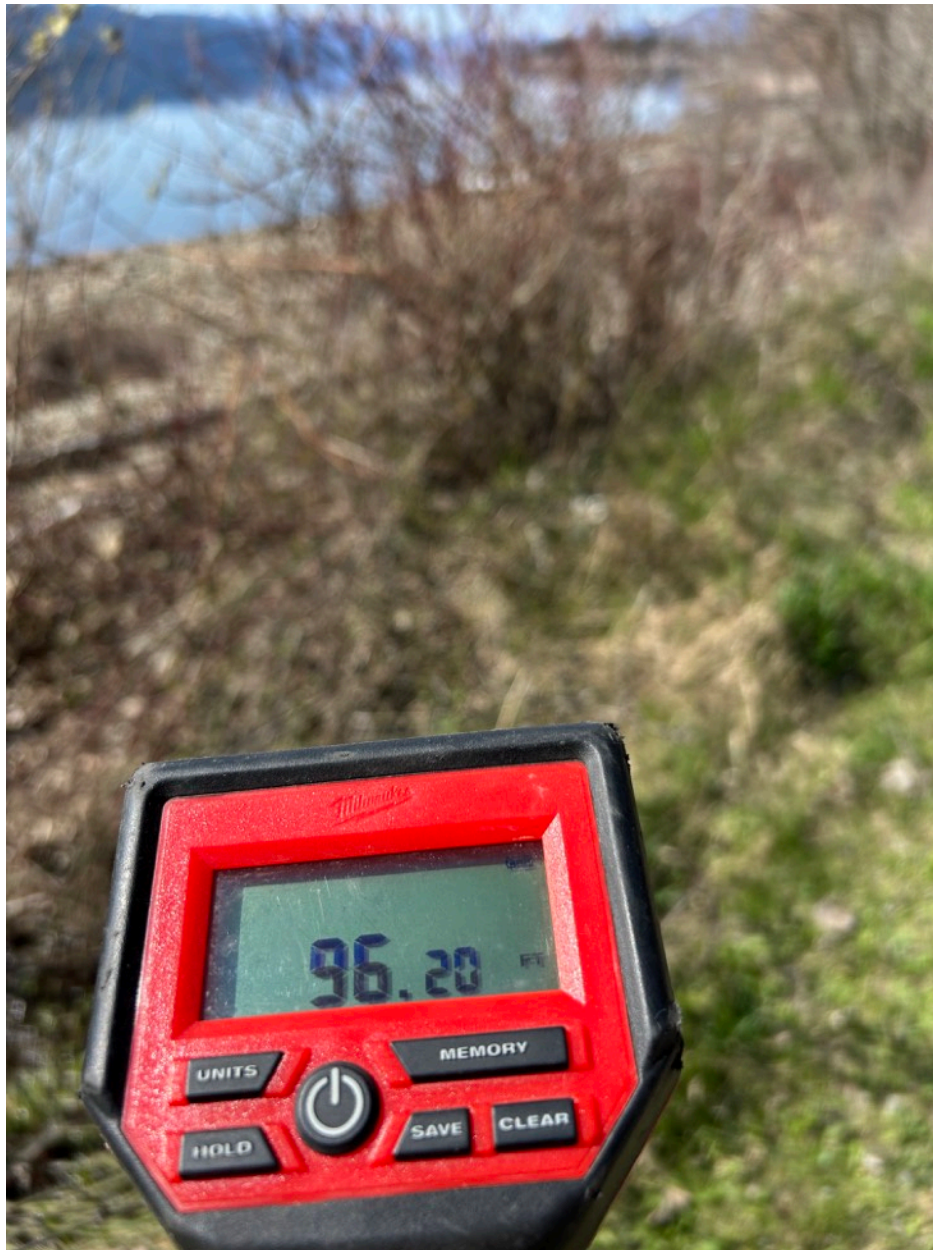
- **Capacity:** 100 IG (120 USG) serves as a buffer for peak flows; adequate for temporary use.
- **Condition:** Located 31 meters from the lake, with pump and float tested and functioning (activated during inspection).
- **Compliance:** Does not meet SDR standards for pump chamber design and but meets SSR setbacks (>30m from Lake ).

*Photo 3. Distance from the pump chamber.*

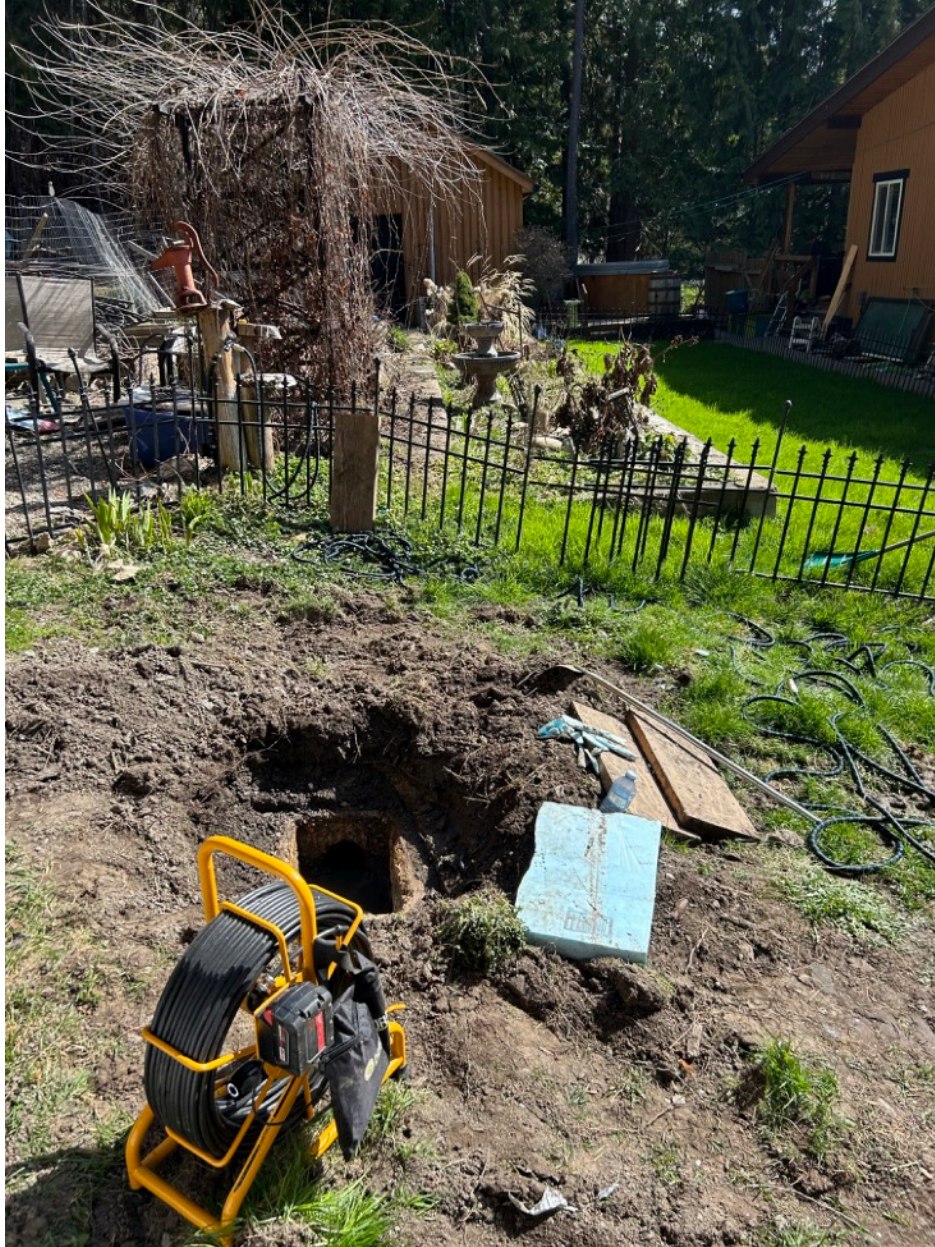
- **Type:** Distribution box with three 3" PVC laterals behind the house. 15m each.
- **Condition:** No surfacing or ponding observed; solids buildup in lines noted (see recommendations).
- **Setbacks:** Assumed >3m from property lines; lake setback covered by pump chamber distance.
- **Compliance:** Appears adequate, pending soil verification.

*Photo 4. Distribution box*

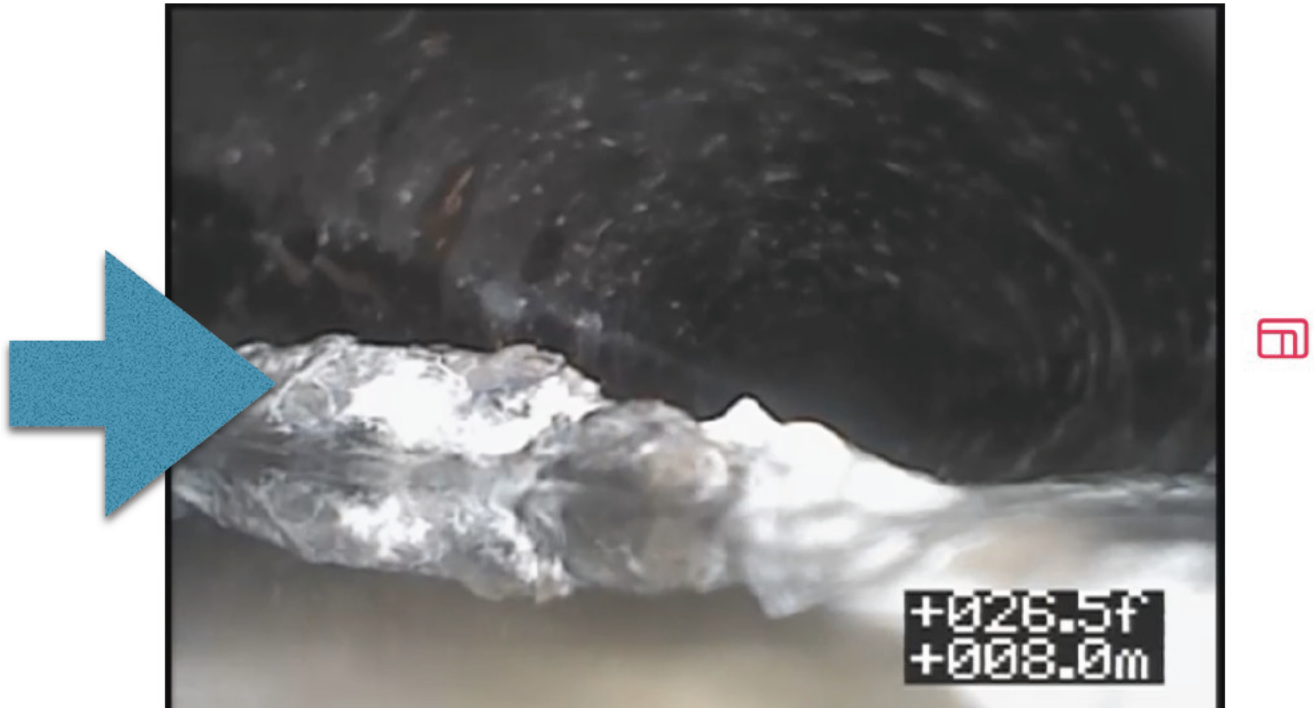
*Photo 5. Sludge inside laterals*

1. **Line Jetting:** Remove solids buildup in the 3" PVC laterals to maintain flow efficiency.
2. **High-Level Alarm:** Install on the pump chamber to alert for overflow risks, enhancing system reliability.
3. **Maintenance Schedule:** Pump the tank every 2 years. Inspect pump annually.
4. **Operation and Maintenance Plan** should be made.

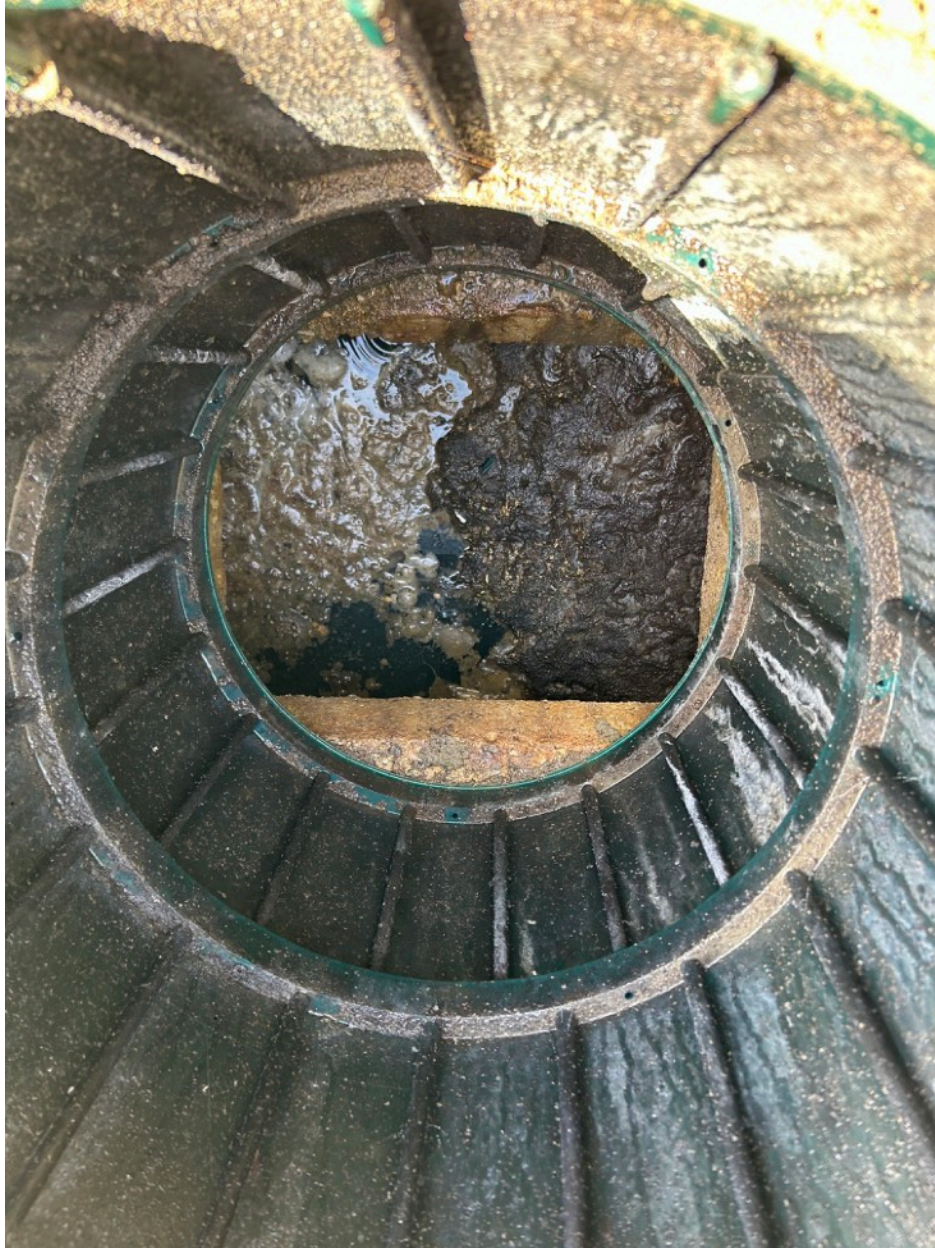
- **Capacity:** 800 IG (960 USG) exceeds the minimum 2-day retention for 450 USG/day (900 USG total capacity needed for 2 days). Suitable for short-term rental use.
- **Condition:** Cast concrete tank with access riser at grade appeared intact; no visible cracks or leaks noted externally.
- **Compliance:** Meets SSR Section 7(1)(b) for watertight construction.

*Photo 6. Main tank*
