Report Number: 219132

Spa Hills Farm Inc.  
2223 Yankee Flats Road,  
Salmon Arm, BC

### **Re: Non-compliance Advisory Letter**

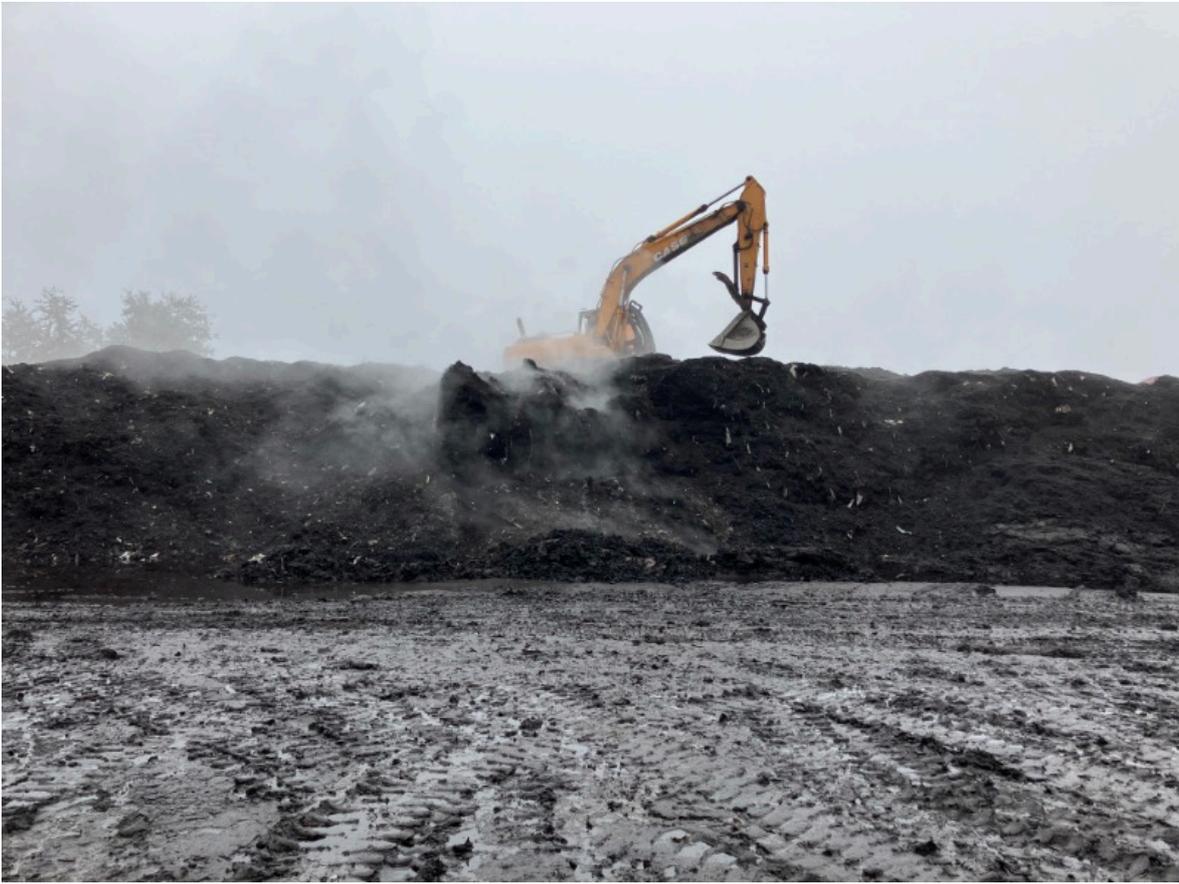
Ministry Staff observed that the receiving, processing and curing areas of the composting facility were covered and sloped to prevent water from collecting around the organic matter and compost. However, the storage area at the Facility was not covered or on a prepared surface. During the on-site inspection, Ministry Staff observed water collecting around the finished compost with no leachate control measures in place (Photo 1).

Ministry Staff observed that the receiving, processing and curing areas of the composting facility were covered and on a prepared surface to prevent run-off from entering the areas. However, the storage area at the Facility was not covered or on a prepared surface. During the on-site inspection, Ministry Staff observed run-off entering the finished compost storage area (Photo 1).

Photo 1. Run-off water collecting around the compost pile at the storage site with no leachate control.

Ensure Spa Hills has a roof, cover or a prepared surface designed to prevent the surface collection of water around the base of organic matter and compost within the storage area.

Ensure Spa Hills has a roof, cover or a prepared surface designed to prevent run-off water from entering the storage area.

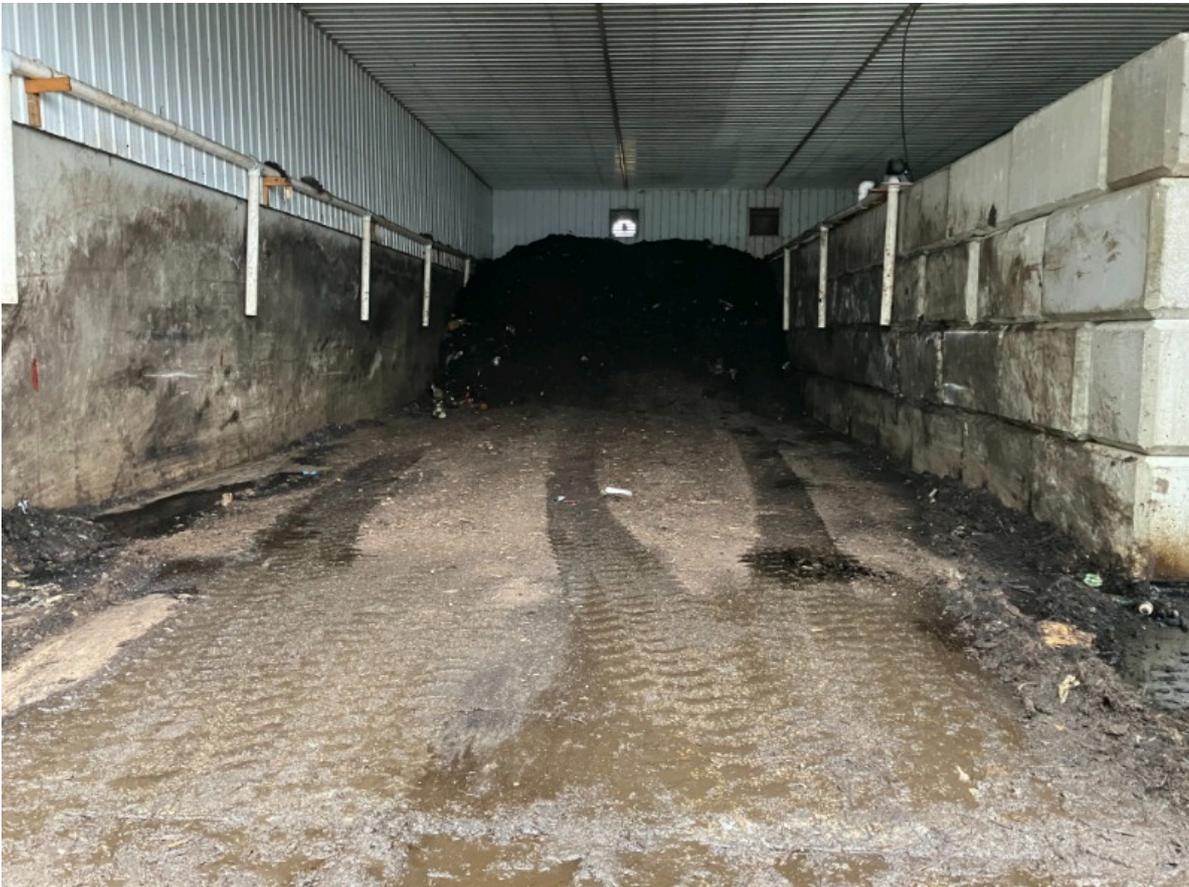
Ministry Staff reviewed the 2024 Operational Plan and determined that a leachate management plan was included under Section 4.2. Within the 2024 Operational Plan it stipulated how leachate generated from the composting process will be minimized, managed and treated. It should be noted that the 2024 Operational Plan explains that "no leachate is anticipated during material storage as a result of considerable moisture loss during the active composting process." However, during the on-site inspection, Ministry Staff observed leachate surrounding these piles (Photo 2), with no management processes in place.

During the on-site inspection, Ministry Staff observed that the receiving, processing and curing areas of the composting facility were located on concrete to prevent the release of leachate into the environment (Photo 2). However, Ministry Staff observed that the storage area at the Facility was not located on an impermeable surface that is capable of withstanding wear and tear from normal operations and did not prevent the release of leachate into the environment.

Photo 2. Composting facility located on concrete to prevent the release of leachate into the environment.

Ensure that the receiving, storage, processing and curing areas are located on an impermeable surface that is capable of withstanding wear and tear from normal operations and that will prevent the release of leachate into the environment.

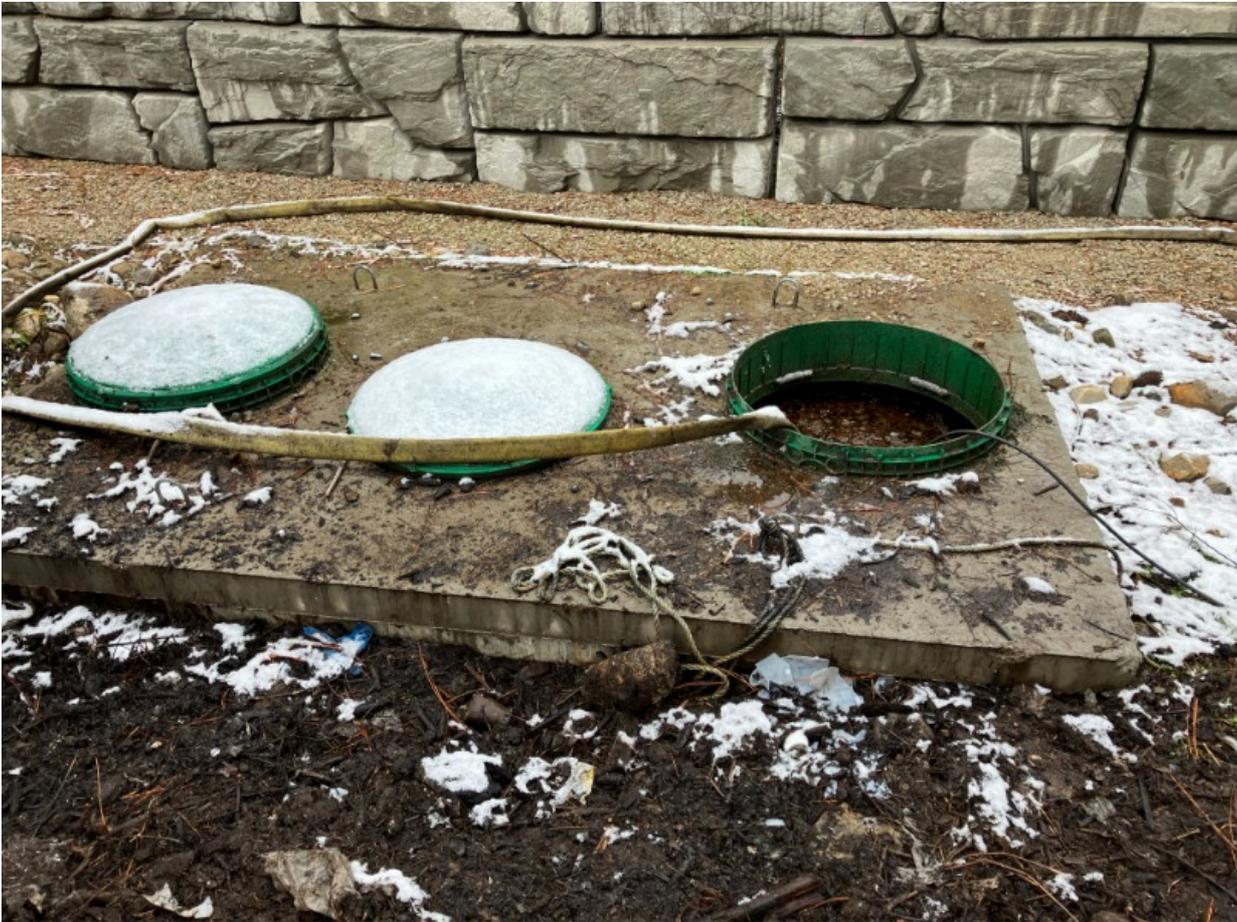
Spa Hills informed Ministry Staff that all composting and storage areas had a sloped surface. The receiving, processing and curing areas have a sloped area where drainage into a 4500L leachate collection system recycles the leachate back into the composting process (Photo 3). The Co-Owner showed Ministry Staff the operation of the leachate collection system.

Photo 3. 4500L leachate collection system.

Ensure Spa Hills has a leachate collection system designed to reuse or remove leachate from the storage area.

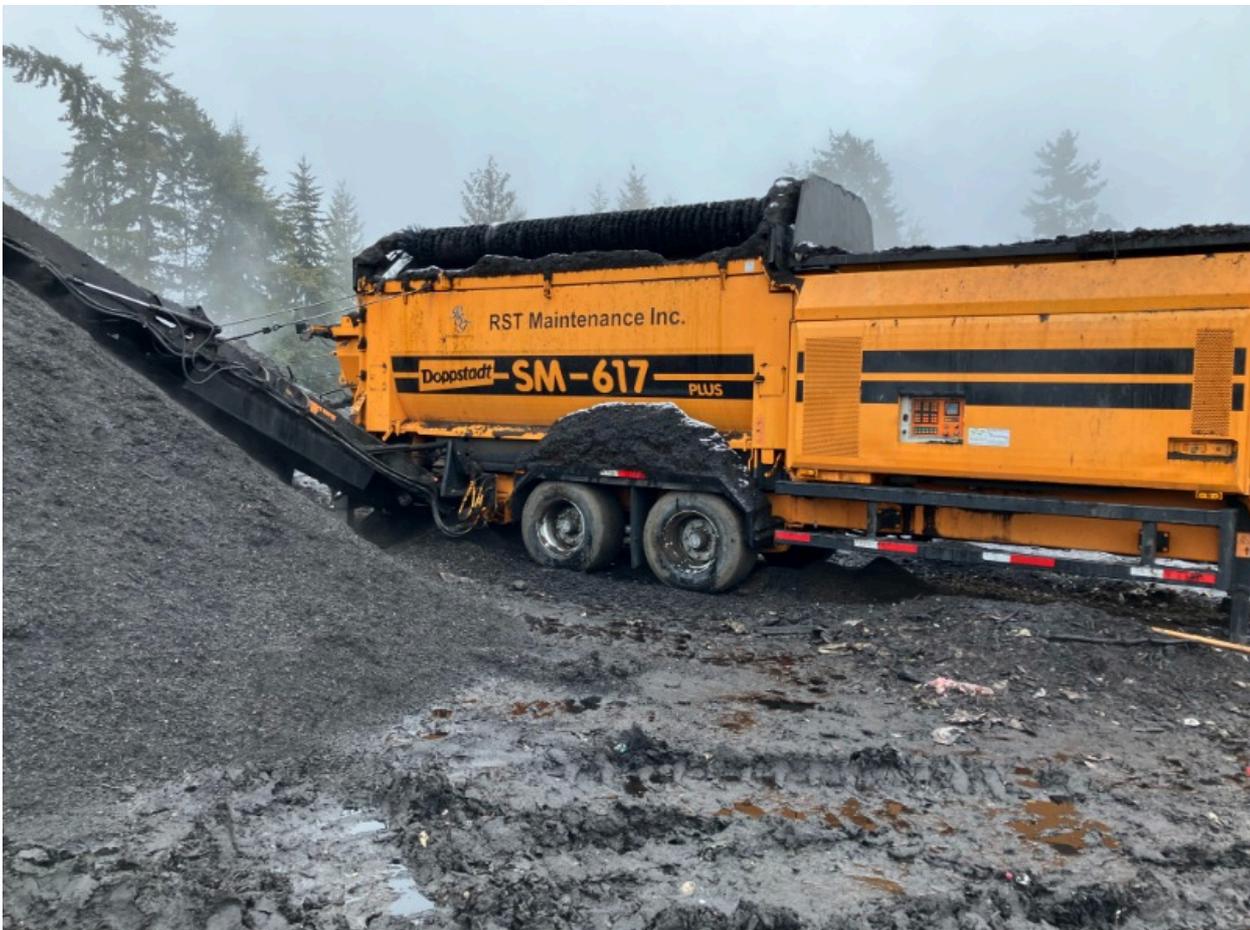
The Facility has an impermeable surface, cover and a prepared leachate collection system for the Facility's processing, receiving and curing areas. However, in the storage area at the Facility, leachate that is not collected and reused is directly discharged to the ground (Photo 4).

Photo 4. Leachate directly discharged to ground.

Immediately cease the discharge of leachate into the environment and ensure that the storage area is managed in a way which prevents the discharge of leachate into the environment.
