**Landslide Hazard Assessment for the
Proposed Subdivision of Lot 1, Section 22,
Township 21, Range 10, West of the 6th
Meridian, Kamloops Division Yale District,
Plan 38427**

**3453 Ford Road
Tappen, BC**

September 26, 2018
File: 1765-1

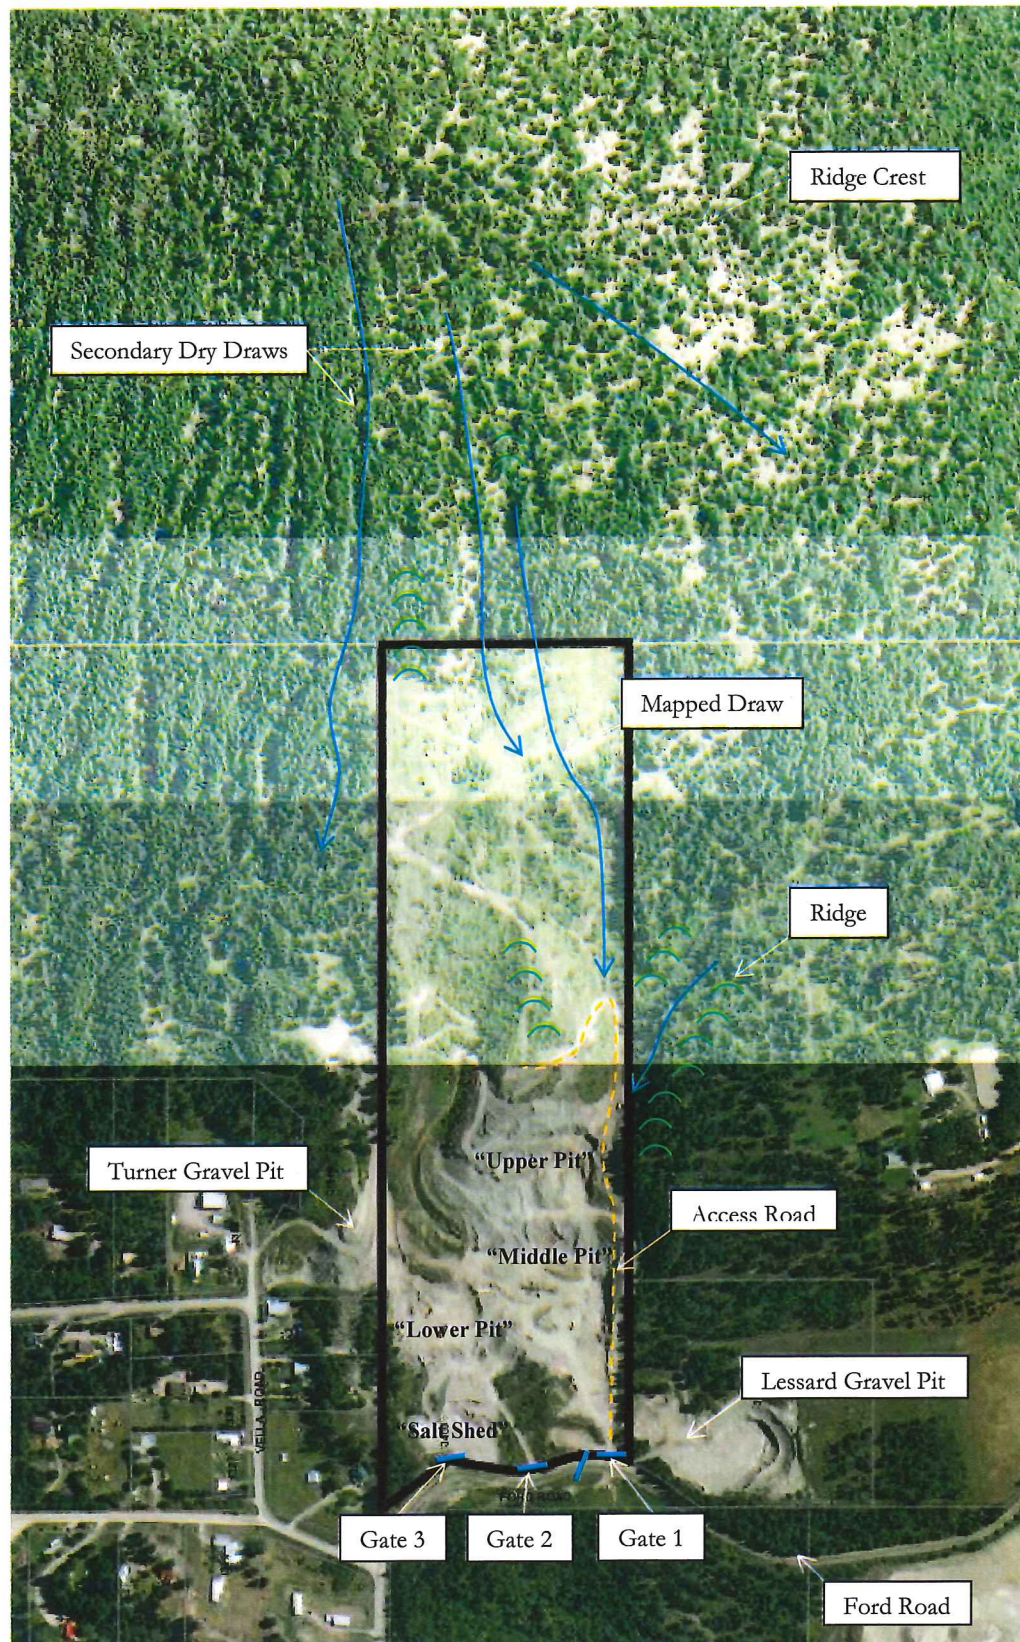
Figure 2: Detailed Site View

The slopes above the subject property extend to the height of land of a ridge on the west flank of Bastion Mountain that separates the White Creek and Farrell Creek drainages. Several dry swales and small draws originate on the slopes below the ridge (see Figure 2). The draw of the unnamed stream that is shown on the regional watershed mapping originates within this area. A second dry draw originates to the south of the subject property and merges with the mapped draw before diminishing above the road that accesses the terrain above the gravel pit. A more pronounced draw originates above the subject property and heads along the northern boundary of the property. The draw diminishes prior to reaching the development on the lower slopes of the hillside.

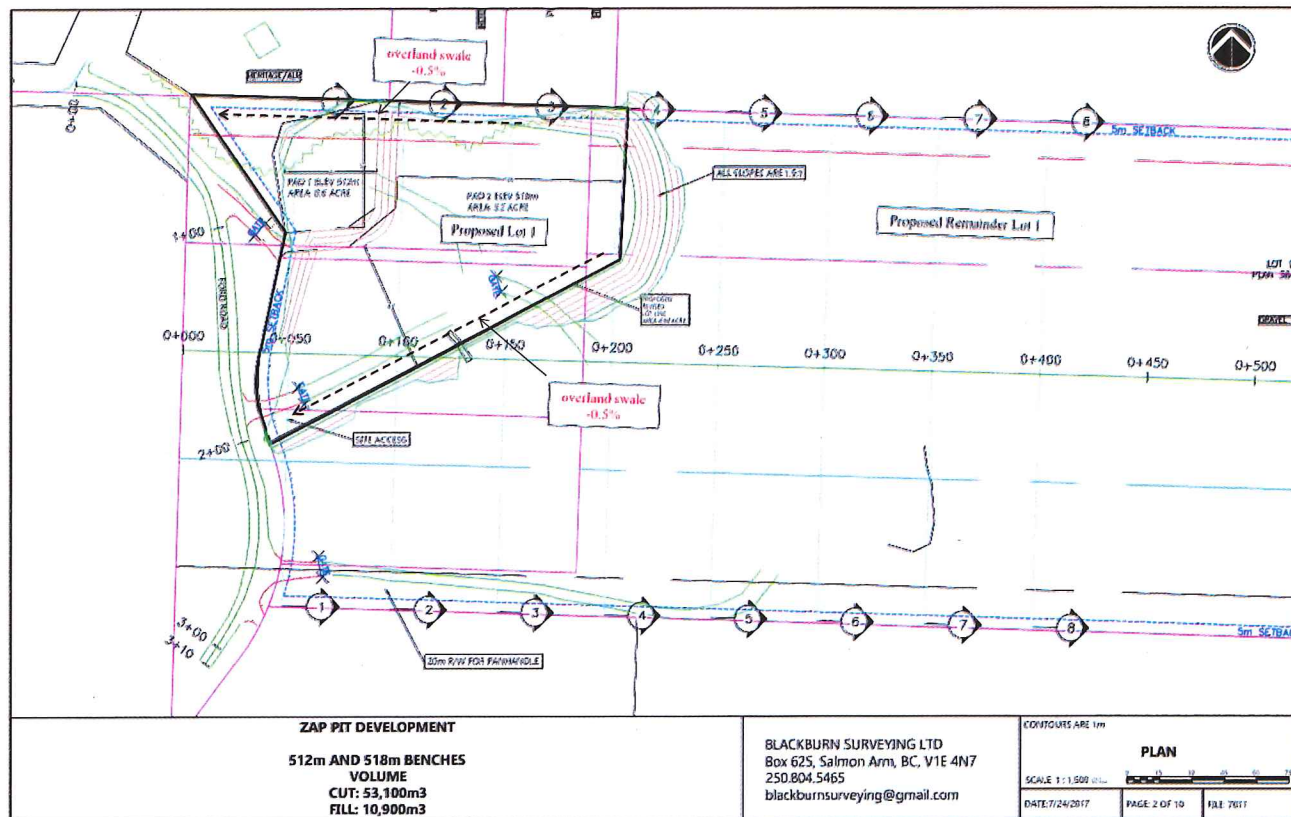
Figure 3 Proposed Lot Layout and proposed reclamation of proposed Lot 1.

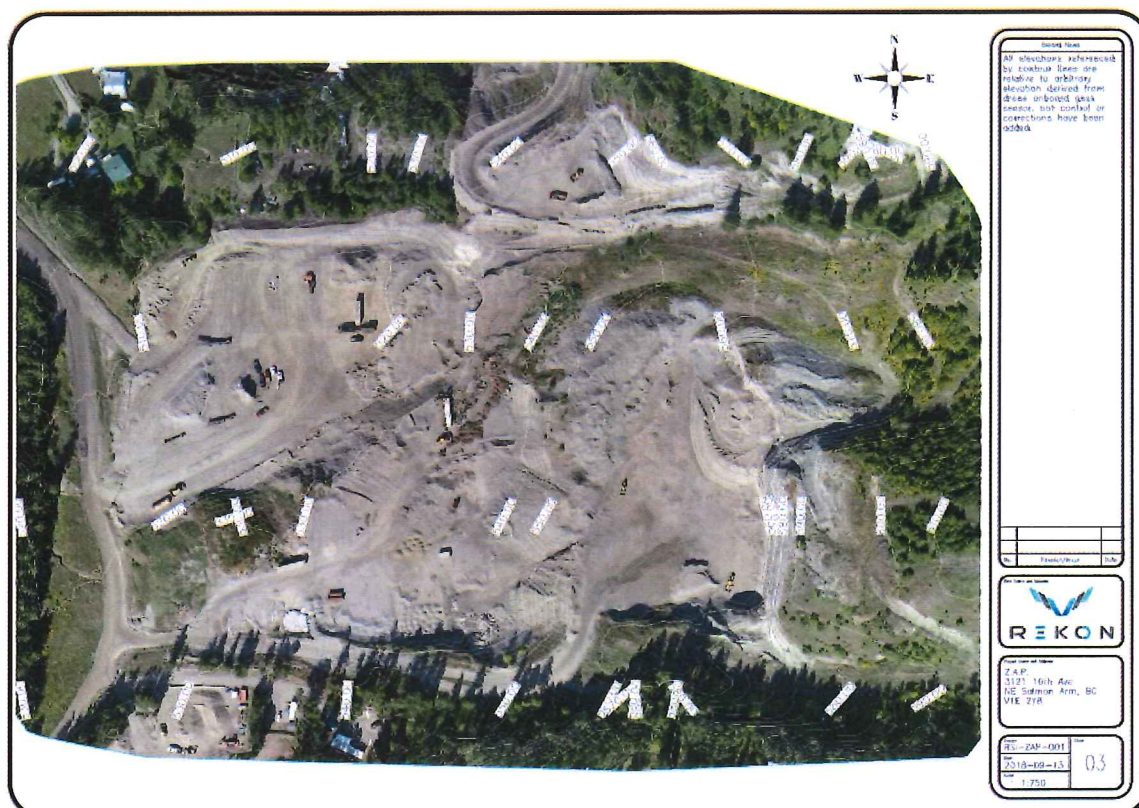
Figure 4 Aerial Imagery Site Plan of the subject property with contour and relative elevation data prepared by Rekon Solutions Inc. Note: The salt shed was remediated before this aerial image was recorded.

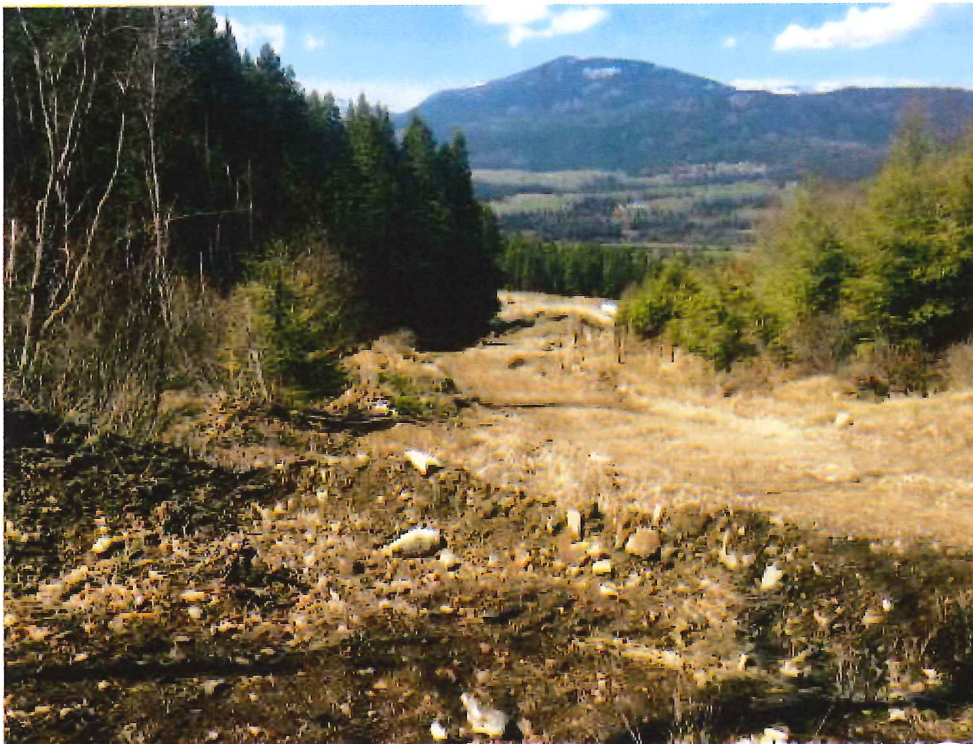
Photo 11 Looking down the access road along the southern property line.

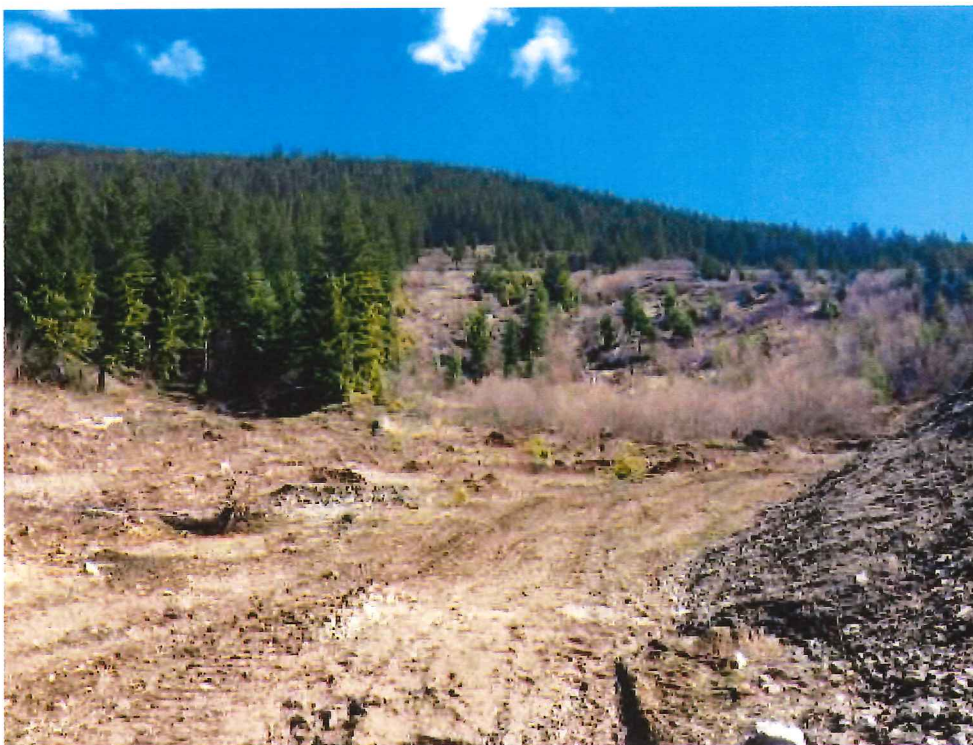
Photo 12 Gentle to moderately steep gradient terrain extending up the hillside along the northern property line, looking east.

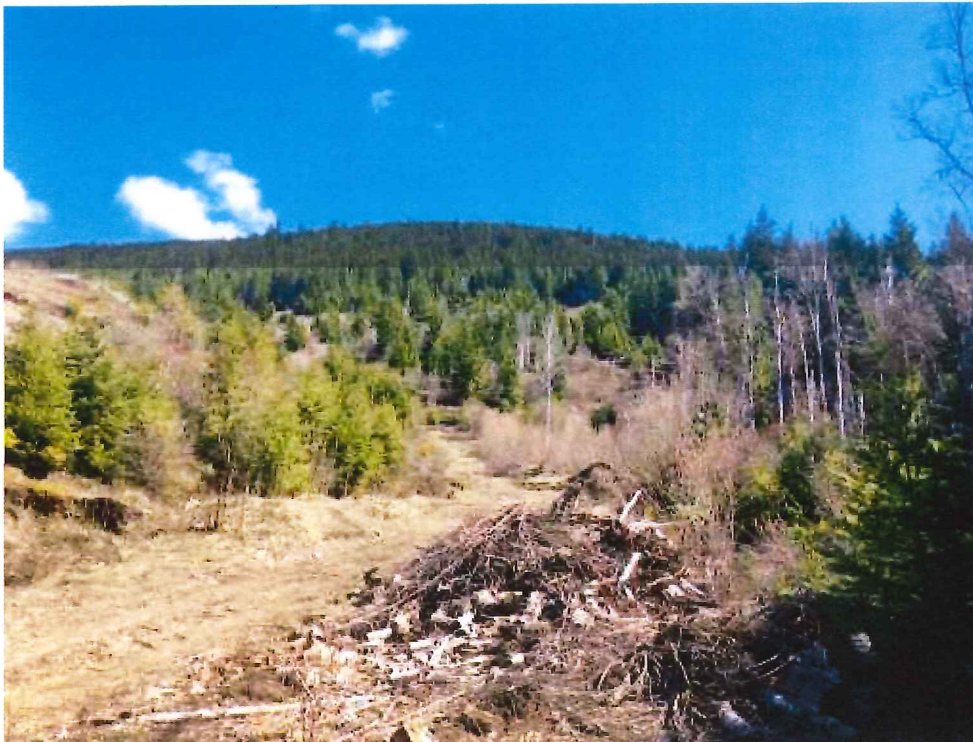
Photo 13 Gentle to moderately steep gradient terrain extending up the hillside along the northern property line, looking east.

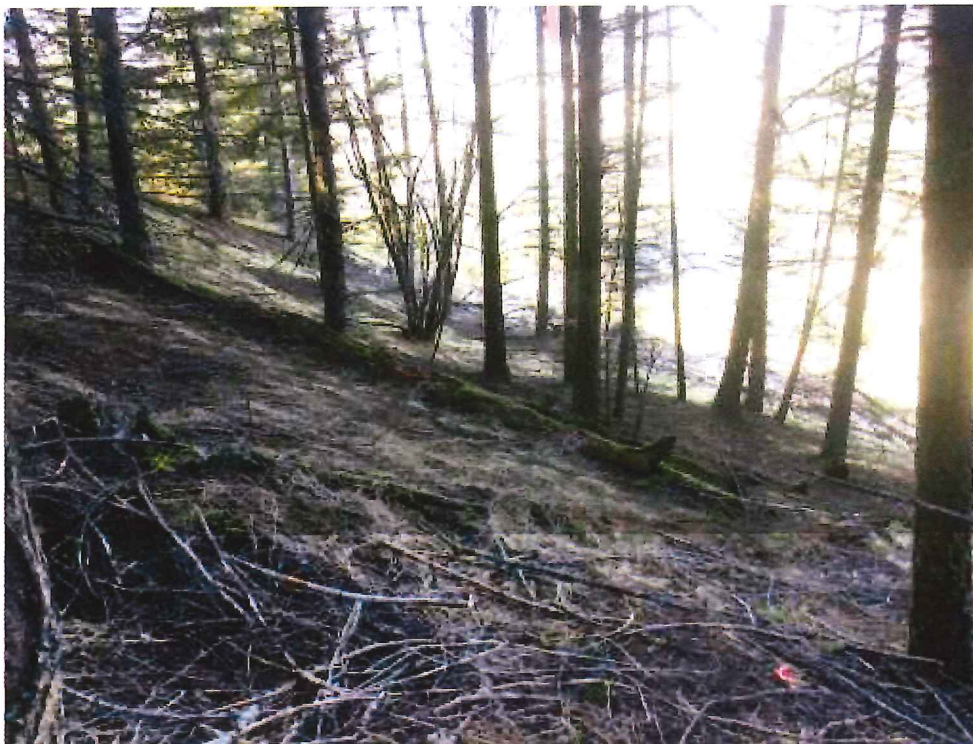
Photo 14 Uniform moderately steep gradient terrain along the upper property line.
