June 7, 2019

Derek Sutherland
Columbia Shuswap Regional District
555 Harbourfront Drive NE
PO Box 978
Salmon Arm, BC V1E 4P1

**RE: Newsome Creek Erosion Mitigation Options
Our File 3234.013**

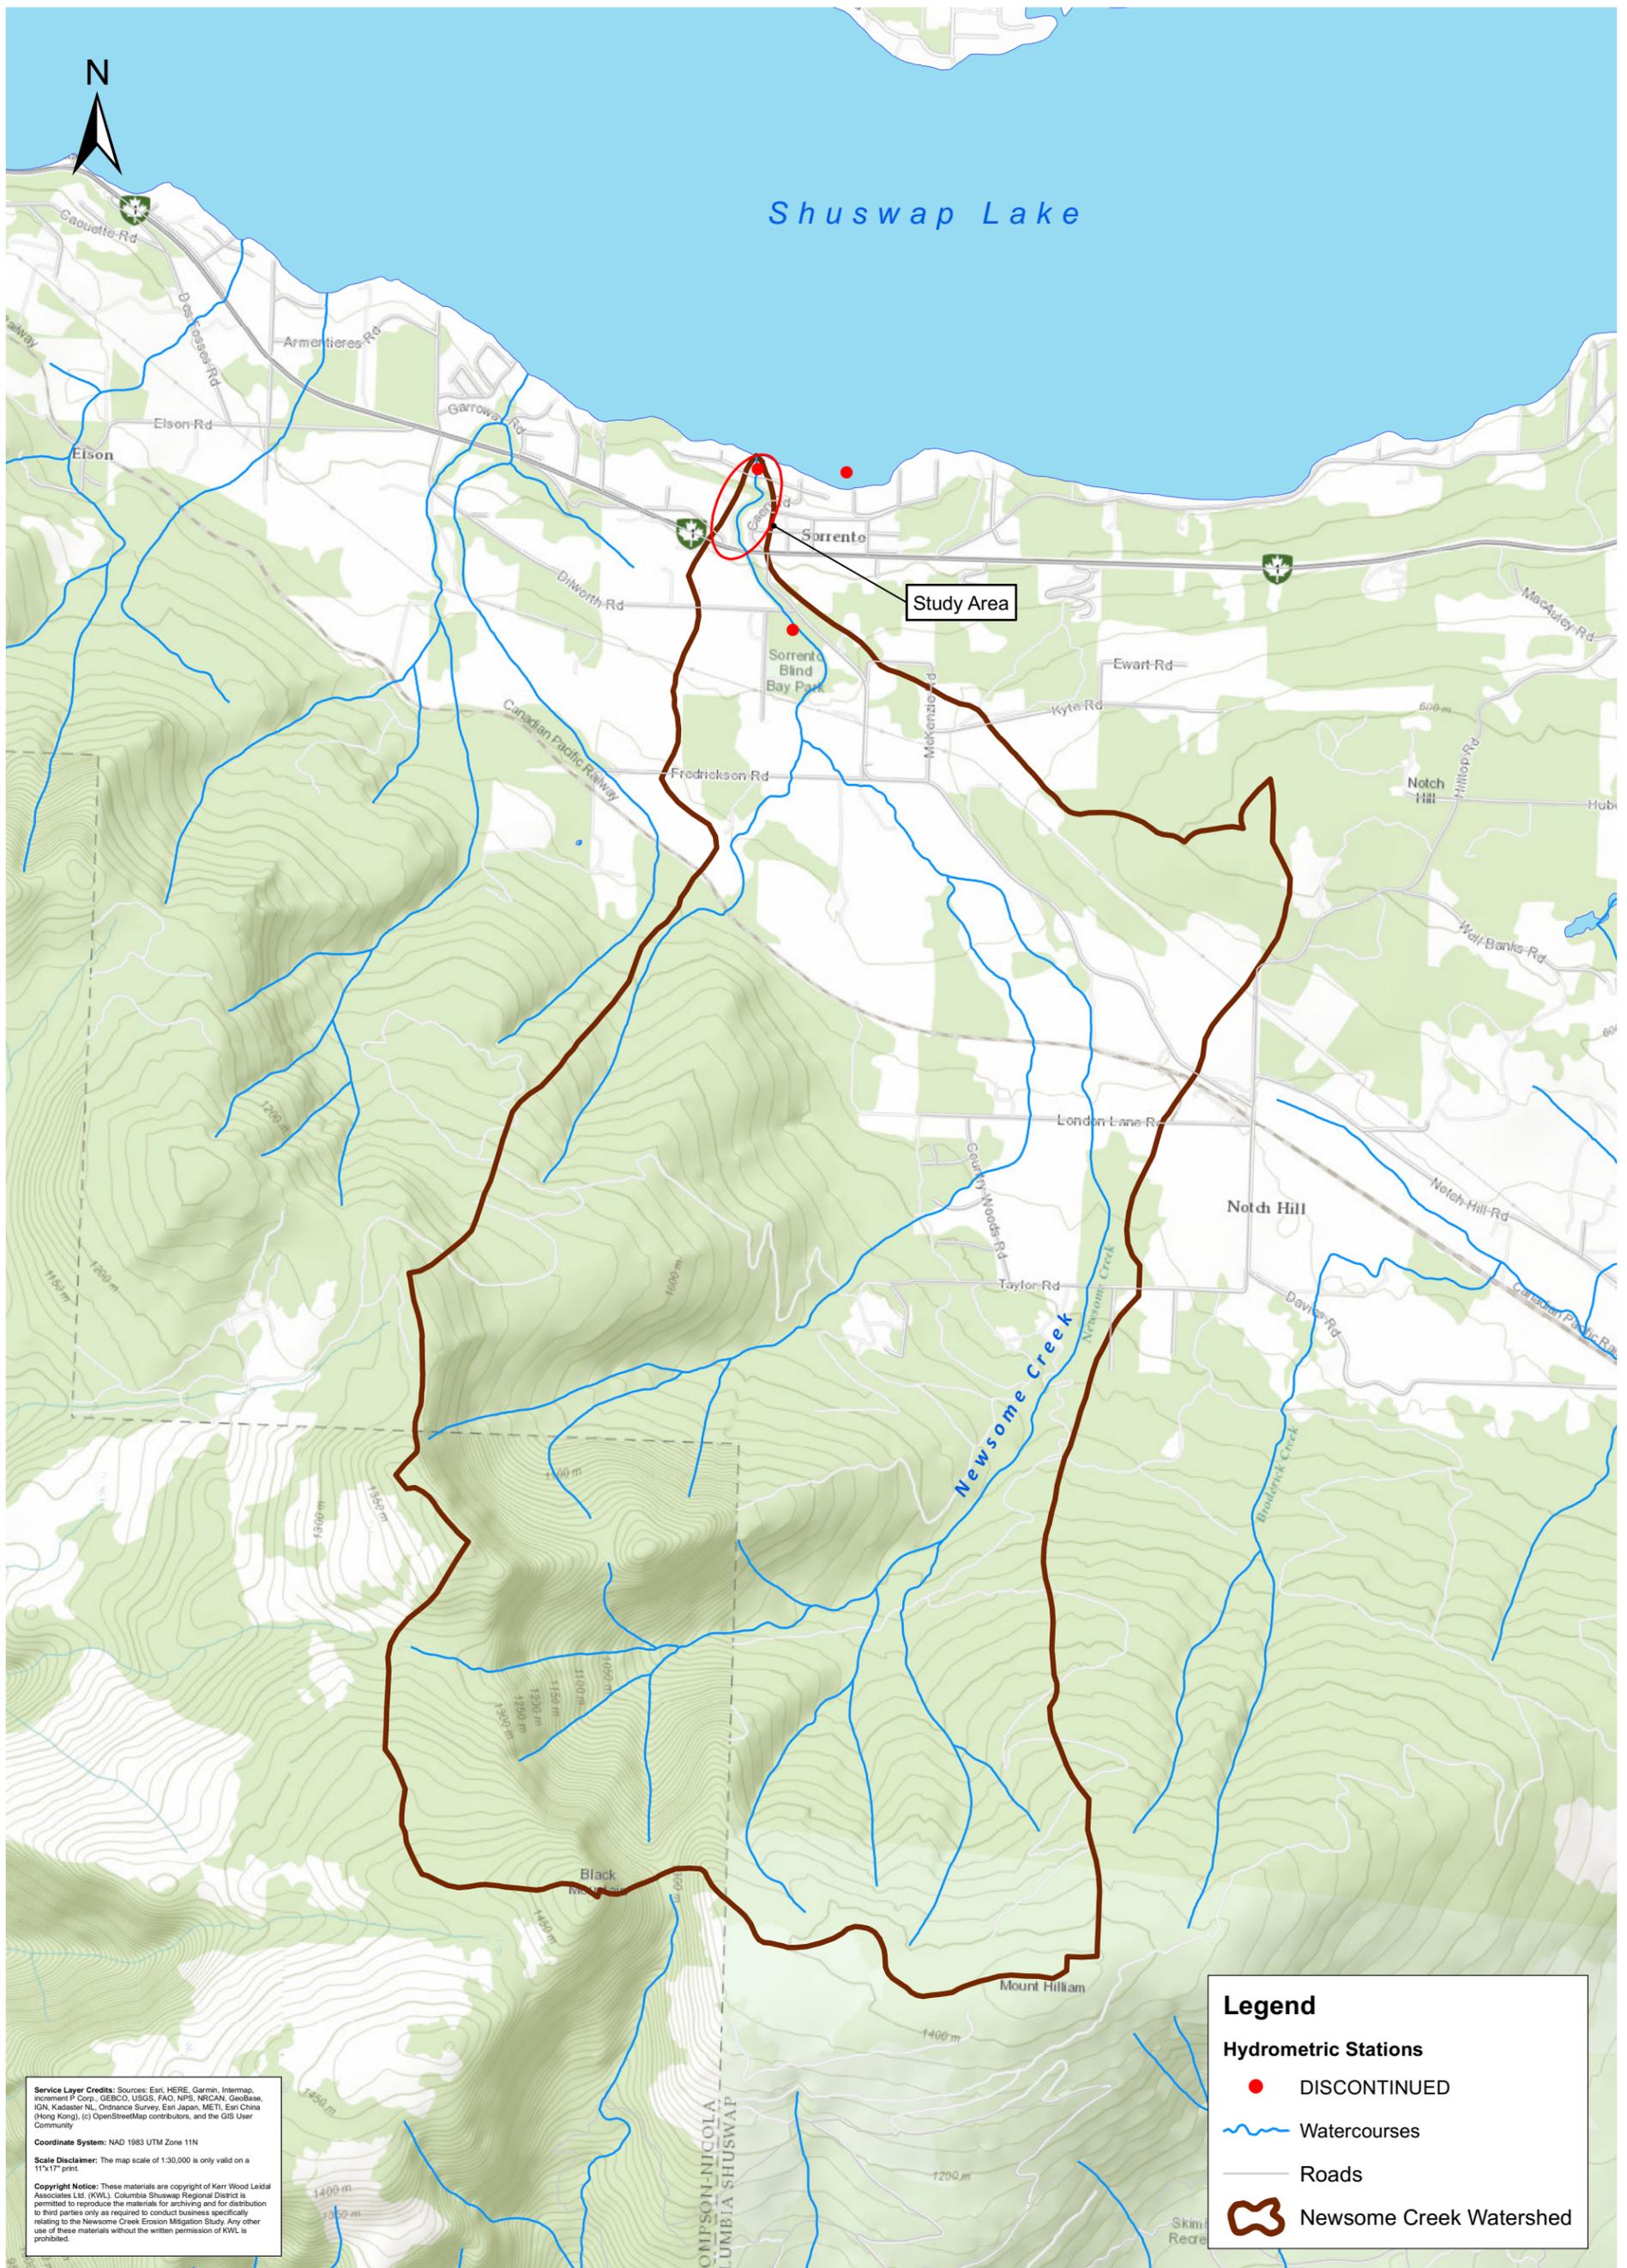
Figure 1

The creek system includes two branches on the east side of the watershed that converge before joining a third branch at about 400 m northwest of the Notch Hill Road and Fredrickson Road intersection. A map of the watershed is shown on Figure 1.

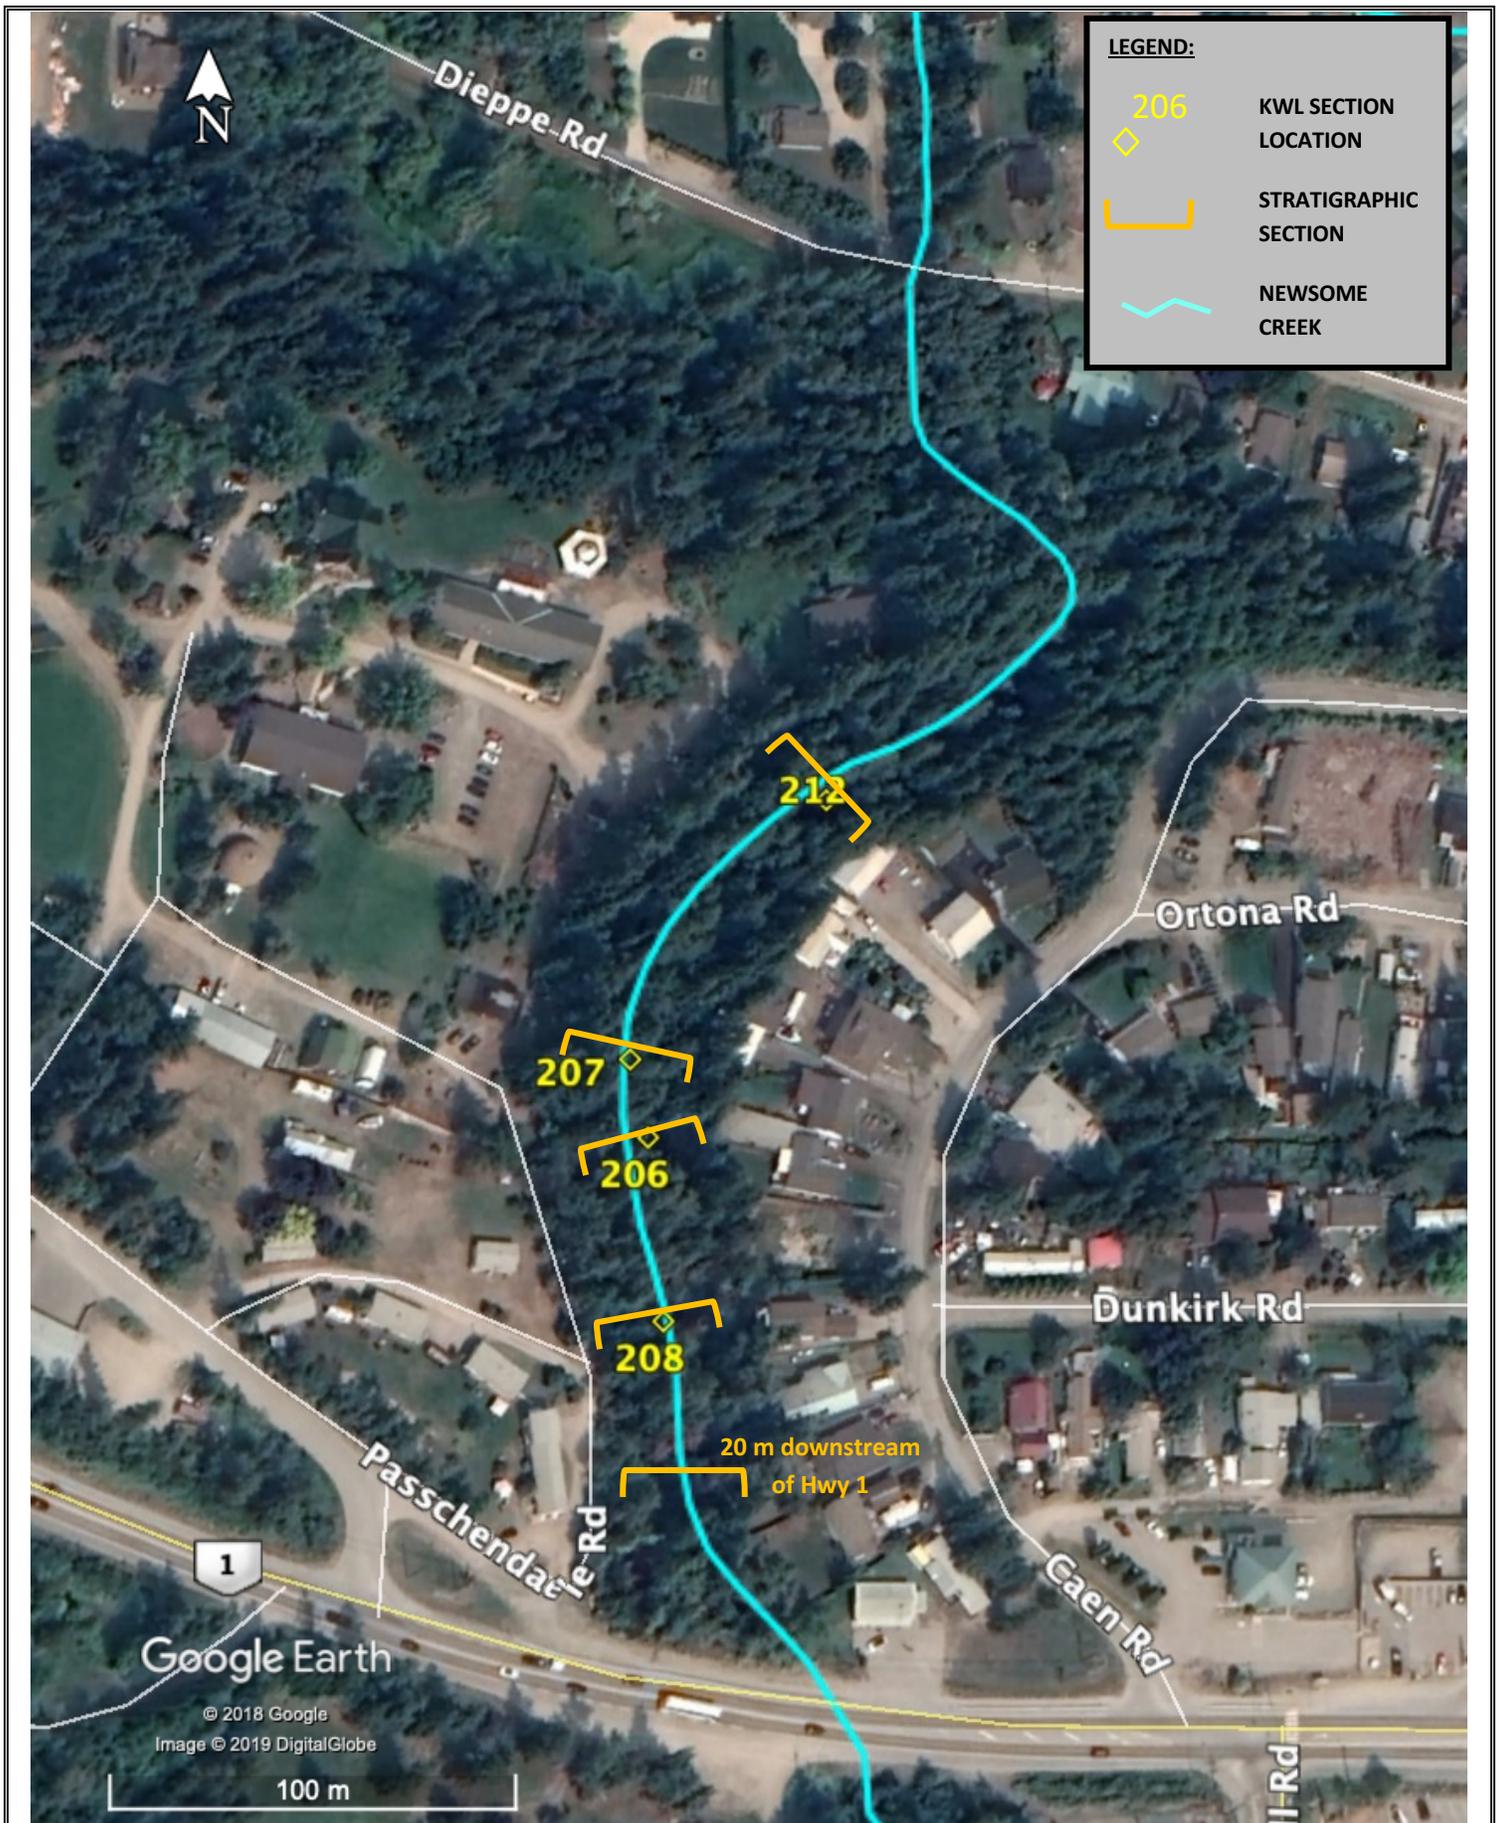
FIGURE 1

Surficial geological mapping by Fulton (1974)¹ indicates the lower reach of the creek is mapped as a lacustrine complex of clay, silt, sand, and gravel that represent open freshwater and shoreline deposits. This deposit is well-exposed in the eroded gully sidewalls immediately below Highway 1 (see Figure 1). The unit generally comprises two main surficial units, as described below:

**NEWSOME CREEK – STRATIGRAPHIC SECTIONS
KERR WOOD LEIDAL ASSOCIATES LTD.**

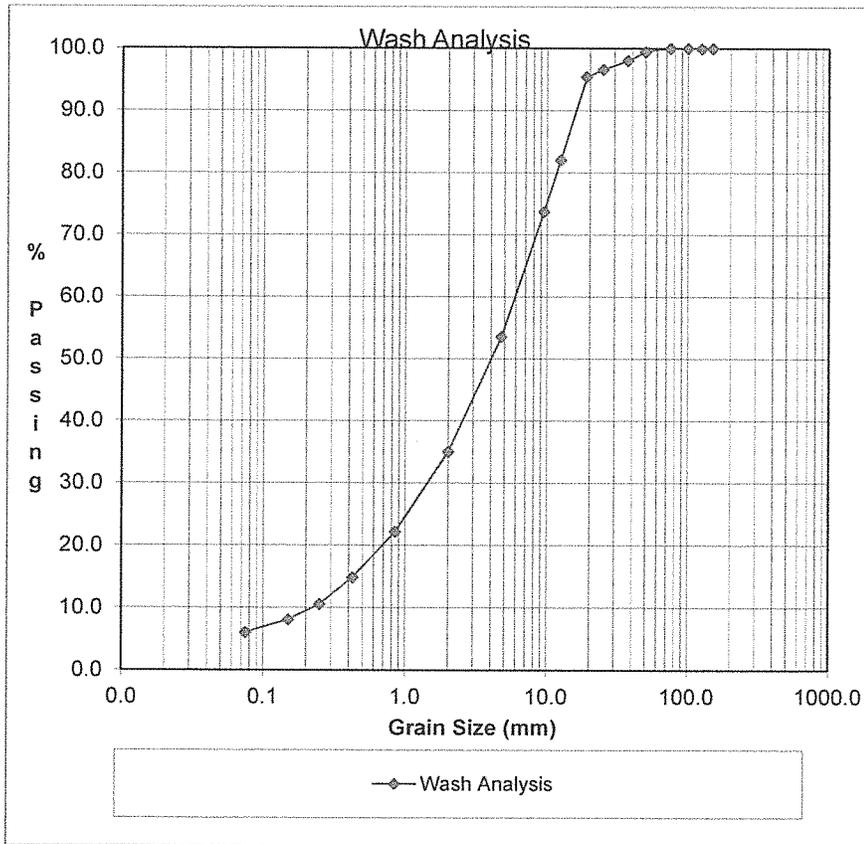
Lower down, this unit is composed mainly of dark grey / black, well-graded **sand and gravel** with trace to some silt. The stratigraphic layers are typically decametre to metre-scale. Gradation testing on two samples of this unit indicated it was composed of 45% to 47% gravel, 44% to 48% sand, and 6% to 11% silt. Maximum nominal particle size was about 75 mm but boulders up to 0.6 m in size were observed in the channel downstream. The layer was generally loose, but in some areas immediately under the **silt** unit, cementation was observed.

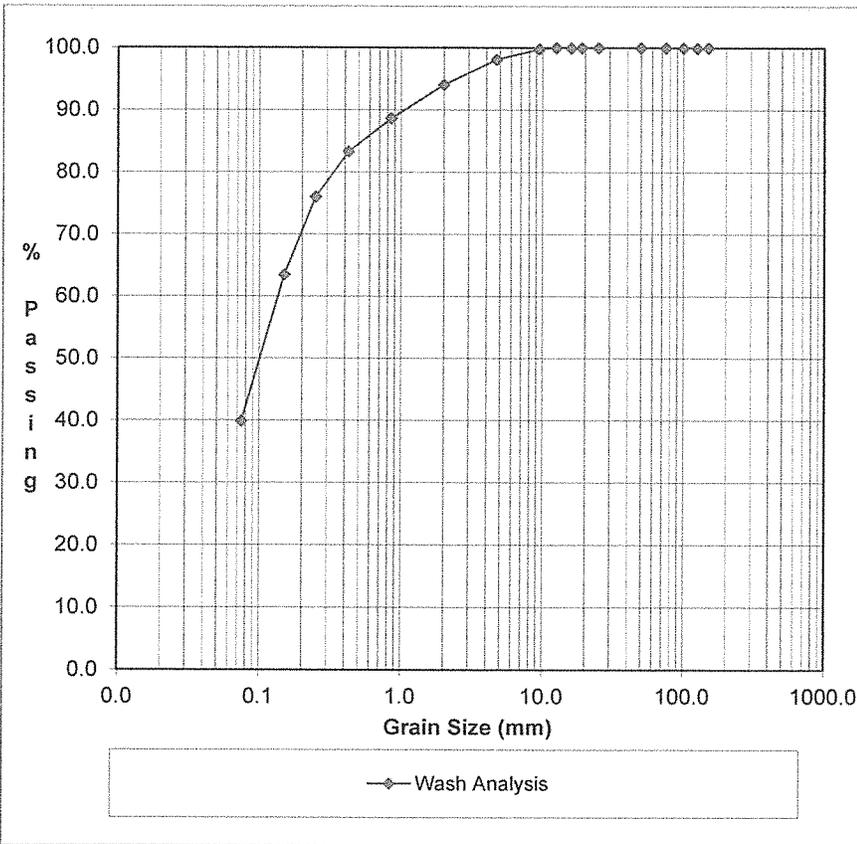
Decameter-scale thick layers of dark grey / black **sand and silt** were observed in the upper part of the lower unit. Gradation testing on one sample indicated it was composed of 2% fine-grained gravel, 58% sand, and 40% silt. The layer was generally loose. Interlayered in this deposit were layers of **sand and silt** as noted above.
