British Columbia Timber Sales – Vernon Office

***CUTBLOCKS K0WG, K5M7, AND K5M8
BASTION CREEK AREA
TERRAIN STABILITY ASSESSMENT***

AZIMUTH FORESTRY & MAPPING SOLUTIONS LTD.

APRIL 3, 2020

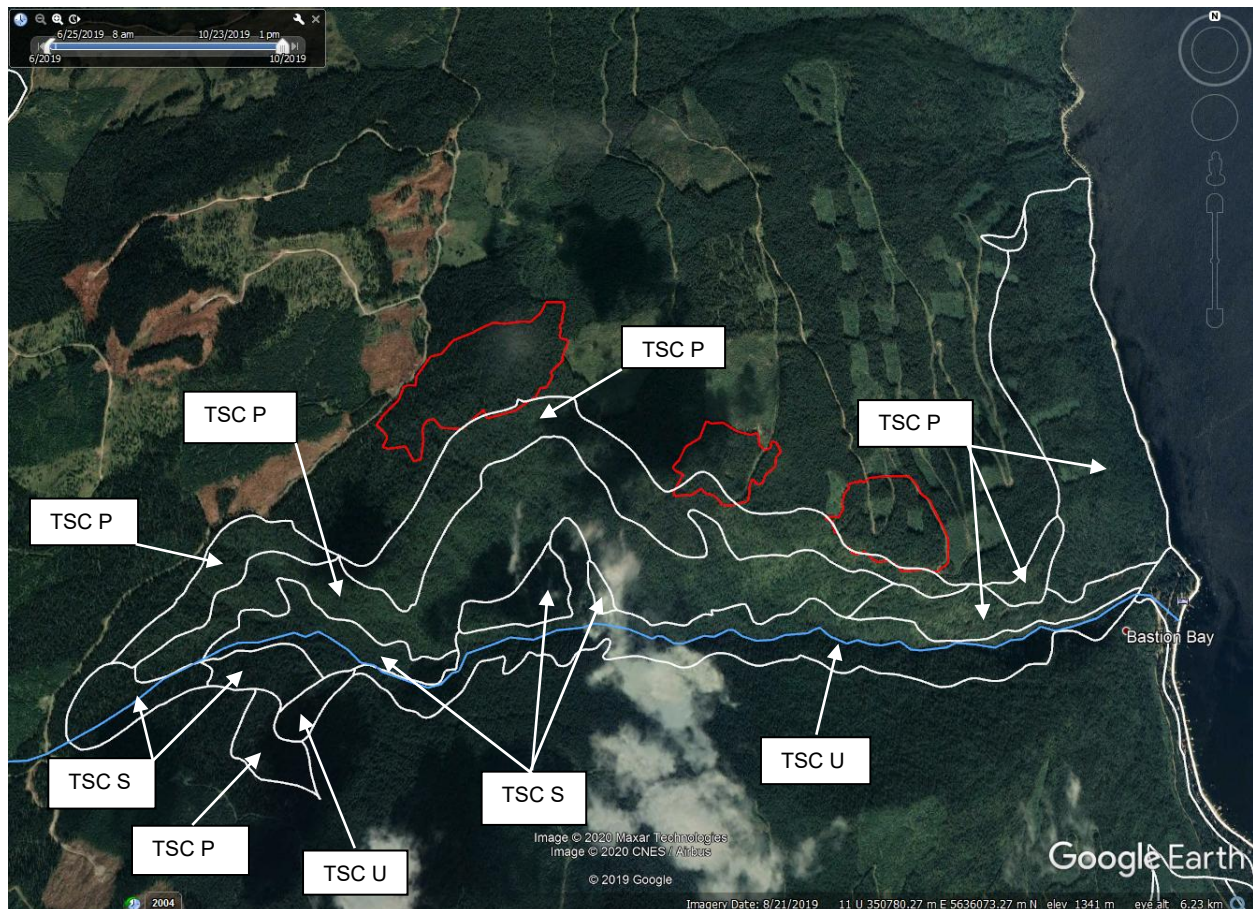
The TSC P and U polygons in the vicinity of the proposed development are indicated on Figure 2 below.

Figure 2 – Terrain stability mapping of the study area.

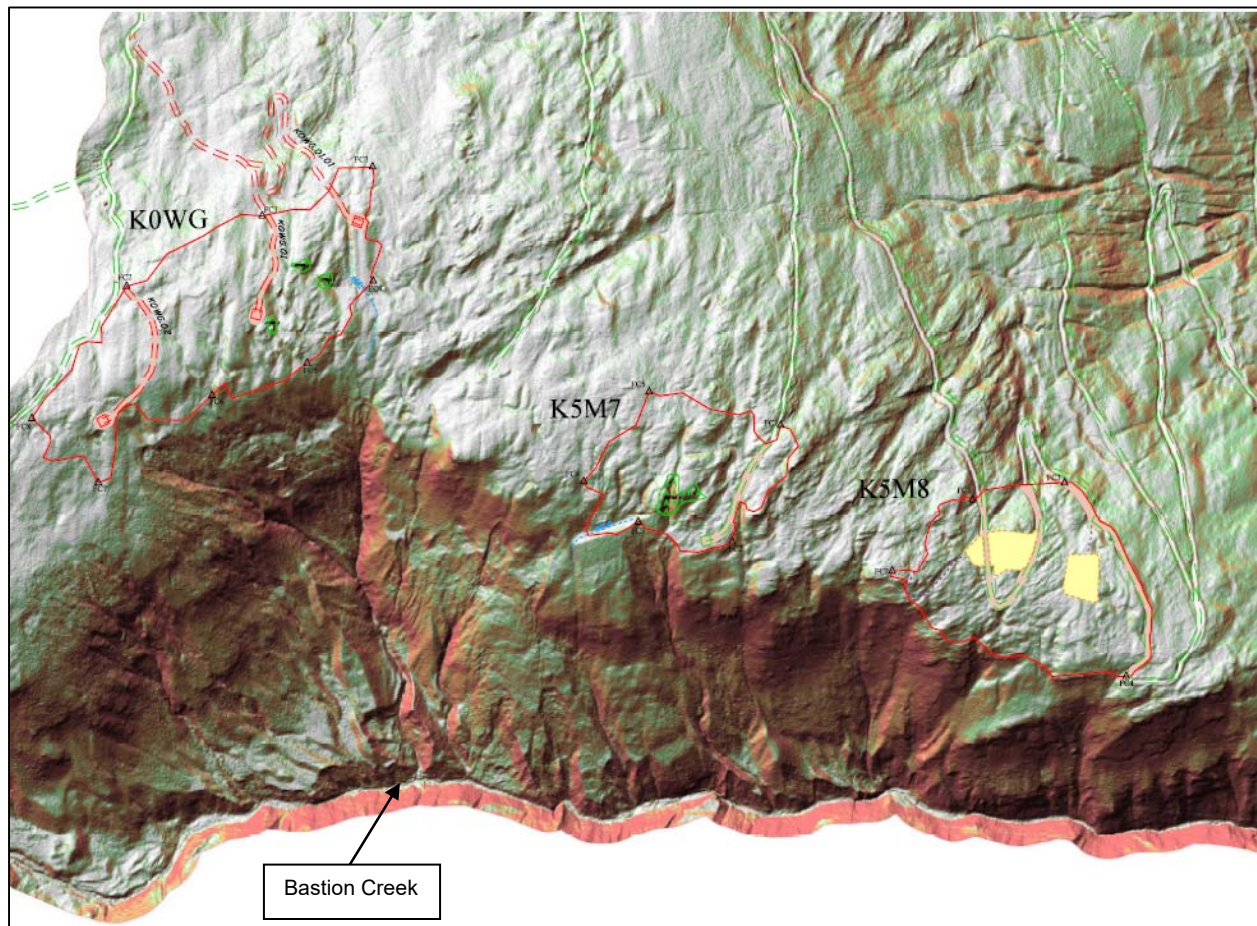
Figure 3 – Overview map of the proposed development. The colour gradient of the terrain correlates with the steepness of the slope.

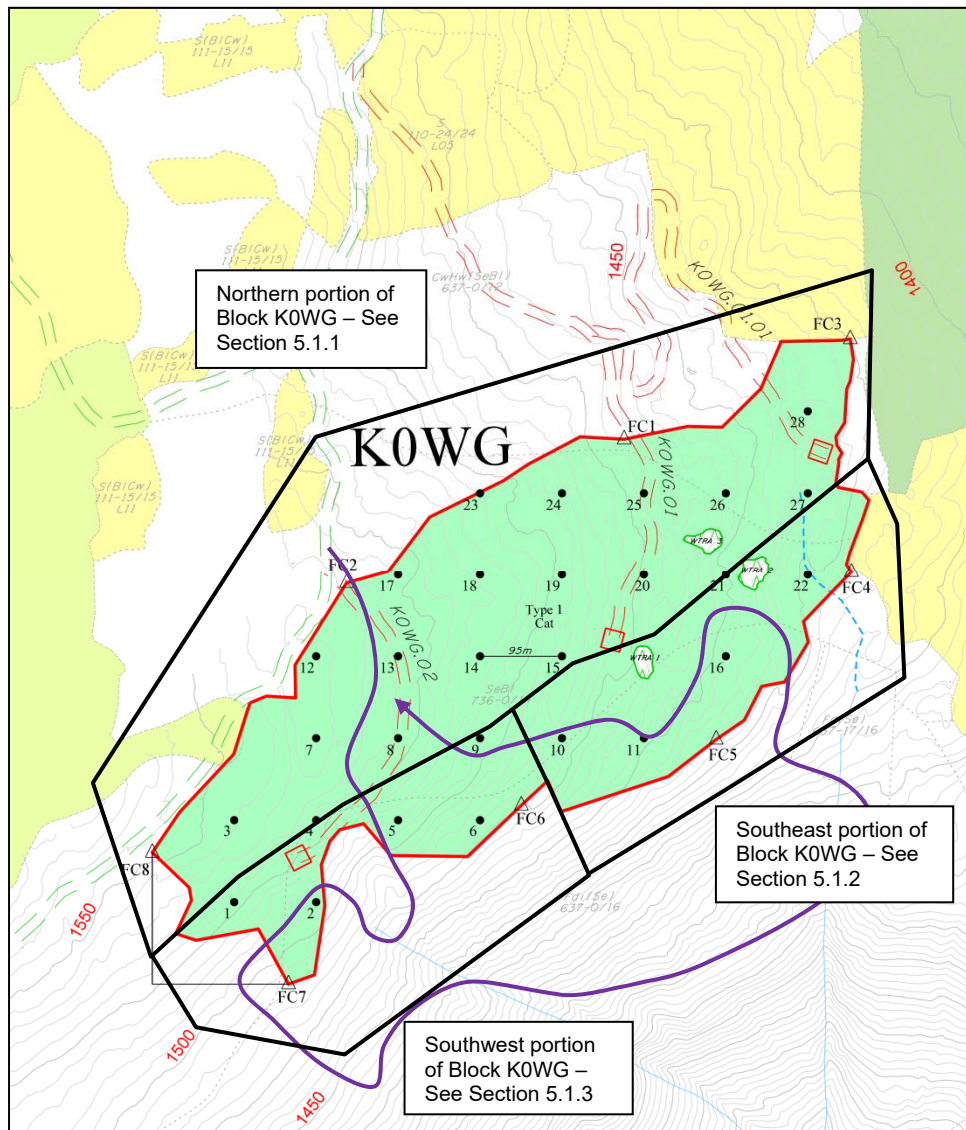
Figure 4 - Proposed Cutblock K0WG. The original map scale was 1:5,000. The traverse route is depicted by the dark purple line.
